Cairns Tilt Train derailment (Ingham-Hinchinbrook)

19 March 2011

Final report, rail safety investigation TMR 3947

Major rail incident investigation

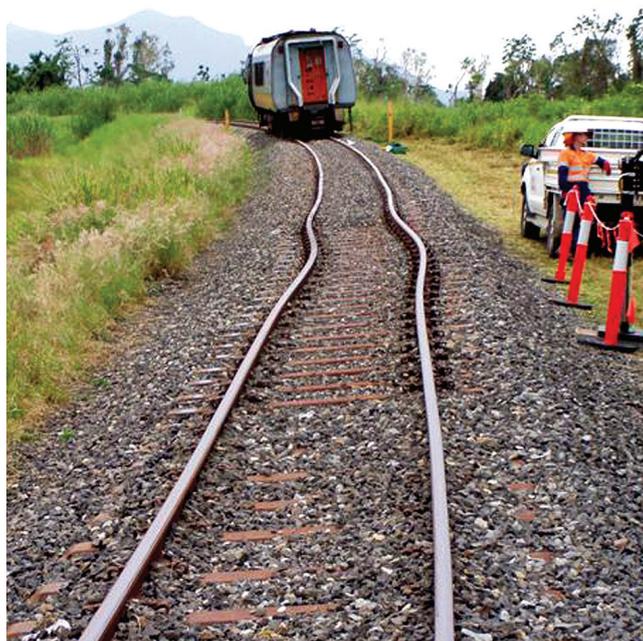
Figure 3: Derailed locomotive in situ

At the point of derailment, and on the right hand rail for north bound trains (the high side) flange climb¹² of the rail was located, followed by scoring on the top of the rail running for approximately three metres in length, before the wheel dropped off into the ballast. Impact marks on the ballast and steel sleepers indicated a derailed running of 62.3 metres.

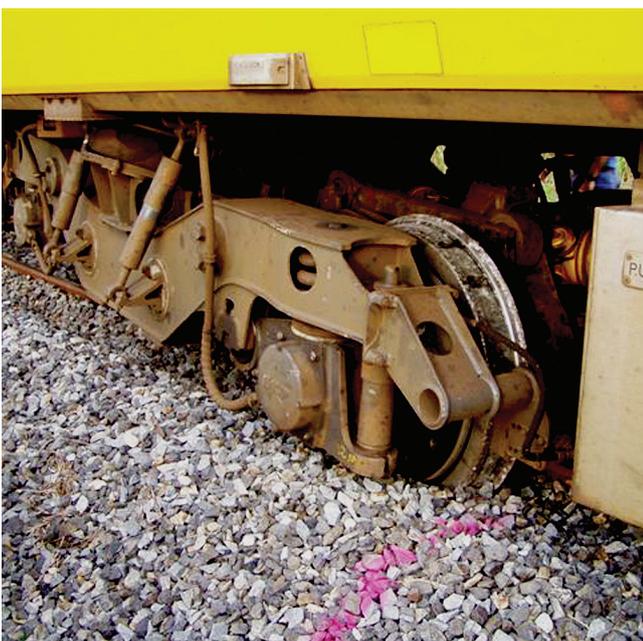
Figure 7: Derailed bogie wheel in situ

Queensland Rail reported that the Cairns Tilt Train, in particular the derailed bogie only suffered superficial damage associated with ballast scuffing. This is supported by photographic evidence. A post derailment inspection of the wheels indicated that they were in good condition, with no wear to the flanges.

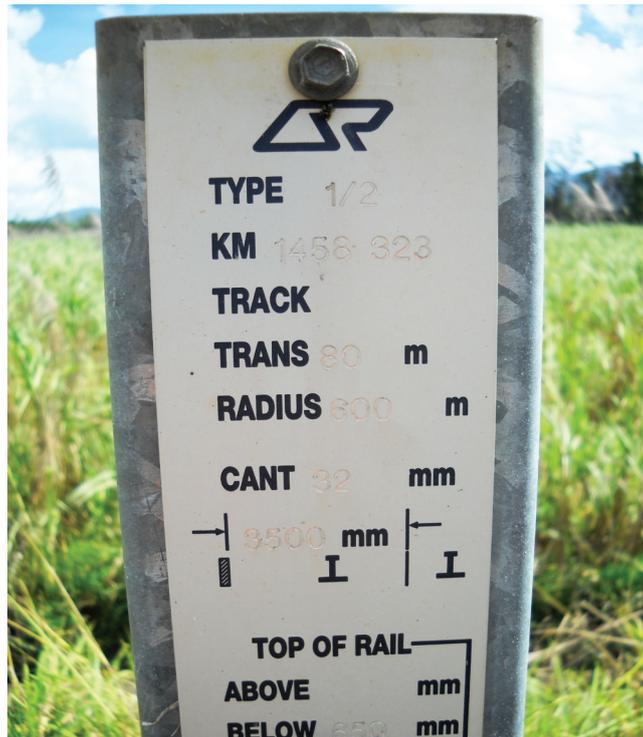
Figure 8: Curve monument situated at the scene of derailment

It was evident upon inspection that curve monuments for the 600m radius curve were not all in good condition, and may have moved since installation. One curve monument in particular was extremely loose and could be moved by up to 150mm. It was established as part of the investigation that the Rail Infrastructure Manager did not have a program in place to check or maintain curve monuments in this area.

Curve monuments¹⁰ were present at the start, middle and end of each transition curve and one at the midpoint of the circular arc at the site. Upon inspection, at least one of these curve monuments was so loose in the ground as to be ineffective. Others may have also been disturbed.

- develops a program to establish and maintain the integrity of curve and creep monuments in compliance with sub-section 10.6.2 SAF/STD/0077/CIV *Civil Engineering Track Standards*.
