Serious Injury Collision, Draper Street, Cairns **15 June 2015**

Final report, rail incident investigation QT5128

Major rail incident investigation

Final report, incident reference: QT5128

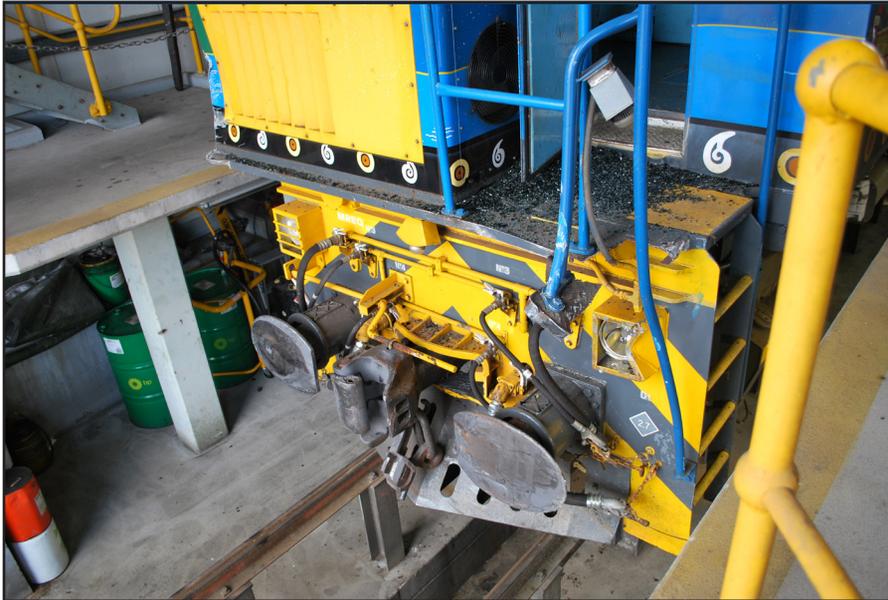
The lead locomotive sustained minor damage as a result of the collision.

Figure 3: Damage to front of locomotive DEL1774

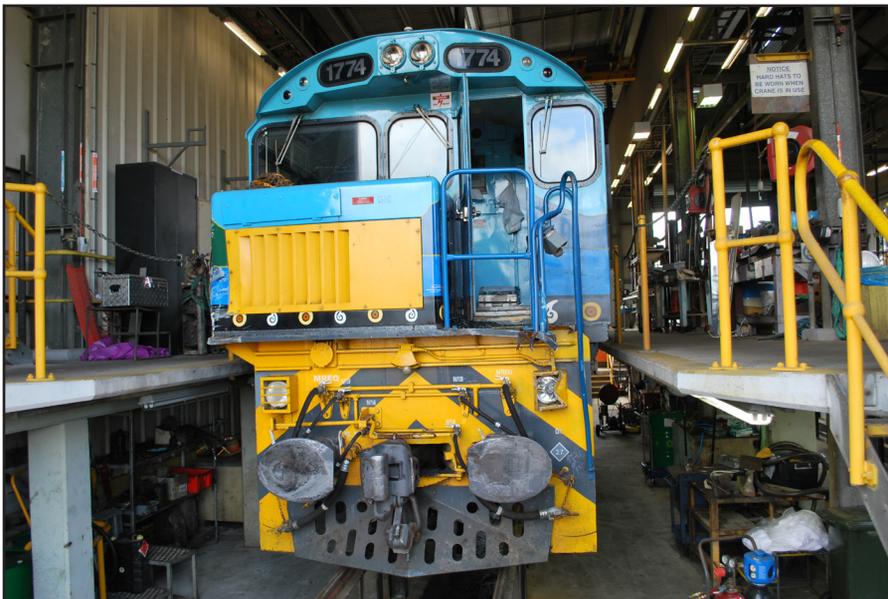
Figure 4: Lead locomotive DEL1774

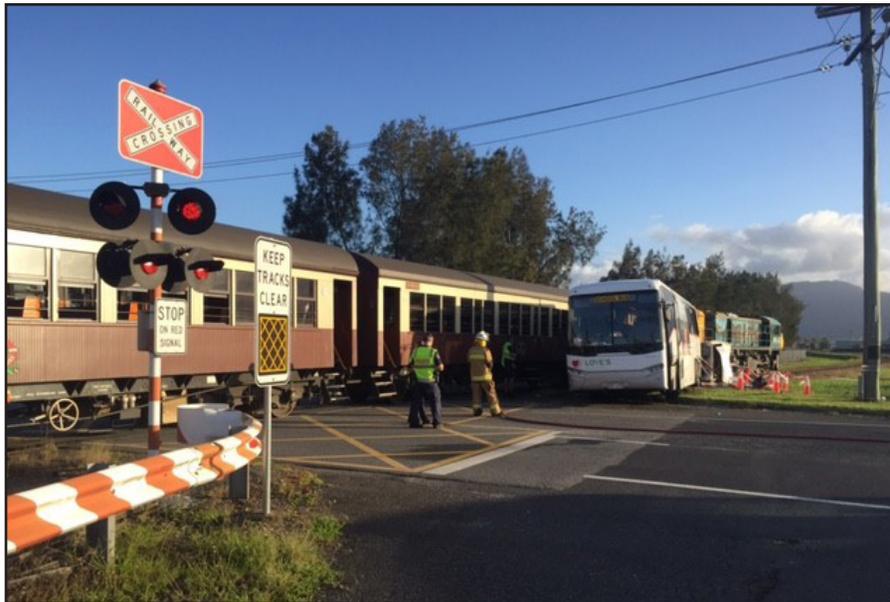
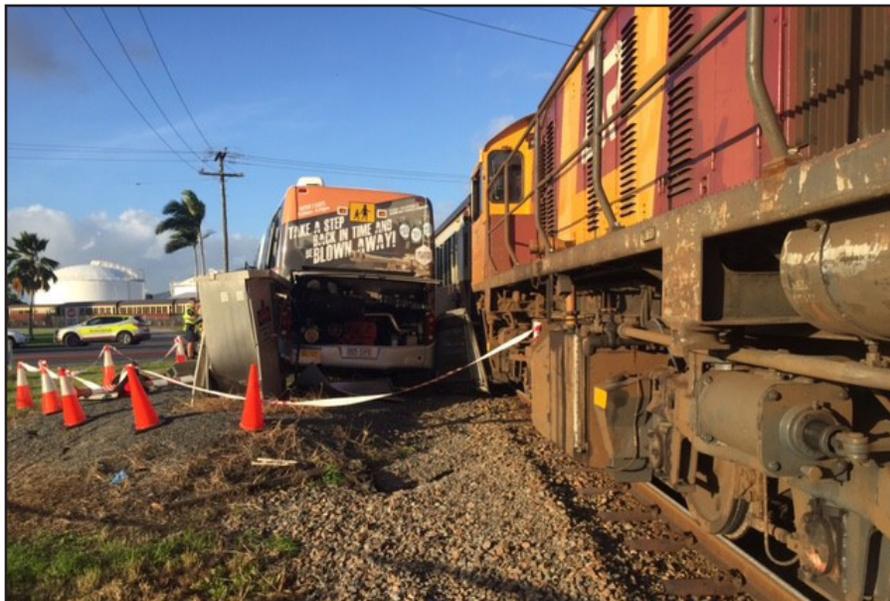
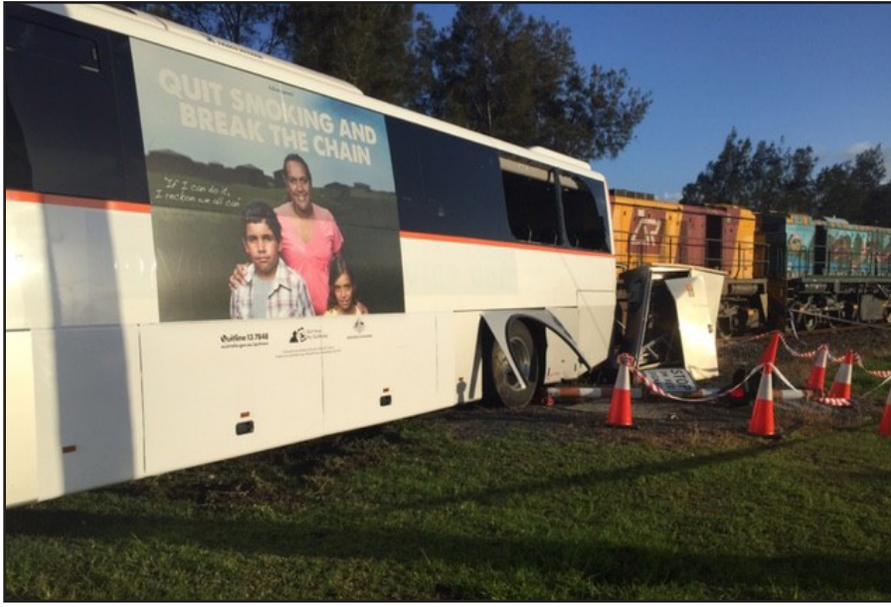
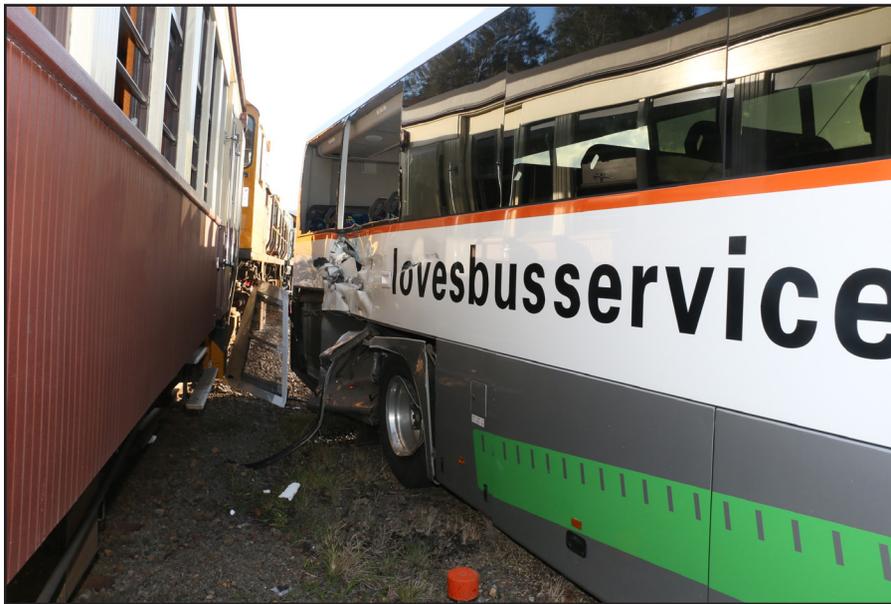
The level crossing signal control box and a red flashing light situated to the north-west of the level crossing received significant damage as a result of the collision.

The bus received damage to the driver's side as a result of the collision with the train. A secondary impact to the passenger side occurred when the bus impacted with the level crossing signal control box north-west of the crossing.

Figure 5: Train and bus in situ

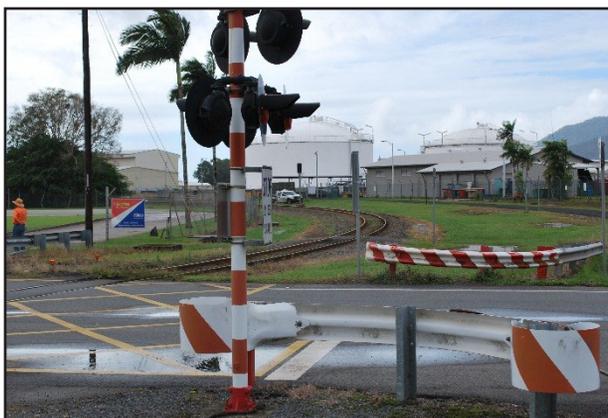
Figure 13: Stop line and red flashing light structure showing crossing the approaching train path

- The incorrect placement of the stop line adjacent to the RX-5 structure (red flashing lights). The placement limits the view of a vehicle stopped at the stop line. This is exacerbated in a bus where the driver sits at the very front of the vehicle. Setting back the stop line the three metres in compliance with the MUTCD provides increased forward vision RX-5 pedestal (red flashing lights).
- The intersection of Comport and Draper Street is approximately 70m north-west of the level crossing. This intersection is controlled by traffic signals and causes traffic to queue back to the Draper Street level crossing and beyond.

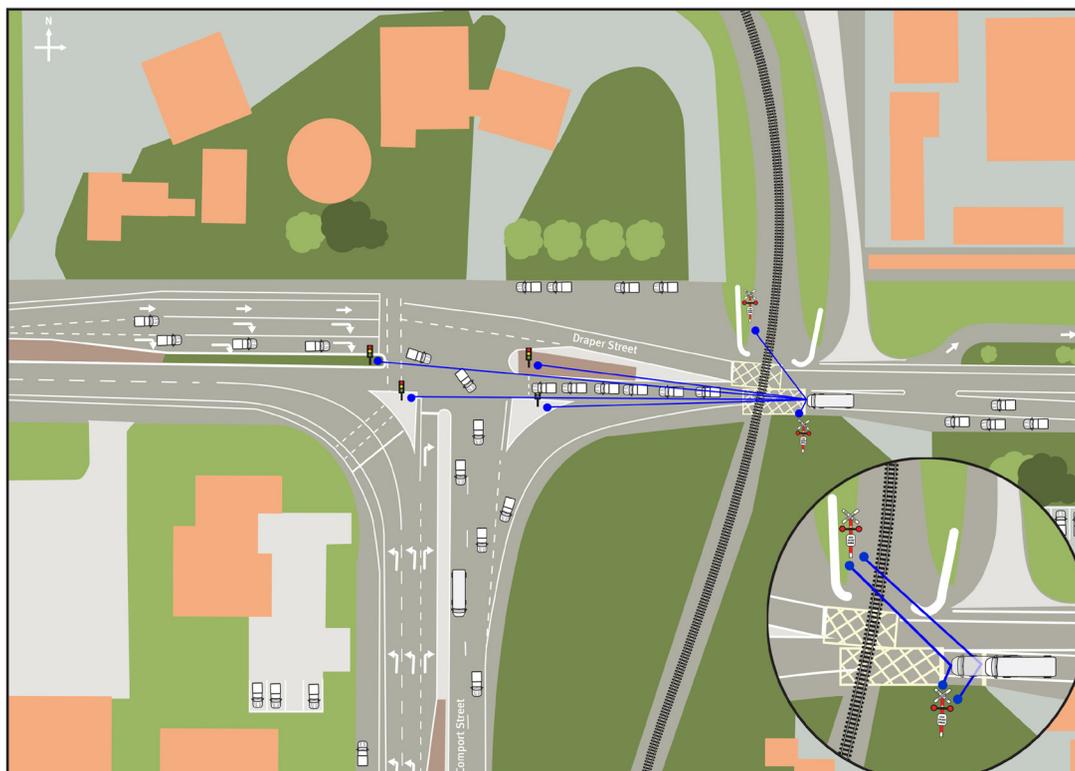
Figure 16: Drawing depicting the position of the bus with the stop line in place at the time of the incident and the acute angle of the primary lights, the inset shows the difference in angle had the stop line been positioned as required in the MUTCD.

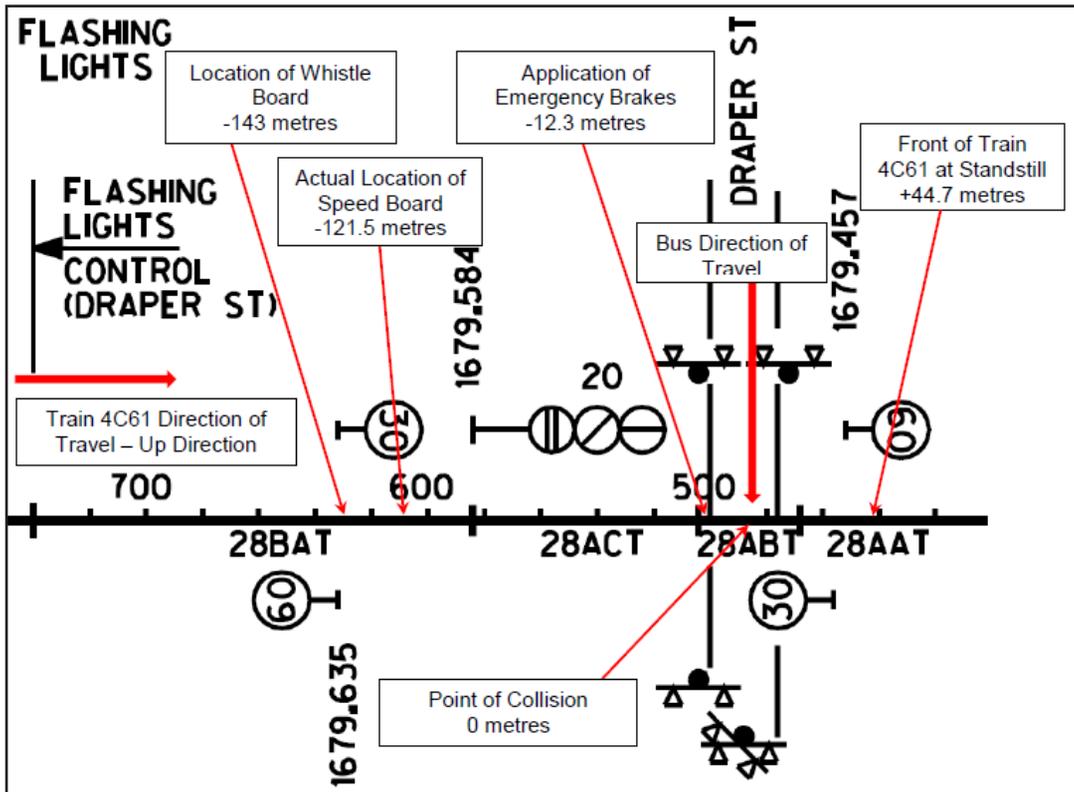
Figure 17: Diagram outlining the location of signage, brake application and stopping location of lead locomotive.

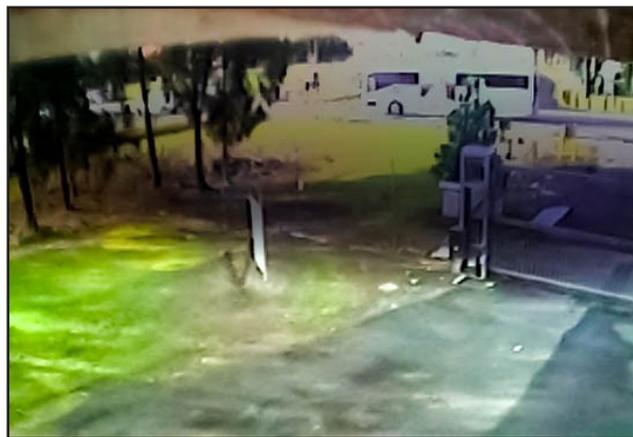
Figure 20: Still image of CCTV footage taken from a nearby business, indicates bus stopped at the Draper Street level crossing.

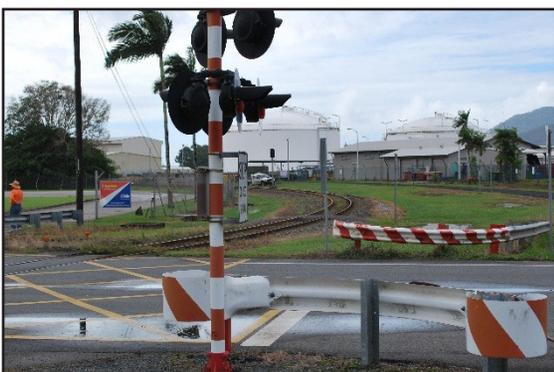
Figure 21: Draper Street level crossing road markings at the date of the collision
