### **FINDINGS OF INQUEST**

**CITATION:** **Inquest into the death of Jason Jon GARRELS**

**DELIVERED ON:** 11 August 2015

**CATCHWORDS:** CORONERS: Inquest – building site – death by electrocution after coming in contact with temporary construction wiring – breaches of Wiring Rules involved in temporary electricity supply

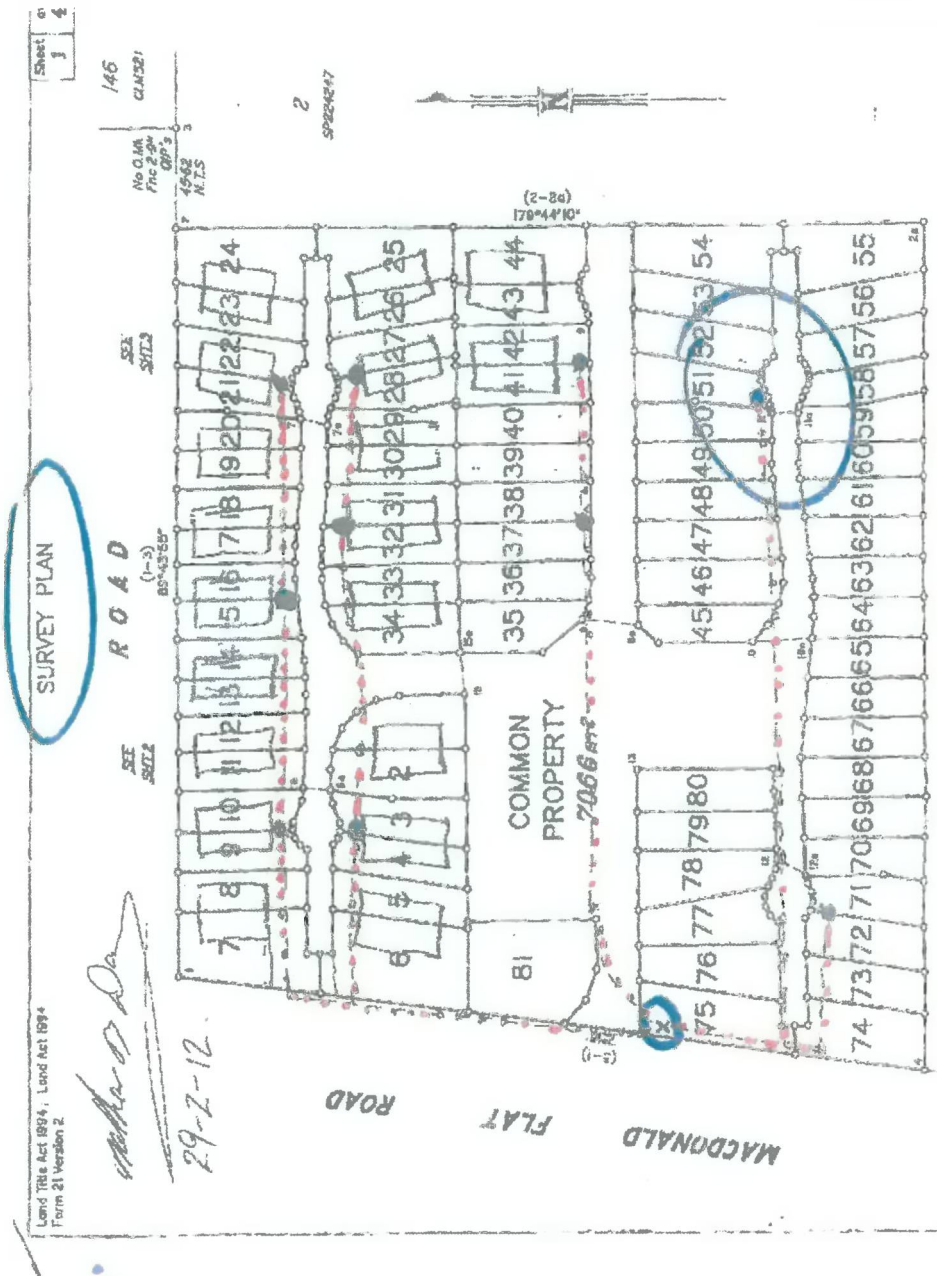
<sup>21</sup> the red dashed lines represent the construction wiring. The blue dots represent construction sub-boards. The construction power pole, and construction switchboard, is indicated by an 'X' in a blue circle seen in lot 75
