Serious Injury Collision, St Vincents Road, Banyo 14 September 2012

Final report, rail incident investigation TMR 4617

Major rail incident investigation

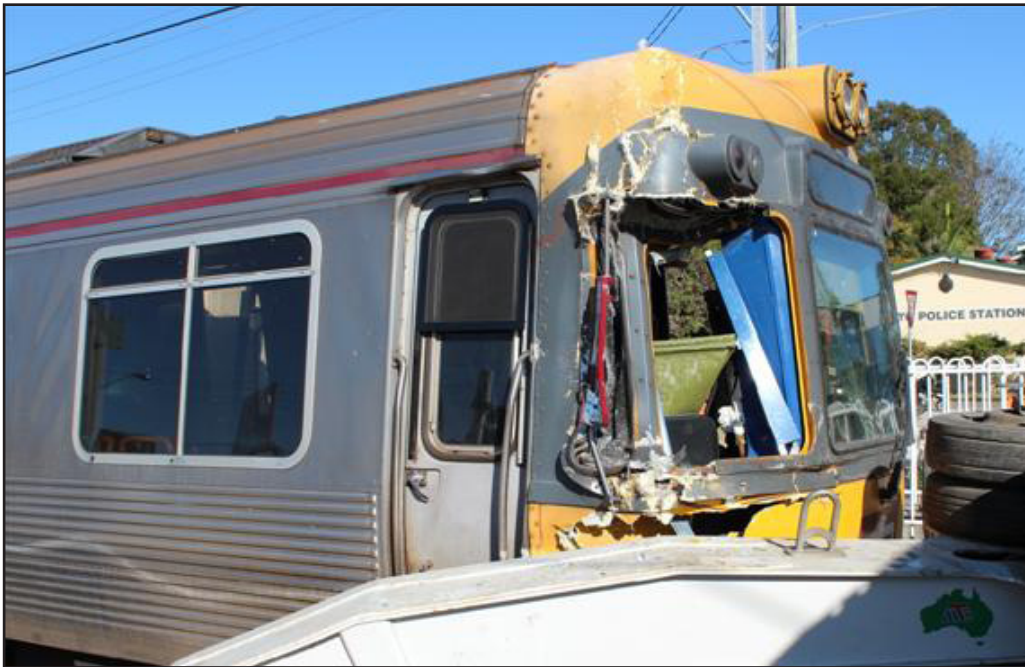
Figure 5: Damage to northbound train

The stationary southbound train sustained minor damage to the front of the cab. The northbound train derailed on impact and sustained significant damage to the drivers cab and along the right hand side of the lead unit, as depicted in Figure 5.

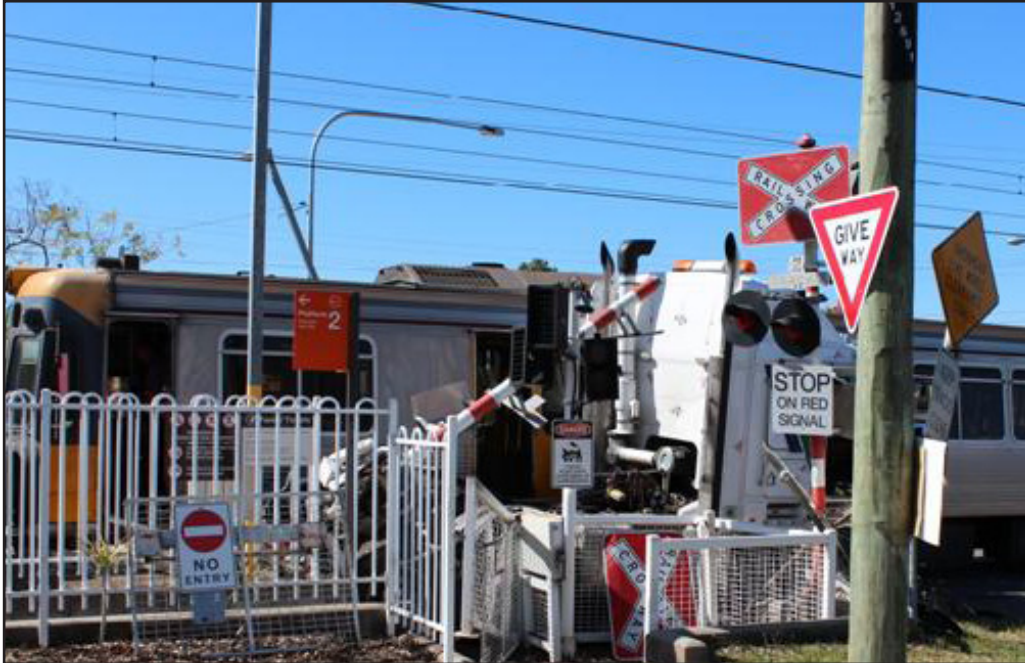
Figure 6: Damage to rail infrastructure

The pedestrian and level crossing protection equipment sustained extensive damage, as shown in Figure 6. The rail infrastructure including tracks and support structures and the overhead electrical lines sustained minor damage.

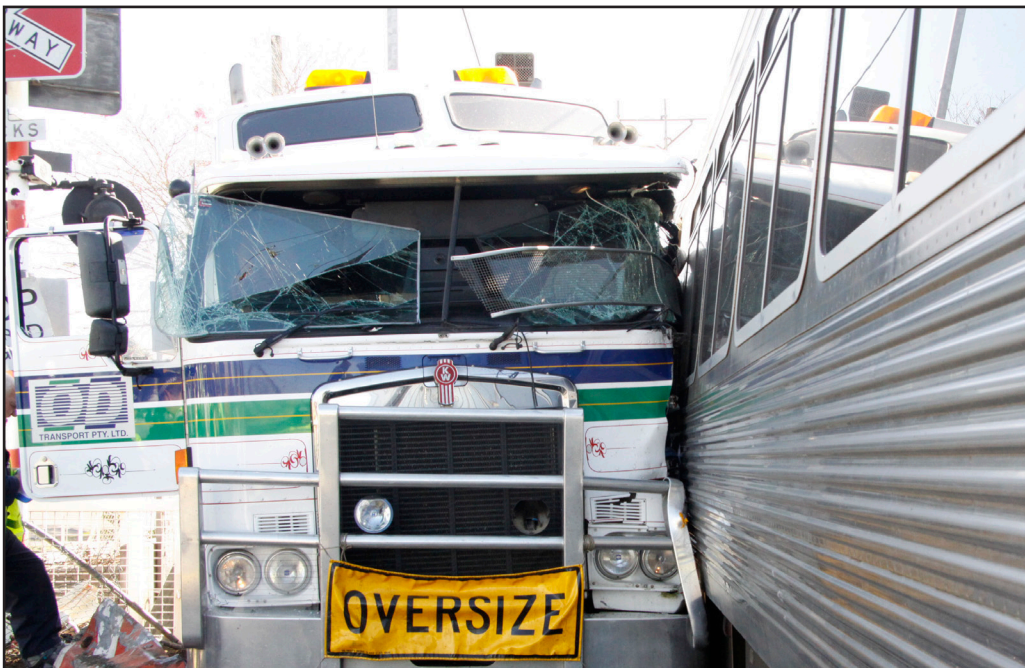
Figure 7: Damage to heavy vehicle

The heavy vehicle sustained extensive damage, as shown in Figure 7.

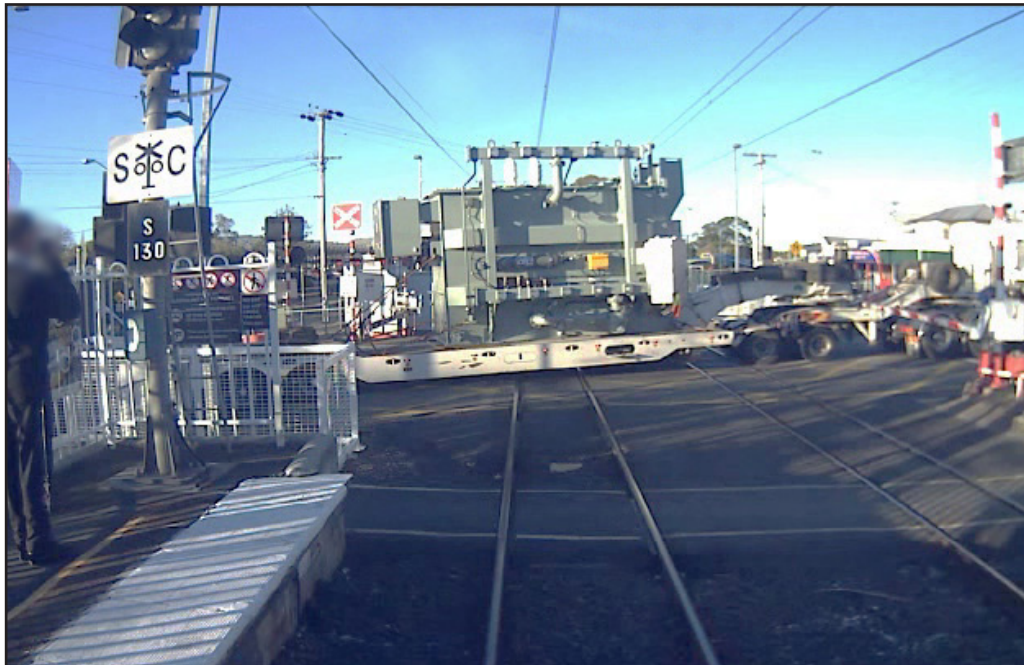
The CSA walked to the front of the office while talking into the hand held radio and checked the Remote Train Overview Application¹⁶ screen to identify the location of approaching trains. At 6:31:32am the CSA left the office while talking into the radio and walked towards the southern end of the platform near the level crossing. Figure 8 shows the CSA talking into the radio and the heavy vehicle grounded on the crossing.

Figure 8: Heavy vehicle grounded on the level crossing, the CSA to the left on the radio

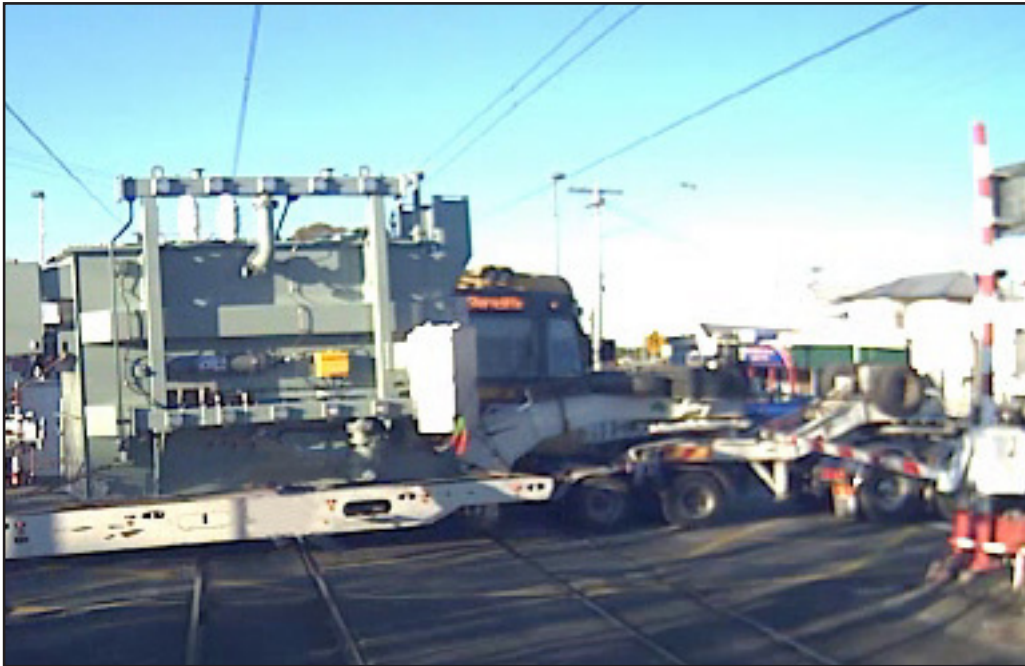
Figure 9: Moment of impact

At 6:32:35am, the northbound train collided with the heavy vehicle in the vicinity of the articulation point between the prime mover and dolly trailer (refer Figure 9). The member of the public escaped uninjured however the driver was struck by the low loader trailer and pushed into the eastern side rail corridor fence.

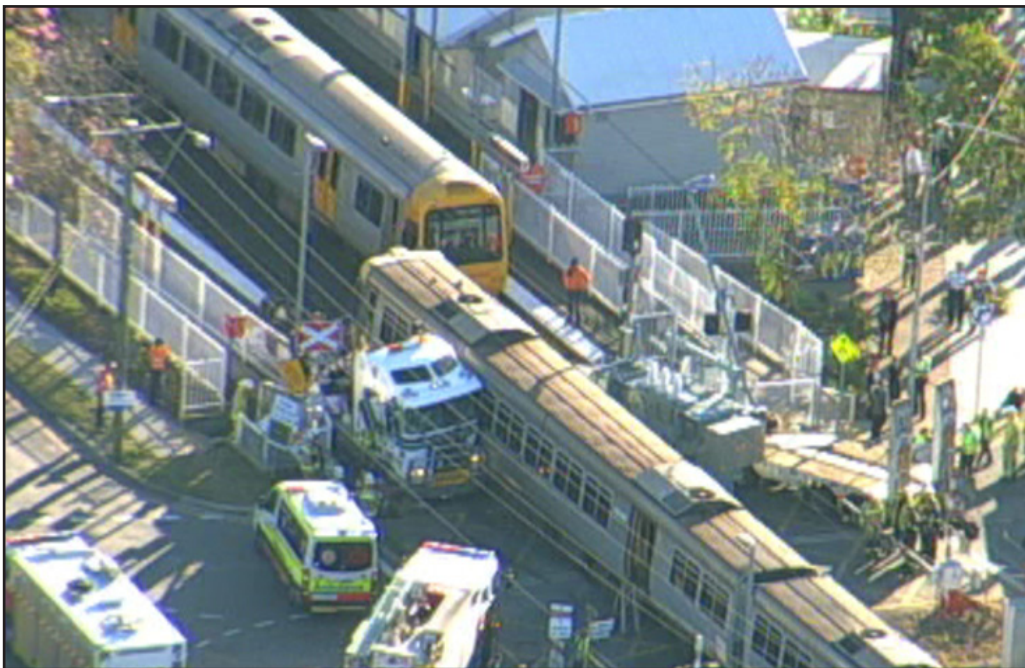
Figure 10: Aerial view

Upon impact, the prime mover was pushed to the western side of the rail corridor against the left hand side of the northbound train. The dolly trailer was pushed north, through the level crossing becoming jammed between the two station platforms and against the stationary southbound train. The low loader trailer, still attached to the dolly trailer, was pushed towards the eastern side of the rail corridor coming to rest against the corridor fencing. The transformer was dislodged and came to rest in an upright position spilling a small amount of oil and fluid on the roadway beside the northbound train. Figure 10 shows an aerial view of the incident site.

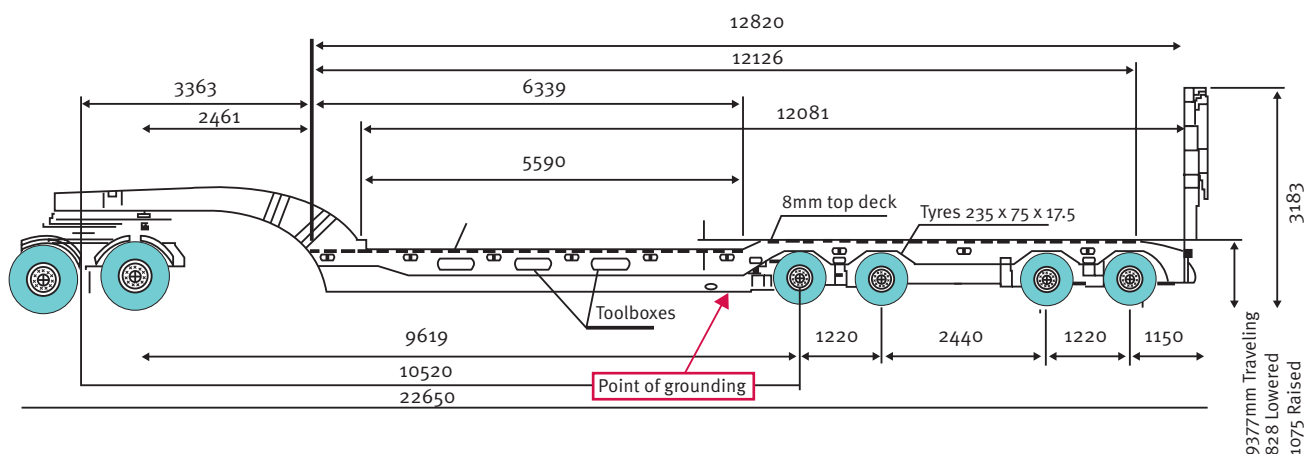
Figure 12: Schematic of low loader

Tufnell and St Vincents Roads are managed and maintained by the road manager. The roads are classified as suburban routes which connect arterial routes in and around suburbs and form important links in the public transport and inter-suburban freight network. The chassis of the low loader of the heavy vehicle combination became grounded on the road pavement in the vicinity of the third axle, which is depicted in Figure 12.

The grounding of the heavy vehicle is considered to be a contributing factor to the incident. Following the incident, the RTO undertook an assessment of the road geometry to determine its potential contribution to the incident. The RTO has created engineering drawings²² that specify details of public road grading and sign posting for level crossings.

The assessment surveyed the geometry with vertical alignment cross sections at the centreline and both shoulders. The assessment found that the vertical geometry of St Vincents Road across the level crossing does not comply with the drawings, in that all three cross sections fall away more steeply on the approach side of the crossing.

The investigation conducted by the RRU determined, from the evidence available, that the existing vertical geometry on the eastern approach to the level crossing was not suitable for low loader vehicles. It is noted that the local road manager did not provide any evidence of any enquires that it had conducted to support its own conclusion.
