**Commission of Inquiry**  
PARADISE DAM

# REPORT

APRIL 2020

In accordance with the *Commissions of Inquiry Order (No. 1) 2019*, we have made a full and careful inquiry into the root cause of structural and stability issues identified with the Paradise Dam near Bundaberg.

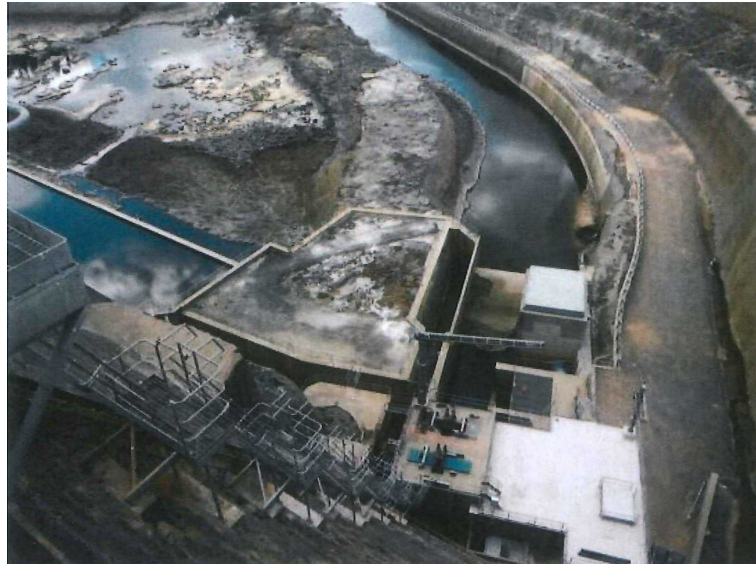
Figure 2.2 – Downstream of the primary spillway following the 2011 event. The outlet works are on the right and the 'central island' is in the centre of the image. (Exhibit 230, **DNR.006.3156**, .3219)

- 2.5 Those areas were said to be of 'elevated' concern with respect to dam stability or operation.<sup>7</sup> The nature of the damage also raised concerns about the stability of the left and right training walls.<sup>8</sup>

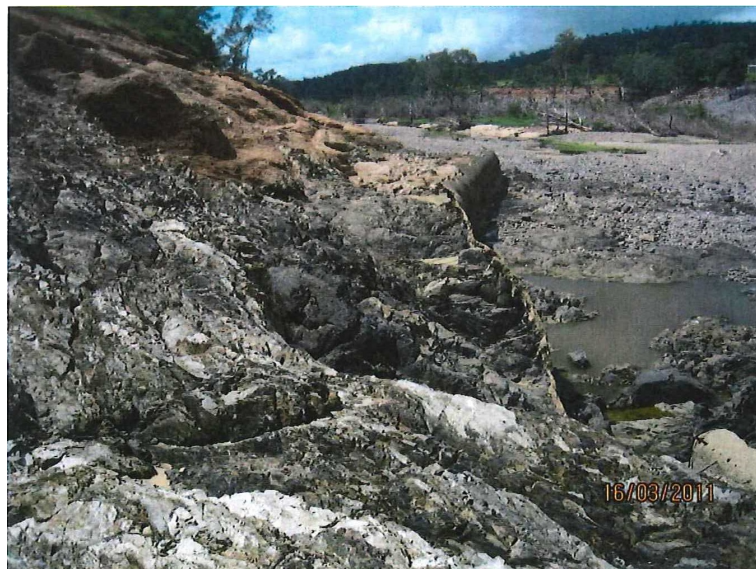
Figure 2.3 – Erosion on the left bank following the 2011 event. (Exhibit 230, **DNR.006.3156**, .3192)

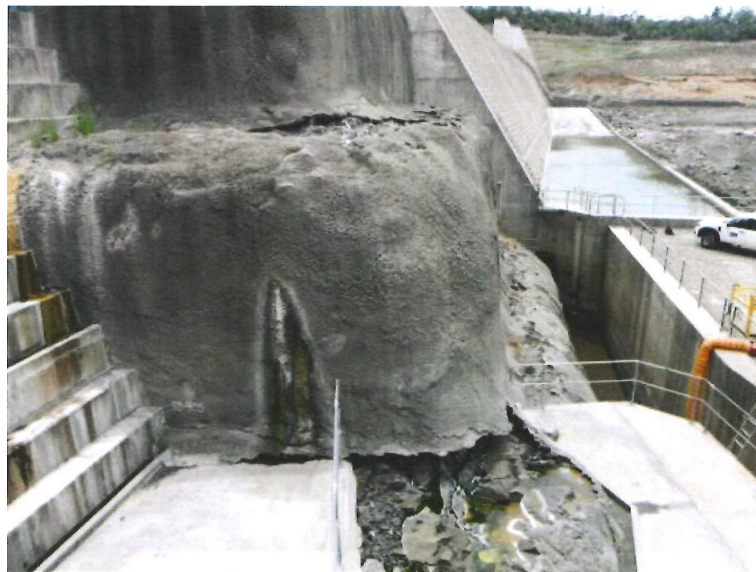
*Figure 2.4 – Damage to the basalt 'pimple' above the fishway channel (to the right of the image). Material was deposited in the fishway as a result of the flood. (Exhibit 230, **DNR.006.3156**, .3218)*

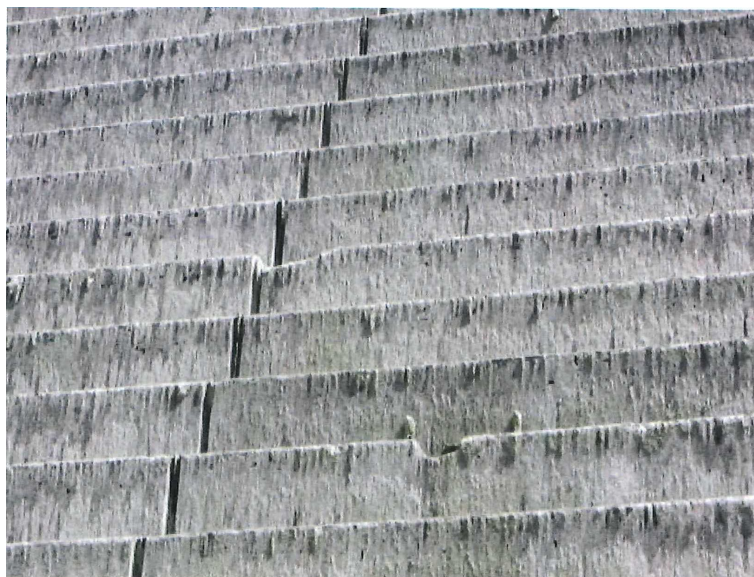
- 2.12 Most of the concrete on the downstream stepped face remained in reasonable condition. However, in places, concrete had been removed from the steps, possibly by log impact. There was some 'pitting' of the vertical face just below the horizontal step which may have been caused by cavitation.<sup>16</sup>

Figure 2.5 – Primary spillway steps showing some damage after the 2011 Event.  
(Exhibit 230, **DNR.006.3156**, .3221)

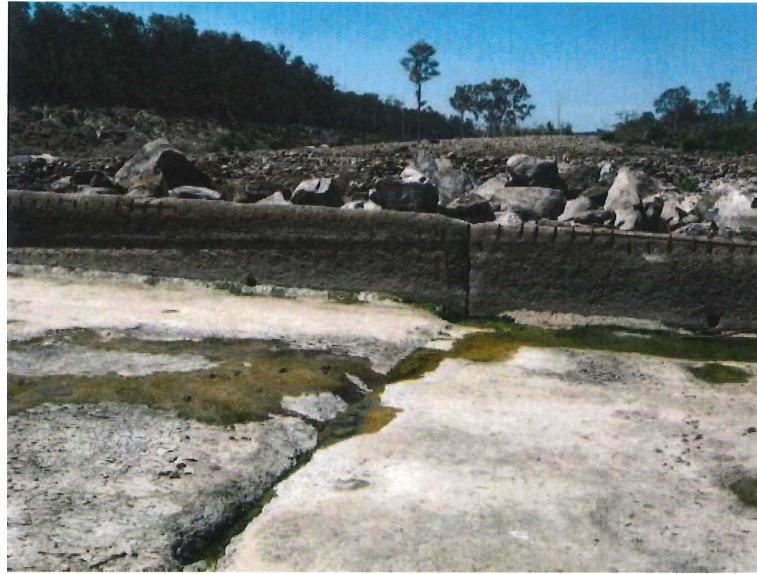
the apron itself. In one location a hole had been scoured to a depth of about 300 mm through the apron.<sup>21</sup>

*Figure 2.6 – Part of the apron and sill following the 2011 event. Abrasion at the top of the end sill is visible. (Exhibit 230, **DNR.006.3156**, .3229)*

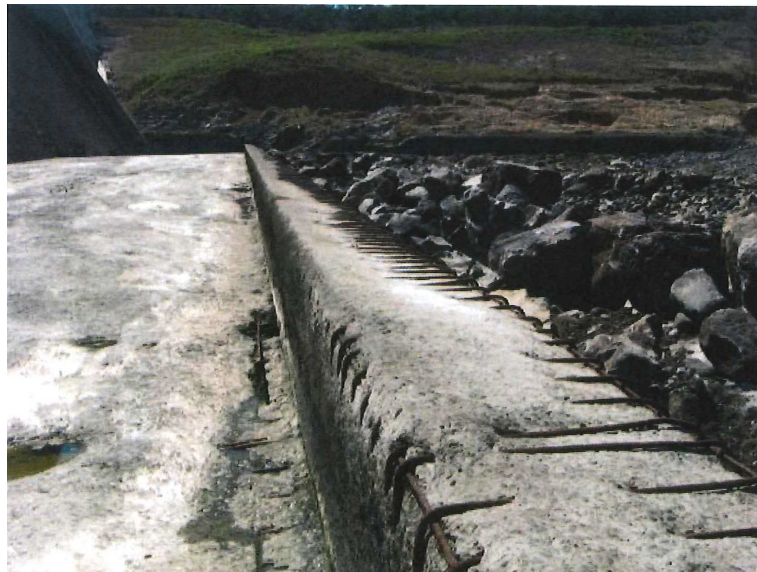
*Figure 2.7 – The primary spillway apron end sill after the 2011 event. Abrasion of the end sill was most likely caused by 'rock drawn into the basin and then tumbled around in the roller flow'. (Exhibit 230, **DNR.006.3156**, .3178 and .3231)*

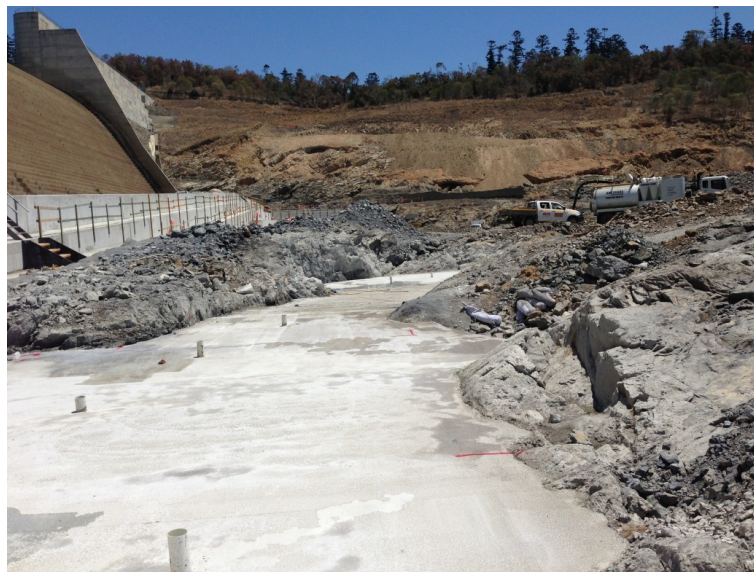
Figure 2.14 – Localised erosion backfilled with concrete in the area immediately downstream of the apron.  
This image was taken in October 2013. (Exhibit 237, **SWA.512.001.0578**, .0609)

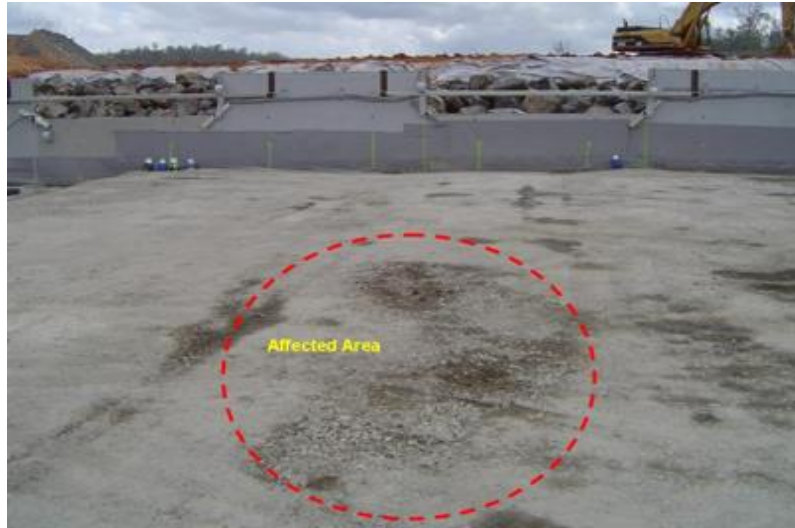
Figure 4.1 – Area of segregation in lift surface

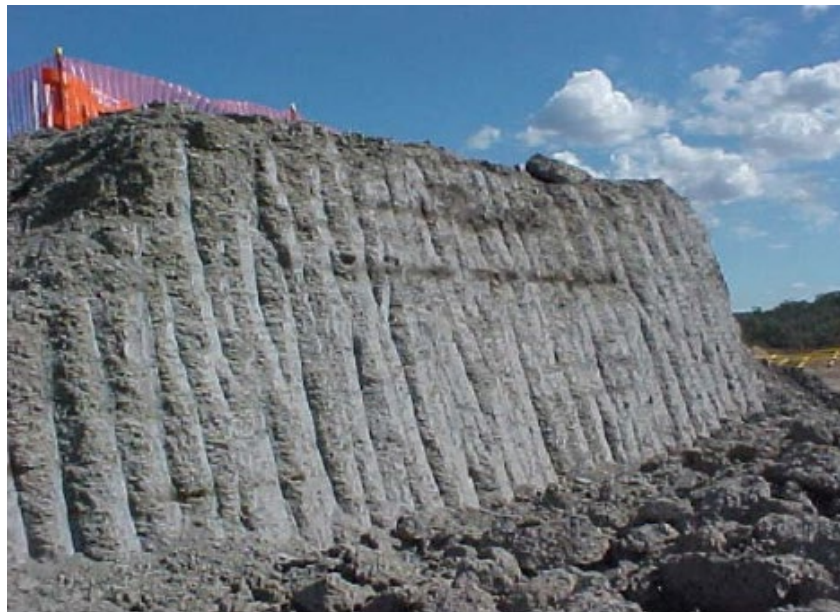
Figure 4.9 – Vertical face cut through at chainage 903 showing damped bond between two lift joints.  
(Exhibit 109, **SCE.019.0001**, .0009)

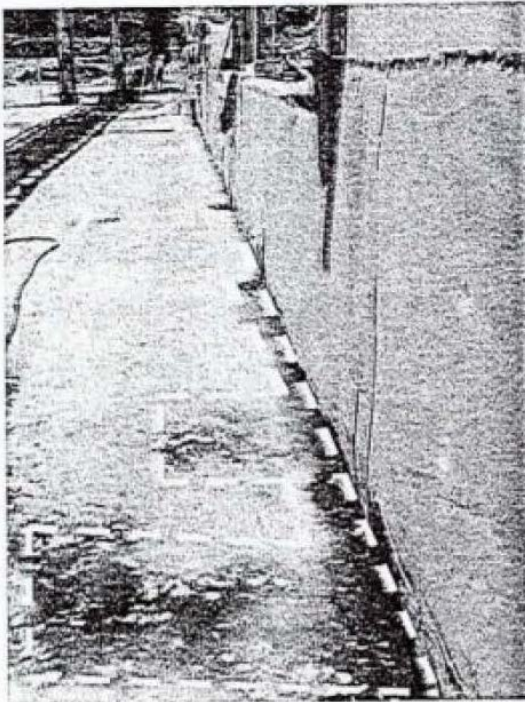
Picture 7. 25 Oct 04 - View of RCC surface next to U/S panel **contaminated** with sand, & mud creating **delays** to start RCC placement.

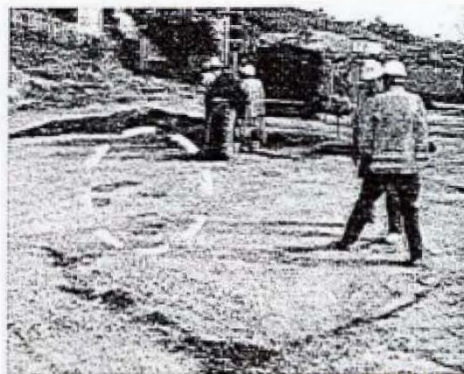
Picture 42. 27 Oct 04 - **Damage of RCC surface by wheels of the placing conveyor. It is advisable to clean & remove this contamination before RCC placing.**

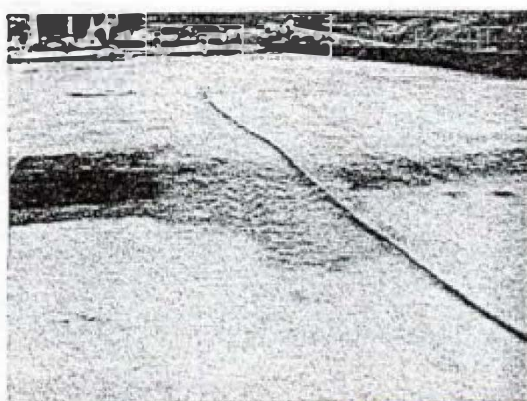
Picture 30. 27 Oct 04 – Dry RCC surface due to the lack of curing.

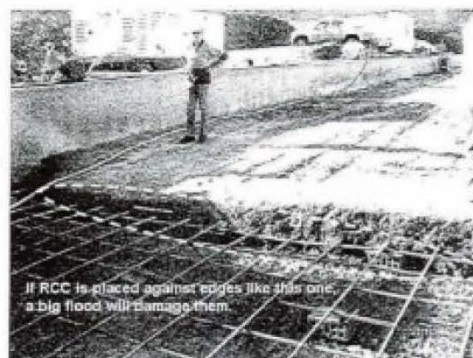
Picture 6 (12 June 05DS). Loose material along RCC edges affects the bond between old and new RCC.

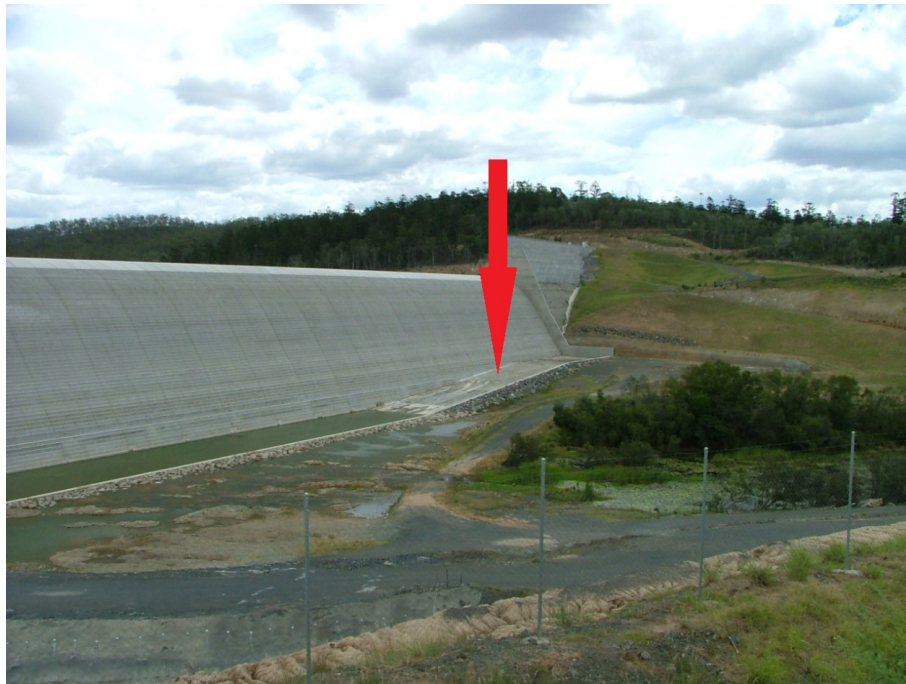
Figure 6.1 – The Dam 'as constructed' in 2005. The asymmetry created by the upwards slope on the left hand end of the apron is visible, depicted by the red arrow. (Exhibit 237, **SWA.512.001.0578**, .0596)

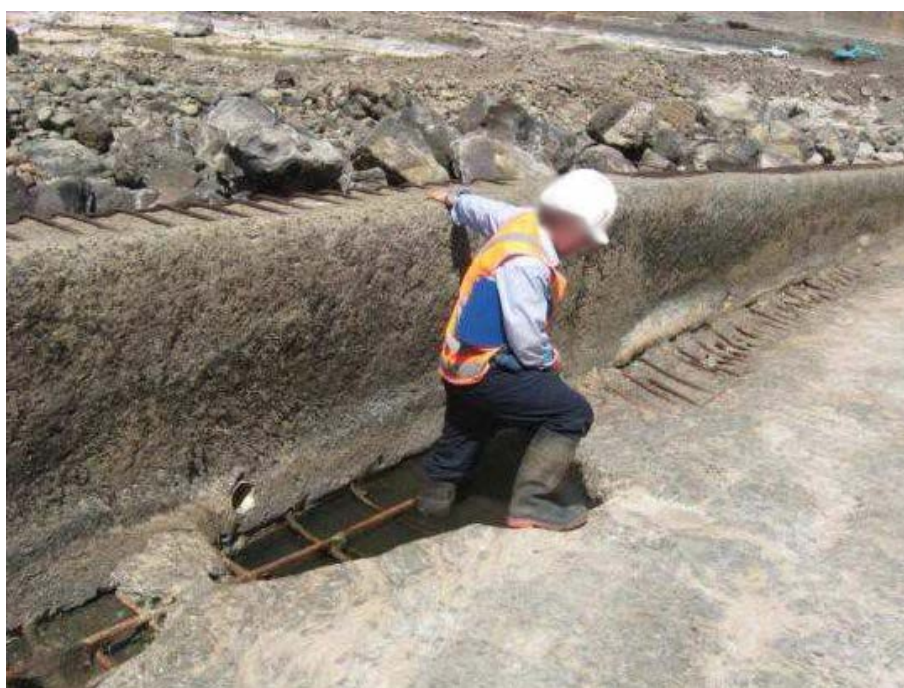
Figure 6.4 – Abrasion damage to the apron floor and the end sill following the 2011 event.  
(Exhibit 5, **DNR.002.8498**, .8520)

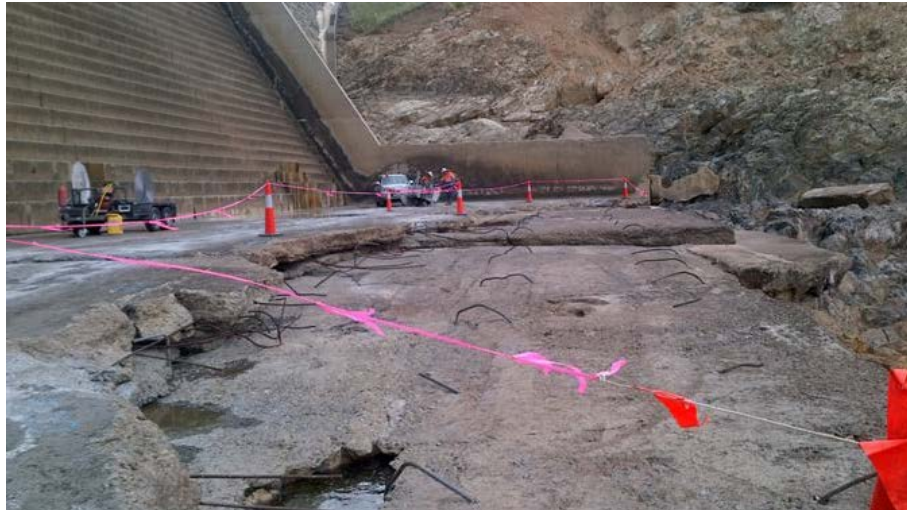
*Figure 6.6 – Damage to the apron following the 2013 event.  
The end sill on the left hand side of the apron has detached. (DNR.001.0036, .0092)*

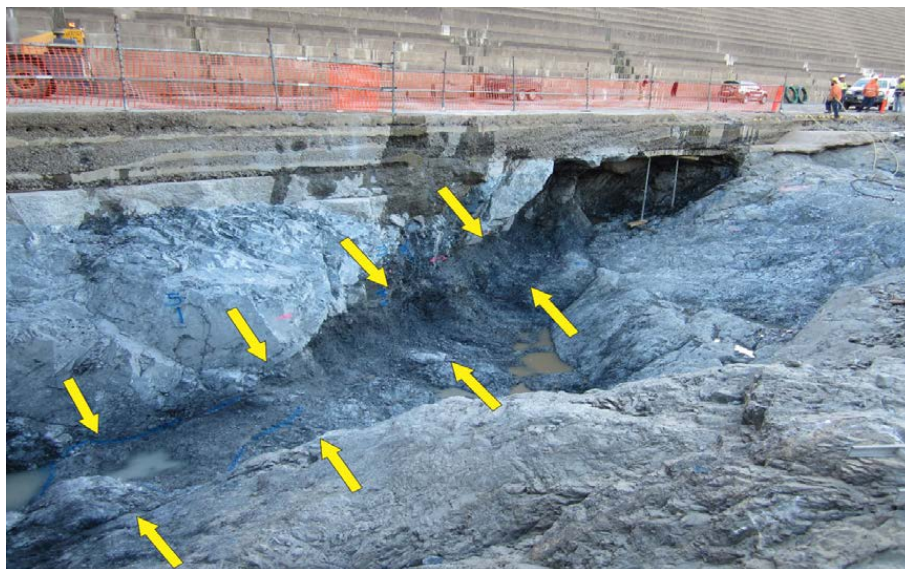
*Figure 6.7 – Scour hole immediately downstream at the right side of the apron.  
The arrows show the estimated region of the fault zone. (DNR.001.0036, .0093)*

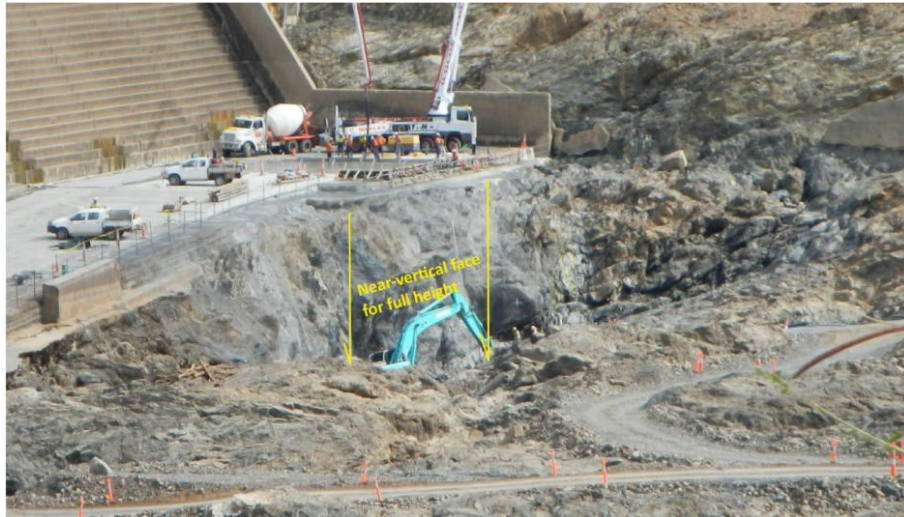
Figure 6.8 – Scour hole immediately downstream at the left side of the apron.  
(Exhibit 7, **IGE.017.0001**, .0059)

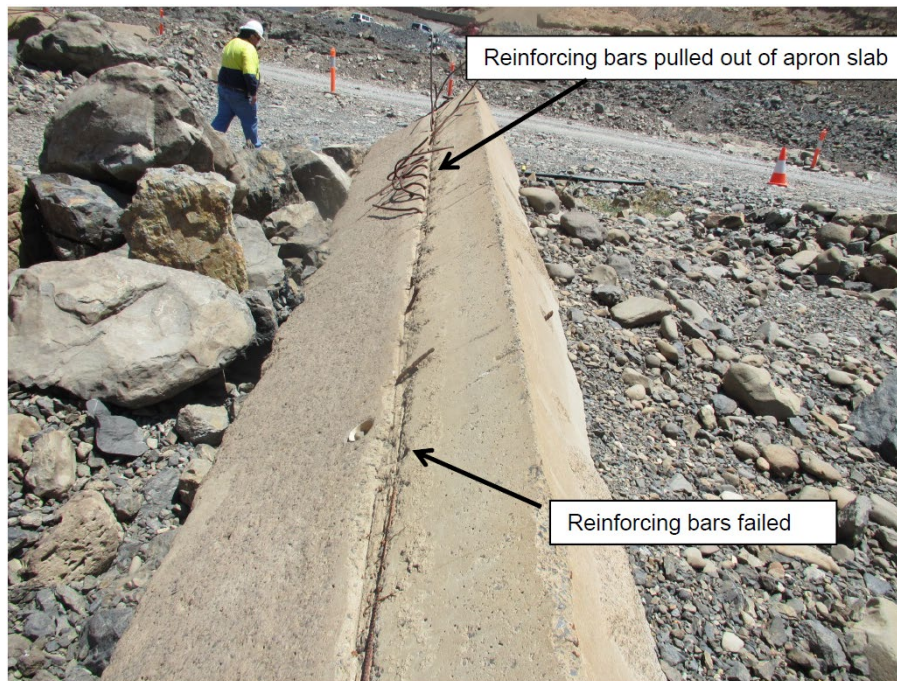
Figure 6.15 – Piece of end sill downstream of the Dam following the 2013 flood.  
The annotations were made by URS. (Exhibit 237, **SWA.512.001.0578**, .0609)

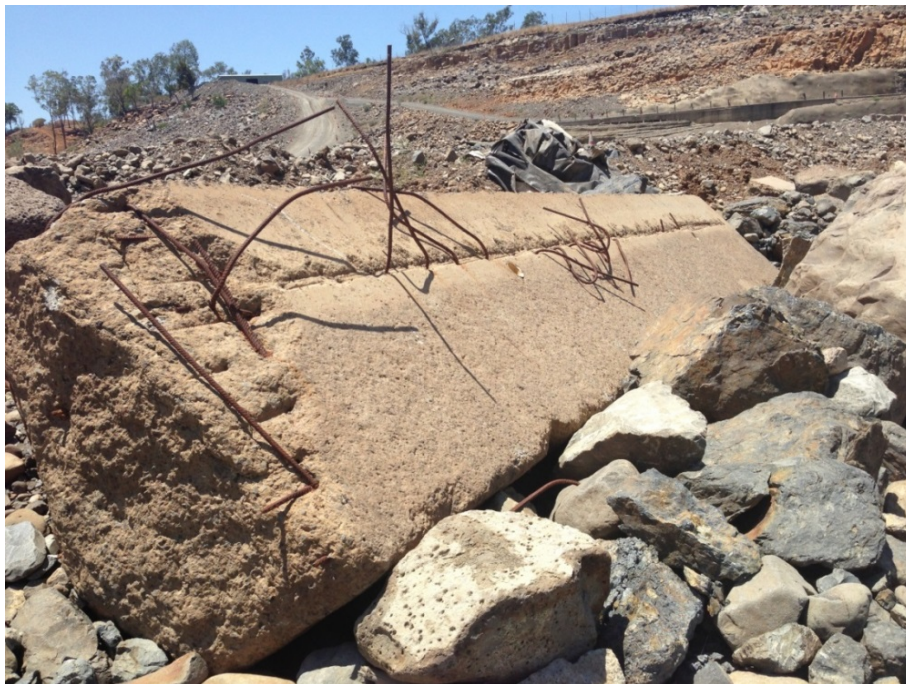
*Figure 6.16 – An end sill block downstream of the Dam's primary spillway following the 2013 flood. N16-350 horizontal reinforcing bars are visible. (Exhibit 237, **SWA.512.001.0578**, .0643)*
