Preliminary Infrastructure Planning Study for Caboolture Hospital

Volume 1 of 2

August 2010

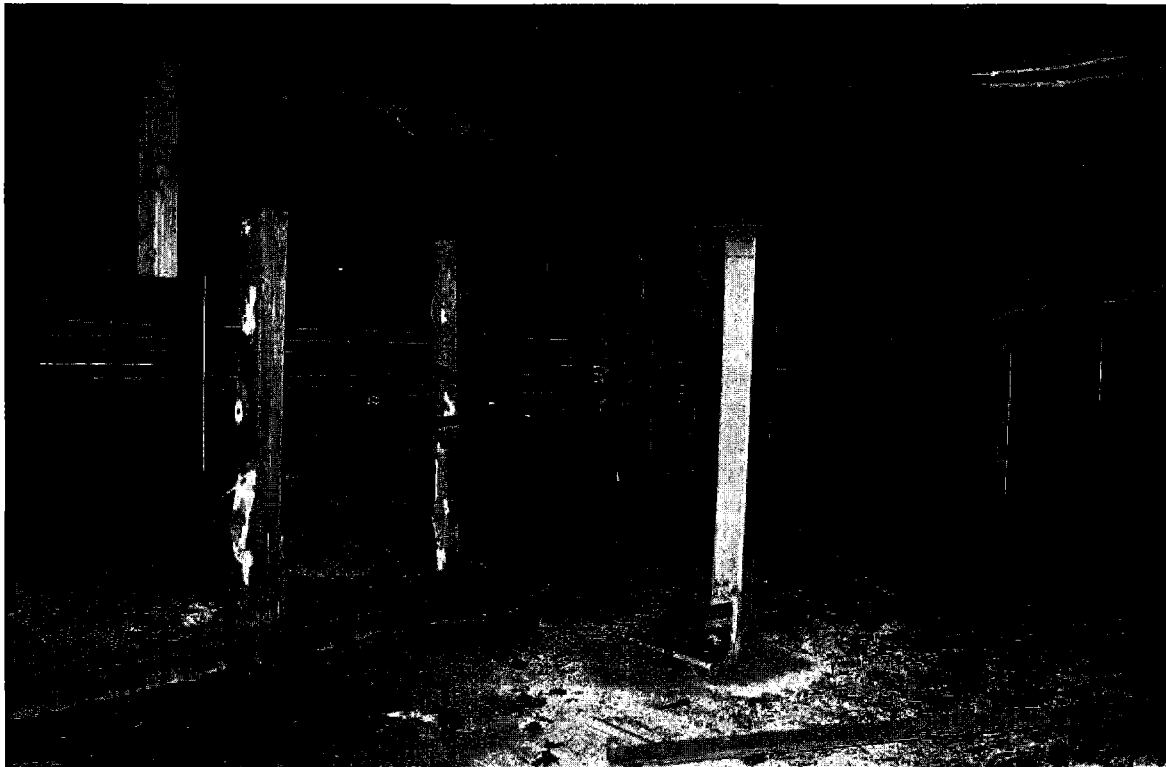
Figure 10: Medical Records Building Subfloor Framing

Generally it is not considered that even with immediate structural repairs being undertaken to ensure the safe use of this building that the structure should be considered as part of the long term plans for the Caboolture Hospital (even in the 'status quo' scenario), up to the year 2026.

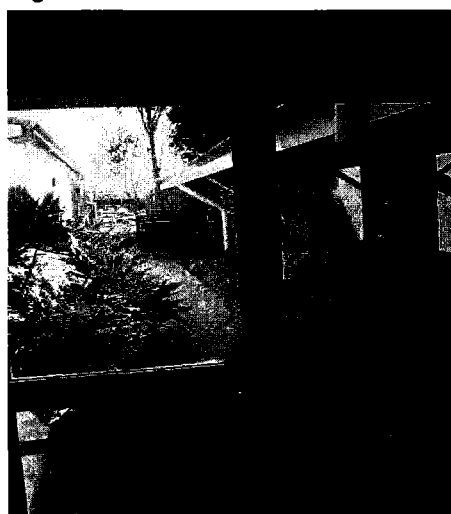
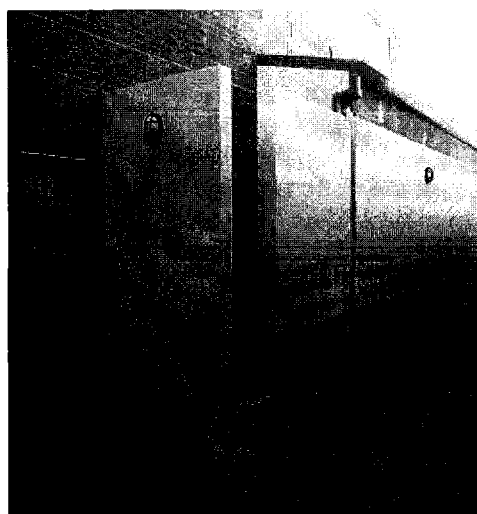
Figure 14: Exit from fire isolated stairway number 6

Protection is required for people exiting from fire isolated stairway number 6 at the eastern end of the main Hospital building at ground floor level adjacent to the single storey Private Hospital, see photos.

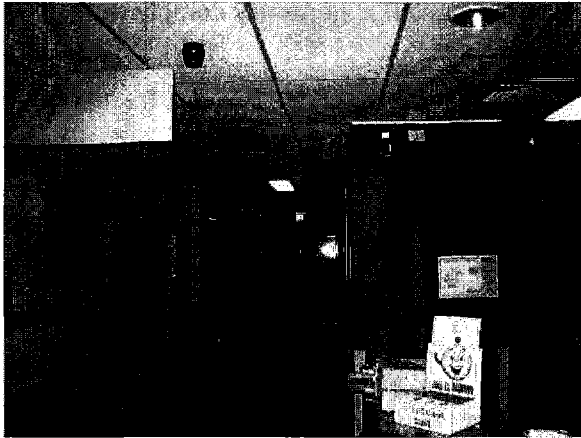
Figure 16: Obscured exit signage

Directional exit signage is installed in the buildings. However in some locations illuminated exit signs are obscured due to in-ward Hospital signage, see photo below.

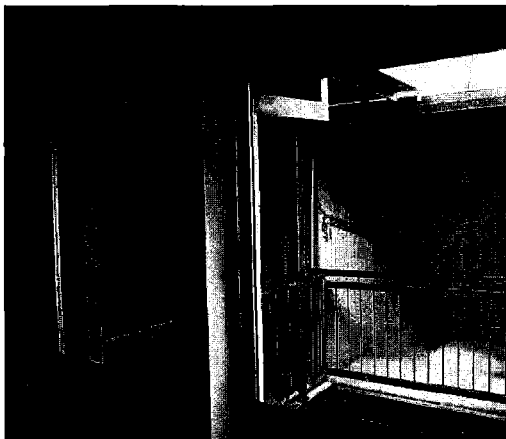
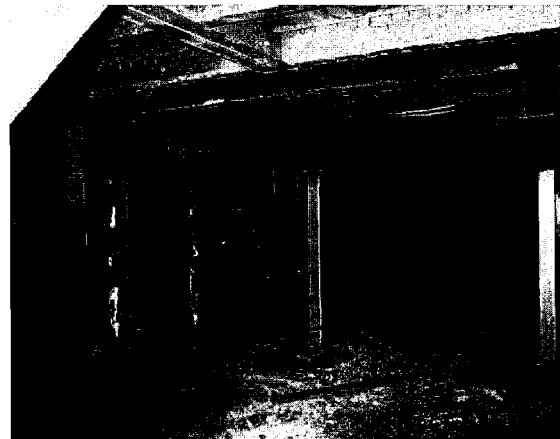
Figure 20: Medical Records demountable

Medical Records Building (condemned as unsafe) - Single storey temporary demountable (floor area approximately 180m² – it is similar to Type C construction – Class 7)

This demountable building is located off the southern side of the main Hospital building and connected by an access ramp and roofed covered walkways of timber construction.

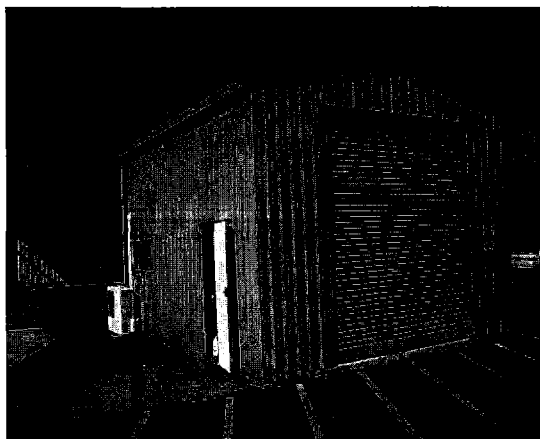
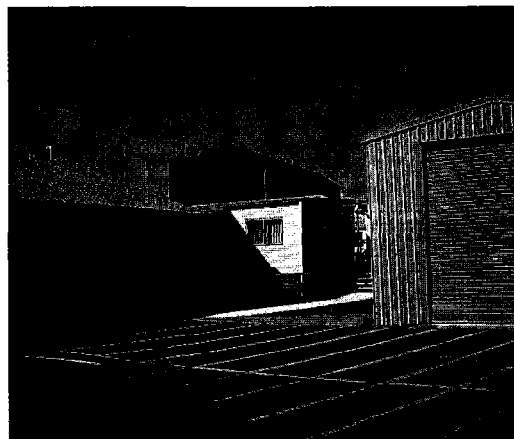
Figure 21: Dental Health Clinic records shed

Similarly, the single storey pre-fab Colorbond steel frame sheds are presently used for storage of medical health files and equipment.
