Parliament House Conservation Plan

Prepared for:
Parliamentary Service
Parliament House
Brisbane

Prepared by:
Project Services
80 George Street
Brisbane

Date: March 2010

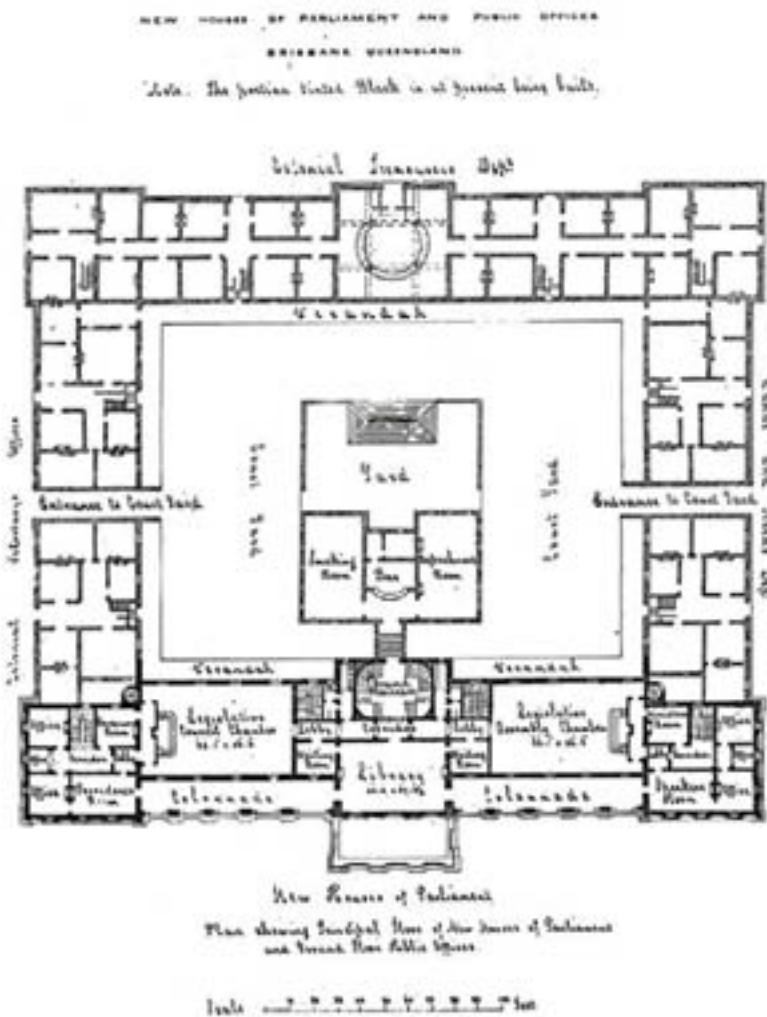
Figure 4: Charles Tiffin's plan for a new Parliament House and public offices, reproduced in *Votes & Proceedings of the Legislative Assembly*, 1867. The plan shows Parliament in the George Street wing, with a refreshment room in the courtyard, while in the other wings are the Colonial Secretary's offices, the Treasury, and the Lands and Works offices. Of this plan, only Parliament House was built; by 1883 the government had decided to erect separate offices at the corner of Queen and William Streets, later known as the Treasury Building and now Jupiter's Casino.

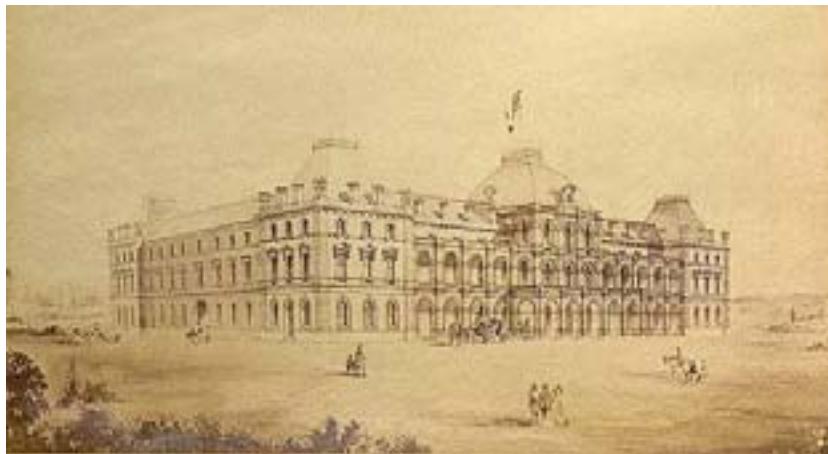
Figure 12: Perspective of Charles Tiffin's design for Parliament House drawn by J.H. Wilson, Chief Draftsman of the Engineer for Roads' Department. The perspective was put on display at the laying of the foundation stone.

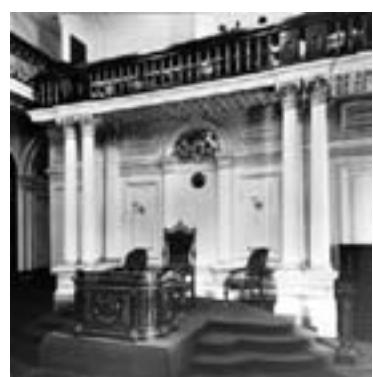
Figure 16: Reporters' Gallery above the Speaker's Chair in the Legislative Assembly Chamber, ca.1934, showing the Corinthian columns added to support the gallery

economies were evident in the 'plain and substantial' finishing of the rooms and in the simple floor coverings of coir matting woven at Sydney's Darlinghurst Gaol. Soon after the building was occupied, the Reporters' Gallery in the Legislative Assembly Chamber was lowered and extended forward so that reporters were better able to hear the proceedings. To support the gallery, Corinthian columns were added either side of the dais, generally improving the Chamber's appearance.

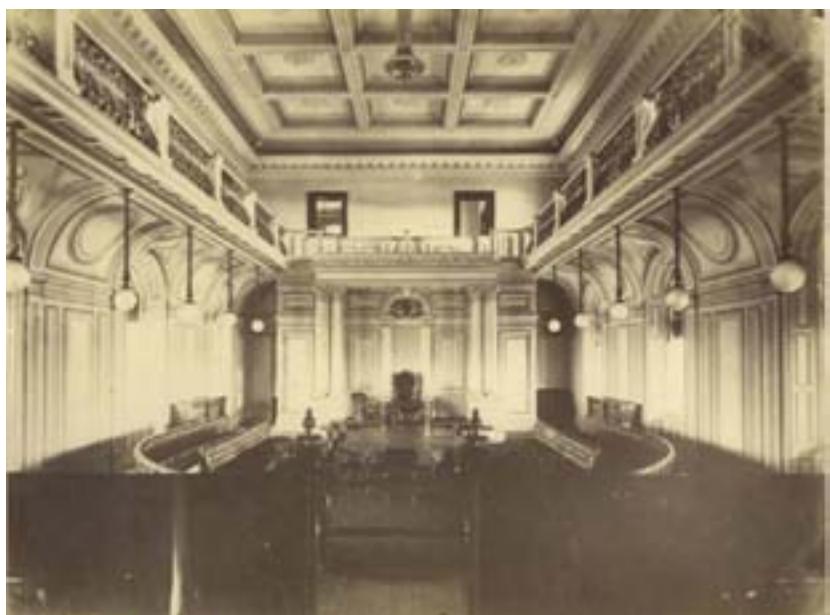
Figure 19: Legislative Council Chamber, ca.1869. This was grander than the Assembly Chamber, the mouldings being more complex and picked out in more colours. At the rear of the Chamber was a screen, seen here in the foreground, which demarcated a space for members of the Legislative Assembly on occasions when they were present.

Chambers had a dais at the front and stepped platforms at the rear. The President's dais and the Speaker's dais were each backed by a wall which formed an anteroom behind the Chamber, giving access to the President's Office at one end of the building and the Speaker's Office at the other. A Governor's Room (now a lift) and a Ministers' Room (now a lobby) also had direct access to the anterooms. The President's Office (B27) was the grandest of the rooms allocated to individuals; at this time the Premier's Office was in another building, in William Street. Back verandahs shaded the Chamber windows.

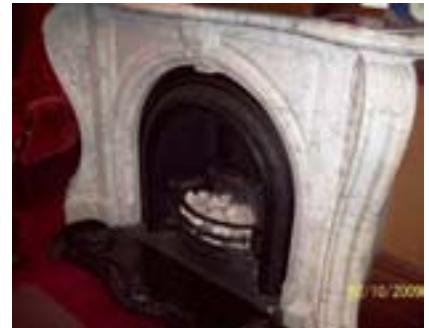
Figure 21: Marble chimneypiece in the President's office

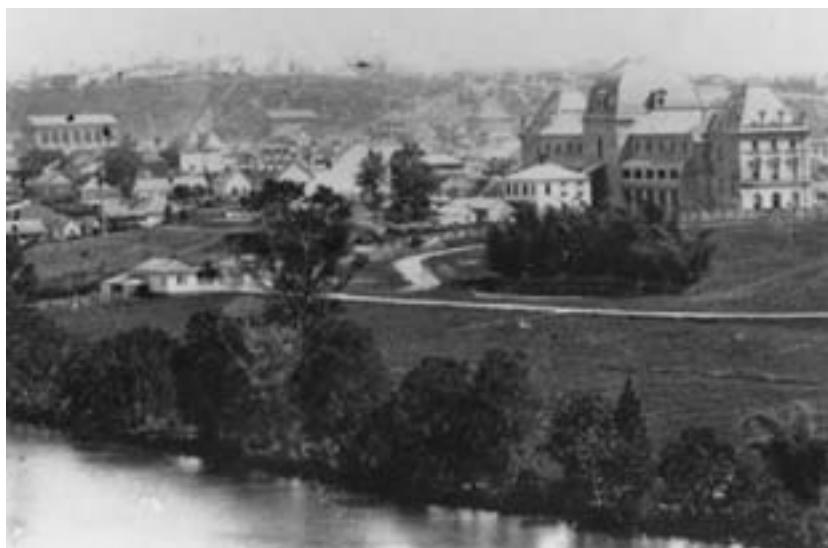
Figure 20: Rear view of Parliament House, ca.1870, showing the rear verandahs and the detached, timber refreshment room. The refreshment room faced the western sun, causing Members to complain that when they went there to get cooked meals, they themselves were cooked.

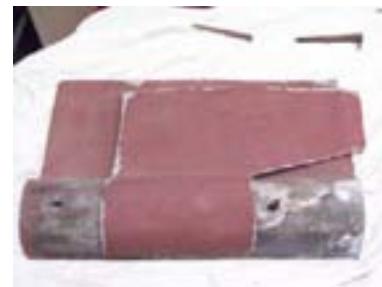
Figure 23: Sample of original zinc roofing viewed from above

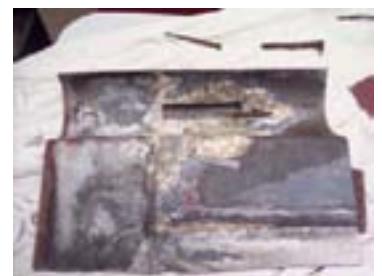
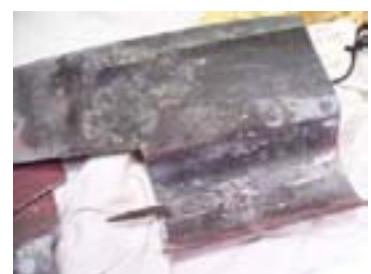
Figure 24: Sample of roofing viewed from below, showing the interlocking system of nails and slots. The nails were soldered to the underside of the zinc.

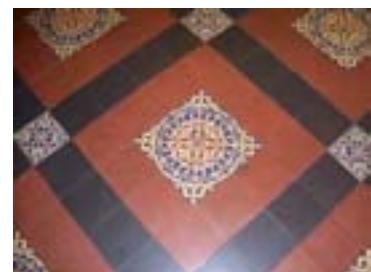
Figure 25: Minton tiles in the main entrance hall

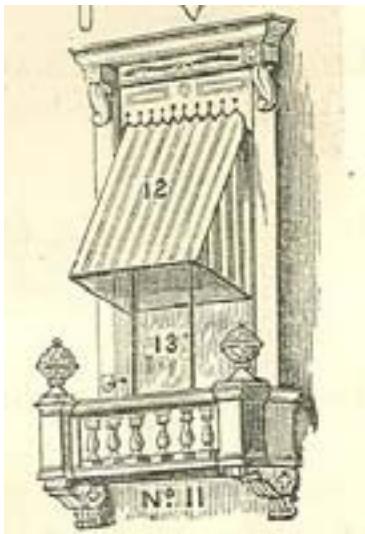
Figure 26: Lenzberg & Walton blind, from a series of volumes on the London International Exhibition of 1862, now in the O'Donovan Collection. This blind appears similar to those used at Parliament House.

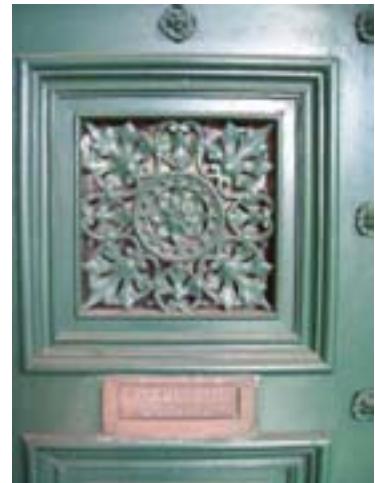
Figure 29: Cast iron vent in the entry door to the Legislative Council Chamber

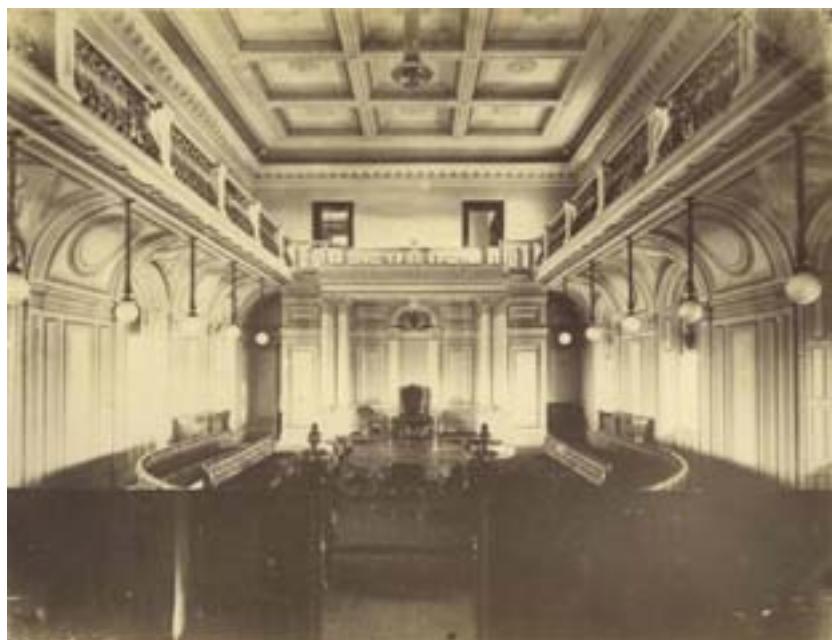
Figure 28: Legislative Assembly Chamber, ca.1869. The *Brisbane Courier* of 8 August 1868 described the Chamber as: '...a magnificent room ... lighted by four large windows, on each side reaching from the floor to the galleries...The galleries are arched underneath, and the ceiling is in panel, richly ornamented, and picked out in delicate tints of colour, which blend very harmoniously, and give a beautiful rich tone to the whole. The Chamber is lighted at night by two large sun-lights.'

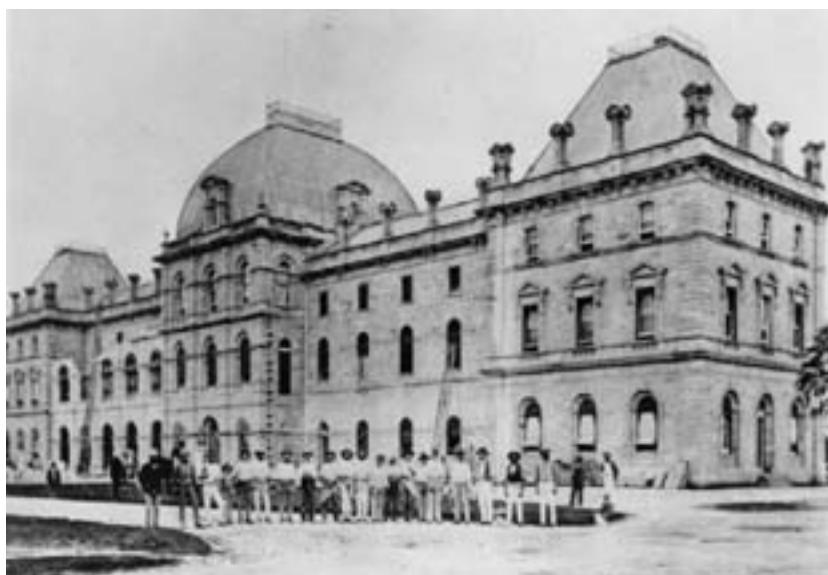
Figure 32: John Petrie's workmen during construction of the arcades, 1879

The new Parliament House remained as constructed until 1877 when a specification was prepared for adding the arcades and porte-cochere included in Charles Tiffin's design. The tenderers were instructed to give a separate price for omitting the porte-cochere. In 1878 John Petrie was awarded a contract for £8,760 for adding the arcades only and again the porch was deferred. The arcades, so essential for shading the building as well as realising Tiffin's design, were constructed of sandstone from Murphy's Creek. The work was completed in 1879 under the supervision of F.D.G. Stanley, Tiffin's former assistant who had succeeded him as Colonial Architect.

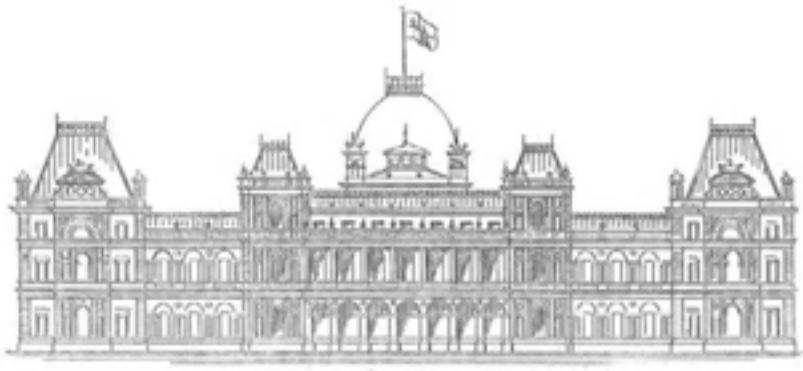
Figure 34: Colonial Architect J.J. Clark's grand plan for a new refreshment room and library, reproduced in *Votes & Proceedings of the Legislative Assembly*, 1884. The central part (between the two smaller towers) is the portion of the extension facing the river.

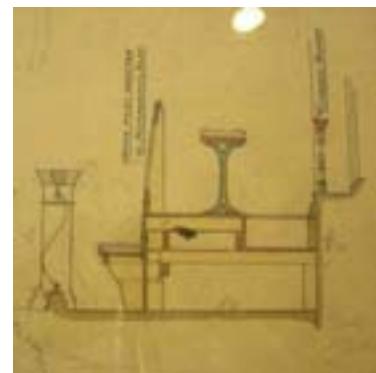
Figure 37: Detail of the Ladies' Gallery

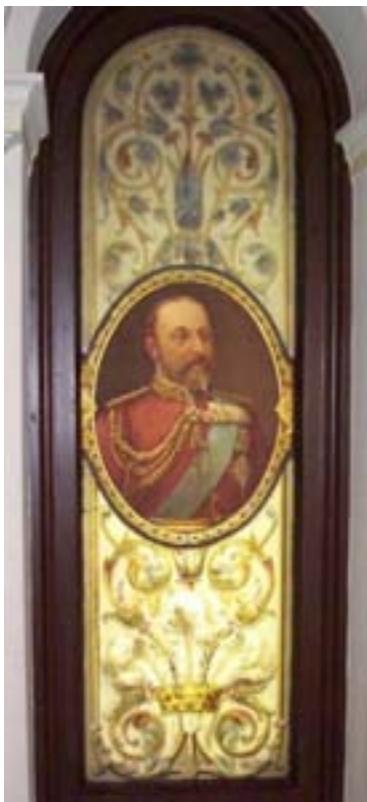
Figure 39: Prince of Wales window

Even so, they have considerable significance as Lyon Cottier & Co. was one of Australia's leading stained glass manufacturers at the time. Established in 1873, the firm undertook important work throughout NSW and the resident partner, John Lyon, was an outstanding portrait painter and capable of producing good likenesses of the royals.

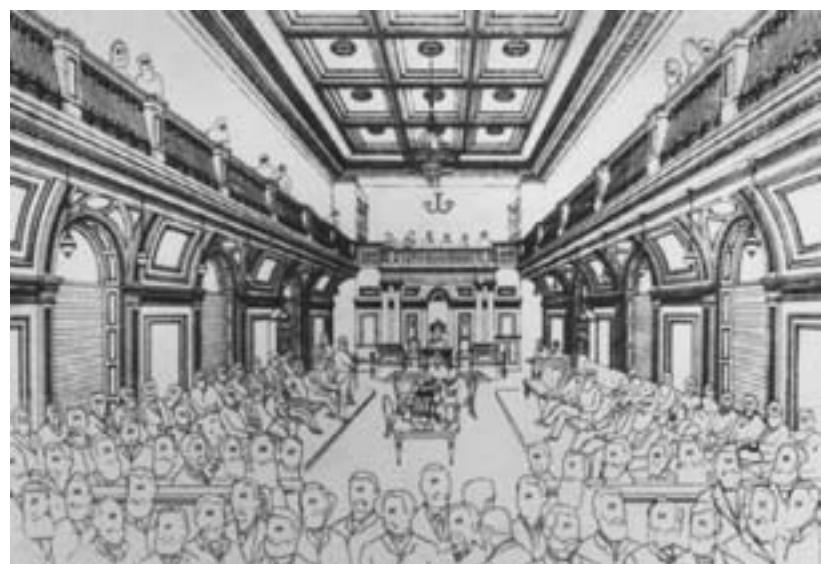
Figure 40: Legislative Assembly Chamber in 1889, by which time the number of Members had doubled from the original twenty-six. When Englishman Anthony Trollope visited the Chamber in 1871, he described the seating arrangements: '...Ministers with their friends sit on the right side of the Speaker, and the opposition on the left, with a great table between them, and benches below the gangway—just as we have at home.'

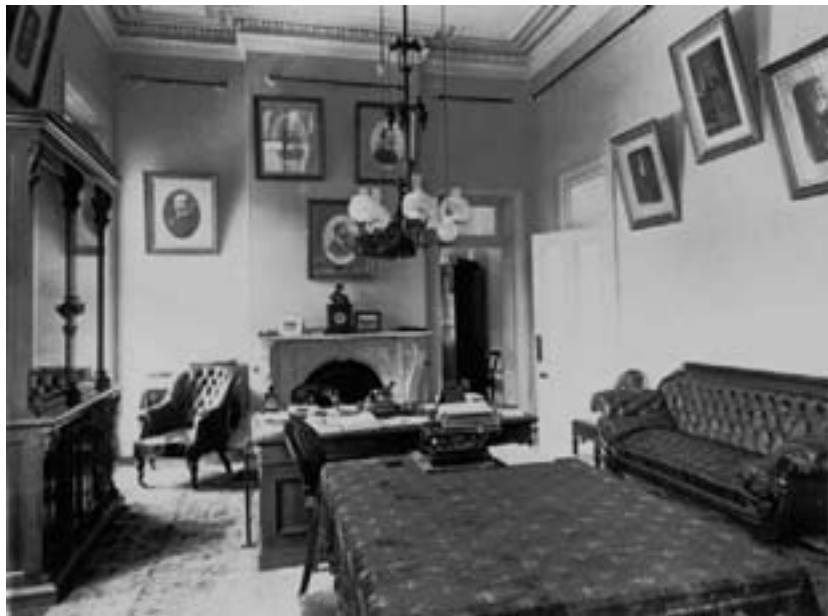
Figure 41: The President's office (B27) in 1912. This was redecorated in 1898, the walls and joinery being painted and new Brussels carpet laid.

The picture rods may hang on original patera although the rods themselves were probably bronzed with brass ends, similar to those in an early photograph of the President's office at the other end of the building (see figure 41). The bookcases probably date from the 1950s but are well built and are sympathetic to the room.

Figure 147: The President's Office with its original Petrie bookcase in its original location at left. The photograph also shows the quality of the natural light when the blinds are open (compare with figure 41).

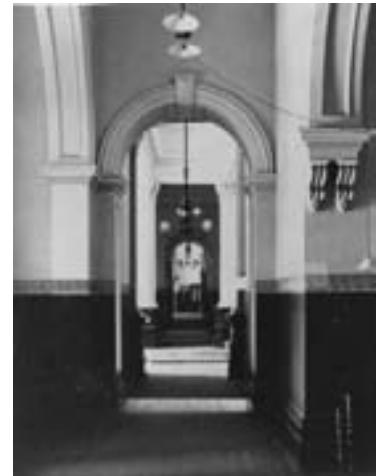
Figure 42: The ground floor eastern corridor in 1912, with a dark dado in Greek key pattern

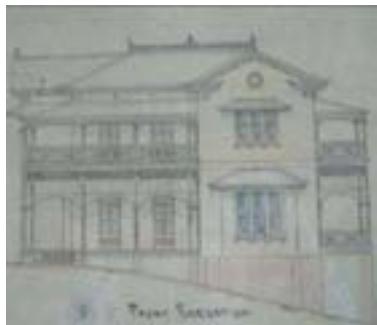
Figure 44: The Clerk of the Legislative Assembly's residence

- the Clerk of the Legislative Assembly's residence, a commodious residence erected in 1881 at a cost of £2,498, later to become the Lodge used for accommodating country Members;
- the Groom's cottage, erected in 1882 at a cost of £140 and extended in 1890;

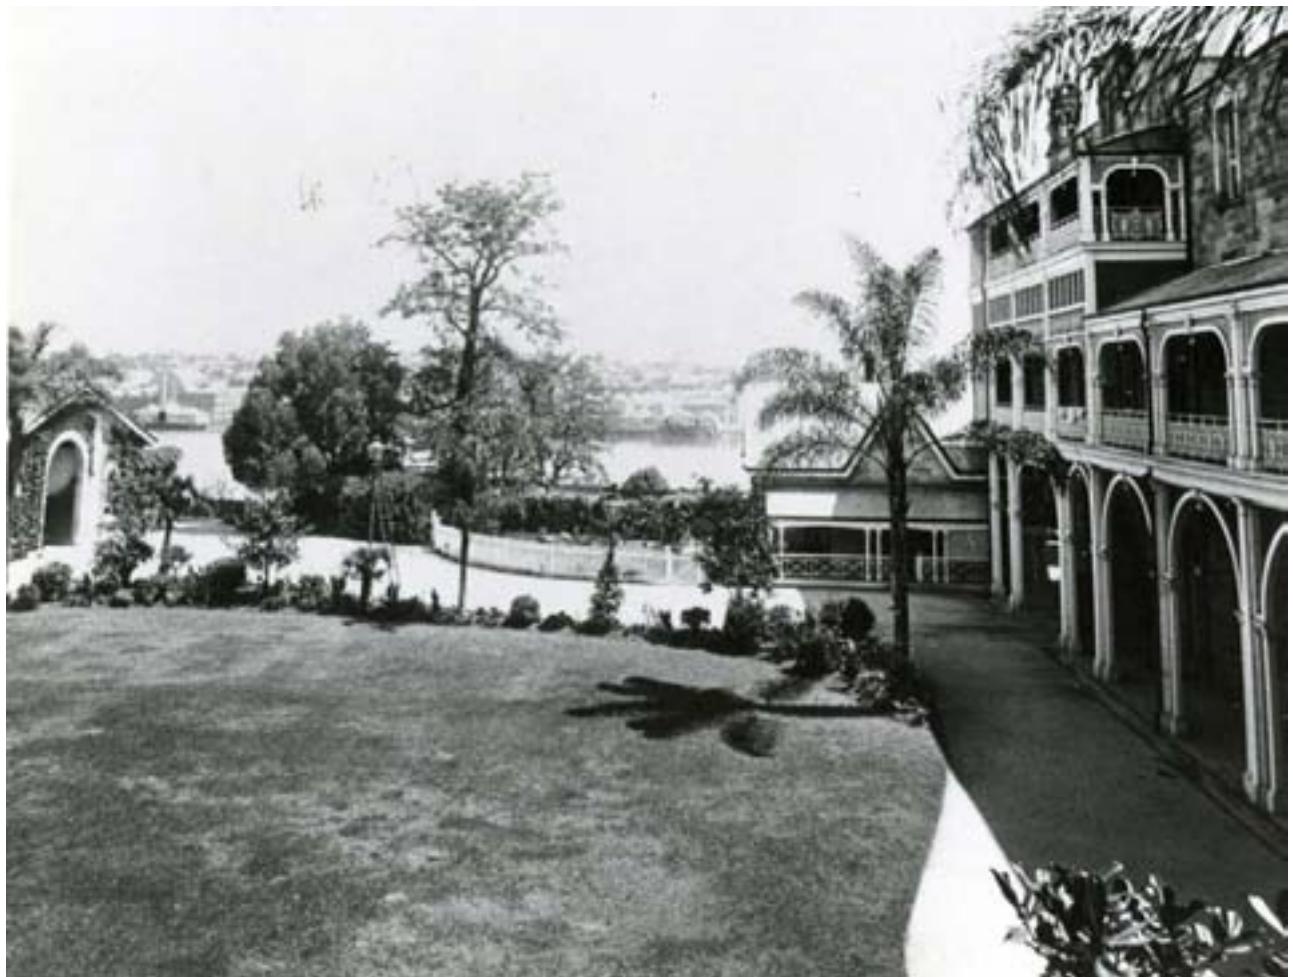
Figure 45: Parliament House grounds in 1912, showing (left to right) the stables, the Providore's quarters and the Alice Street wing. The former two buildings were designed by Colonial Architect George Connolly.

- the Providore's quarters and new brick stables, erected in 1882 at a cost of £2,899, using stone from Brisbane's old gaol on Petrie Terrace;
- a laundry erected in 1883;
- a new carriage shed erected in 1884 at a cost of £90;
- a dairy, store and larder erected in 1888 at a cost of £110;
- a fowl house; and
- a boiler house.

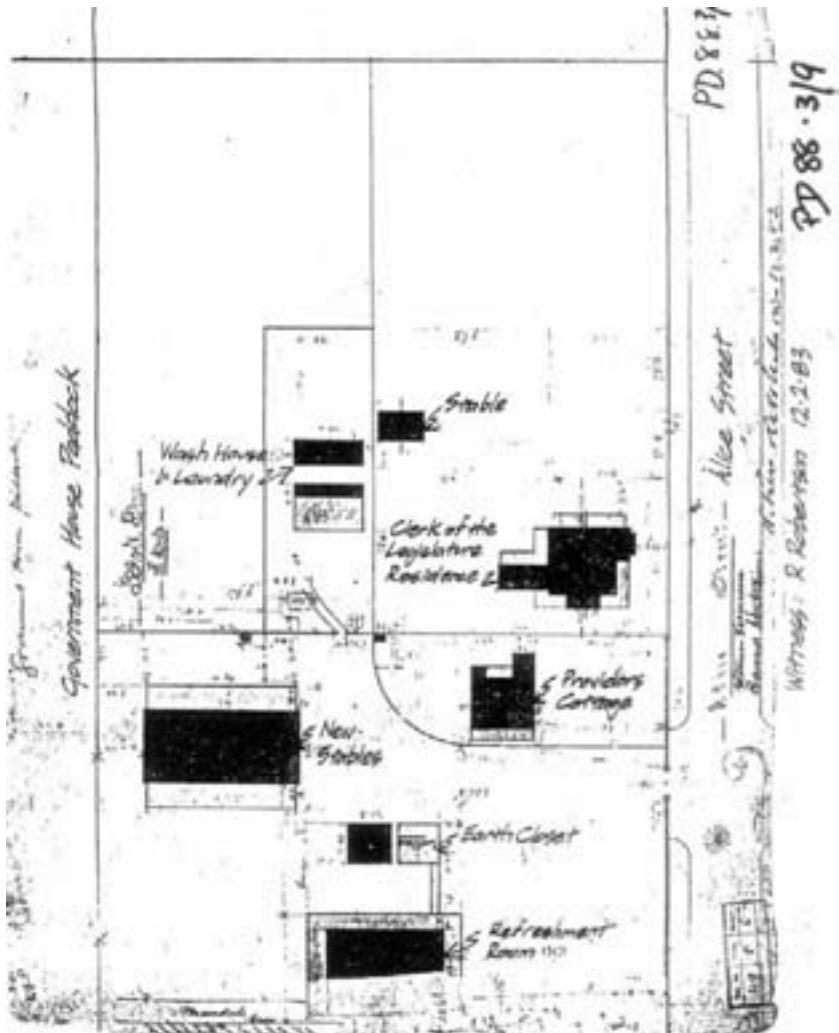
Figure 46: Parliament House site plan of 1883, extending from the back of the original building. The Alice Street wing now extends to the boundary of the Providore's cottage shown on the plan.

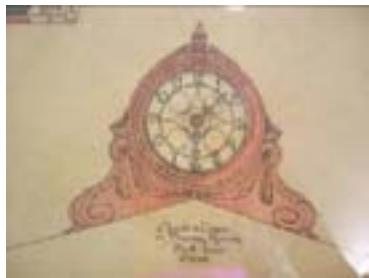
Figure 57: Drawing by Thomas Pye of the Dining Room clock casing

Most of the joinery is early. The original clock casing, designed especially for this room, survives over one doorway (see figure 57). The double doors into the dining room from the corridors have cedar aedicules. The floor springs have been replaced but the cast brass base plates to pull handles are original. The handles themselves may have been crystal rather than wood. The window sashes and sets of French doors leading onto the arcade and balcony on each side are original; however window heads on the south east wall have been modified for air conditioning vents.

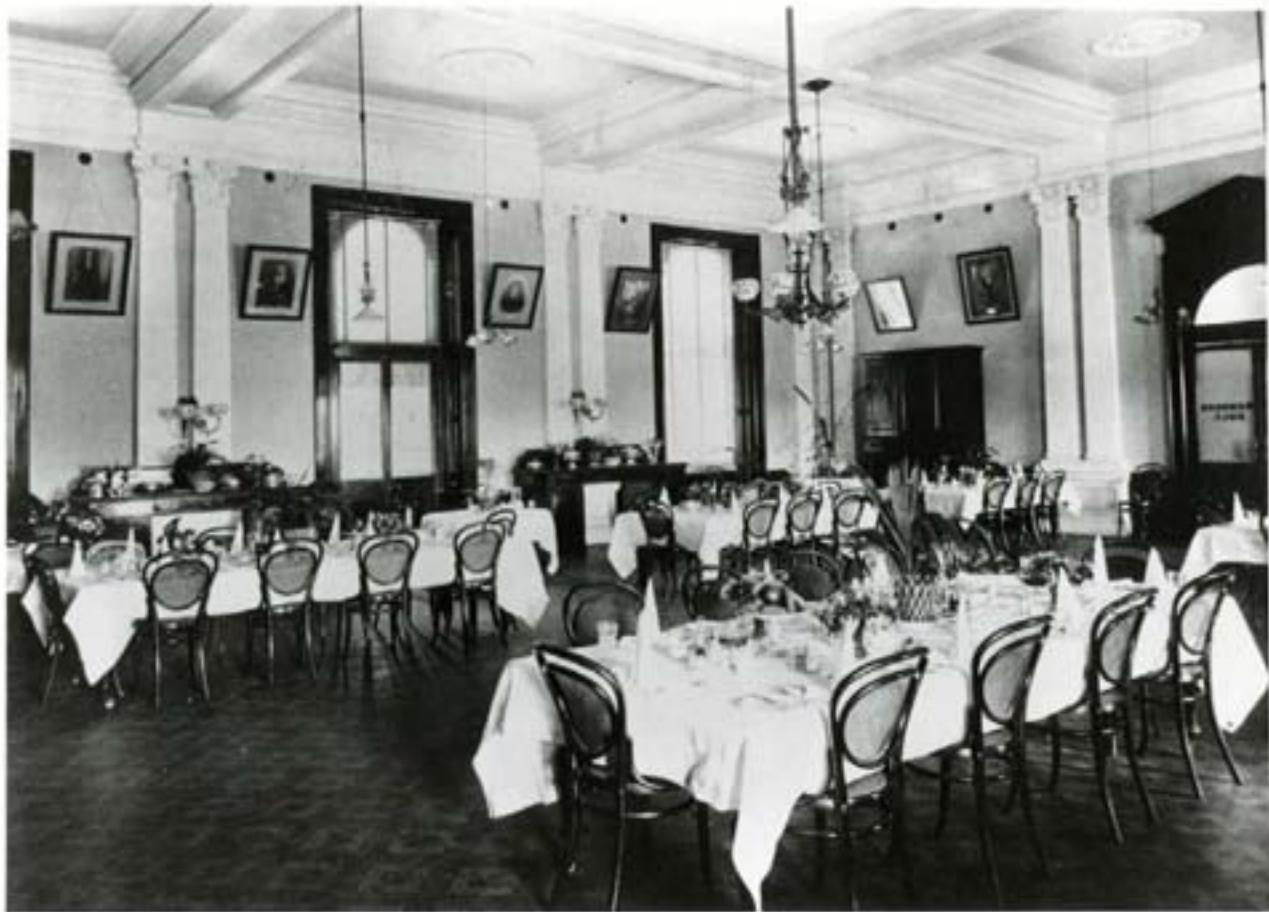
Figure 58: The Dining Room, now the Strangers' Dining Room, in 1912. Note that the room has both gas and electric light fittings, the gas fittings being fixed to the walls as well as the ceilings.

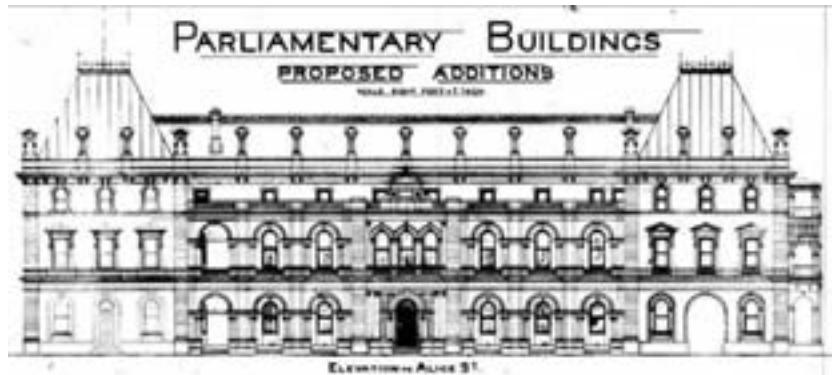
Figure 61: Elevation of 1889, showing the arcade as originally constructed

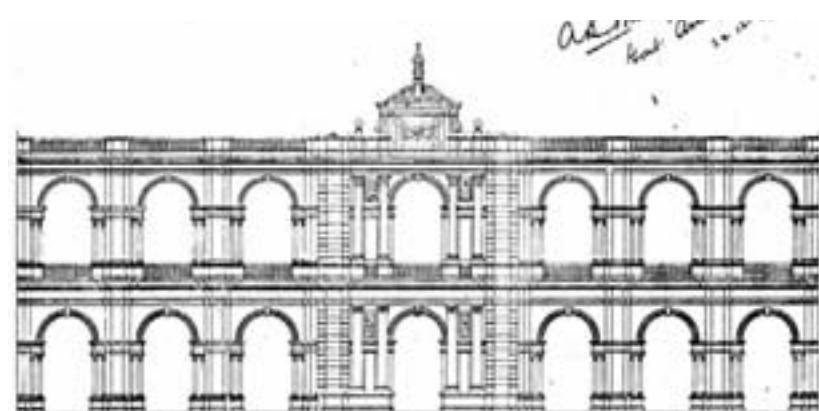
Figure 62: Elevation of 1897, showing the arcade as rebuilt

The stone on the Alice Street arcade failed the test of time. By June 1891, when the wing was occupied, the stone was already showing signs of deterioration, a situation for which Colonial Architect George Connolly was held responsible and contributing to his dismissal in August 1891.²⁴ The deterioration of the stone was so rapid that by December 1892 extensive repairs were needed to the arcade. On 7 August 1897 a

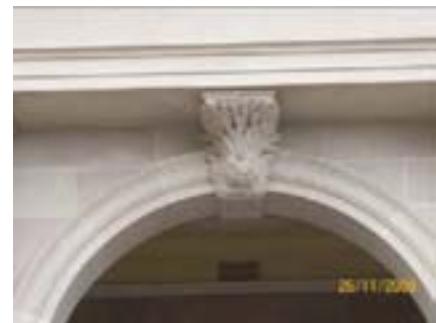
Figure 63: Staghorn keystone over the main entrance of the Alice Street wing

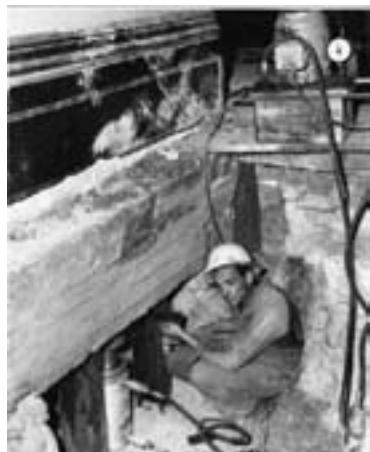
Figure 66: Underpinning Parliament House in 1969

The cracking of walls and ceilings in the George Street wing caused much concern over the years; like most buildings of its era, it lacked deep foundations. In November 1903 Thomas Pye, then the Southern District Architect of the Department of Public Works, reported fractures in the front walls and wrote, 'It appears to me that sooner or later the underpinning to rock will have to be attempted'.²⁷ Later excavations showed that the building was founded in soft alluvial clays and that hard shale bars underlay the areas where the worst fractures had occurred. In 1904 underpinning of the south eastern end of the building was undertaken by the Brisbane contractors Thomas Rees & Son at a cost of £1,321, an operation later described by one of the firm's partners as possibly its most difficult undertaking ever.²⁸ This was followed in 1912 by underpinning of the north tower and in 1969 by more extensive underpinning. The latter operation, undertaken by the Hornibrook Group and costing about \$200,000, involved sinking 125 reinforced concrete piles down to rock level and placing a series of concrete beams under the sandstone walls.

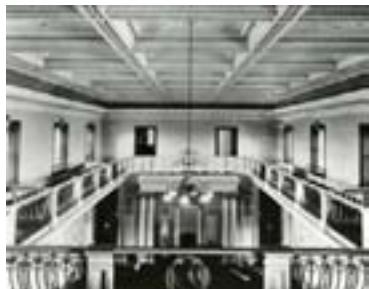
Figure 69: Legislative Council Chamber galleries in 1912

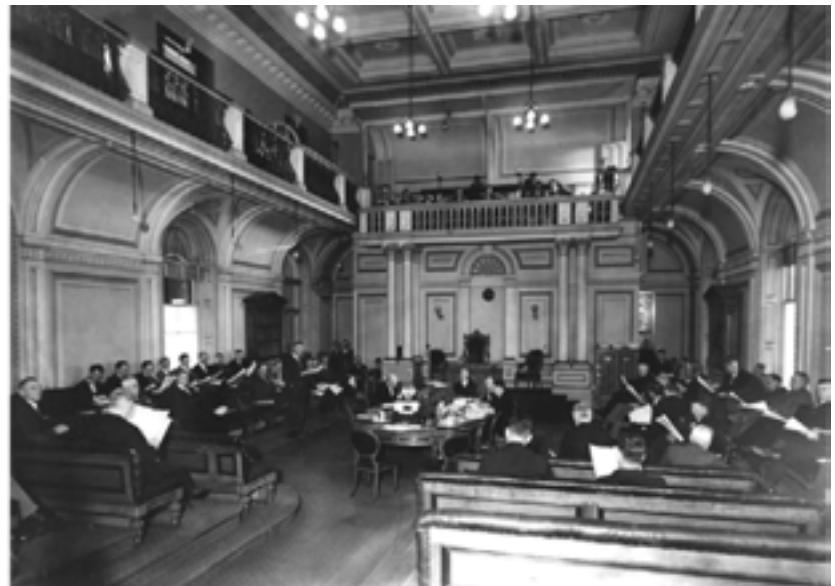
Figure 71: Legislative Assembly Chamber, during the time of T. Dickson as Clerk of Parliament, 1934–54. The photograph shows the Reporters' Gallery extended sideways and the curved screen added earlier to improve acoustics. At the right of the dais is one of the anteroom doors with its distinctive painted glass (now missing).

Various alterations were made to the Legislative Chambers during the twentieth century. In 1904 the Reporters' Gallery in the Assembly Chamber was extended sideways and additional seating was provided in the Ladies' and Speaker's galleries at the sides. The alteration incorporated a new tier of seating and brass guard rails on the windows, which raises doubts about whether the 1880s proposal proceeded at that time. By 1912 the windows on either side of the President's and Speaker's daises were converted into doors and later the painted glass in the Chamber doors was mostly replaced with embossed glass. In 1964–65 the seating in the Assembly Chamber was changed from its original layout to the current U-shaped layout, to accommodate increasing membership, and in 1973 air-conditioning was installed. In 1968 two chandeliers were added to the Council Chamber to commemorate a visit by Queen Elizabeth II.

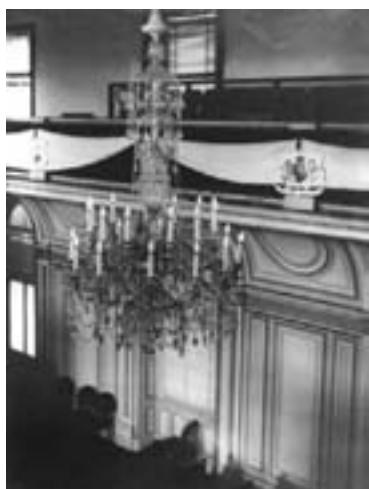
Figure 70: Chandelier added to the Legislative Council Chamber in 1968

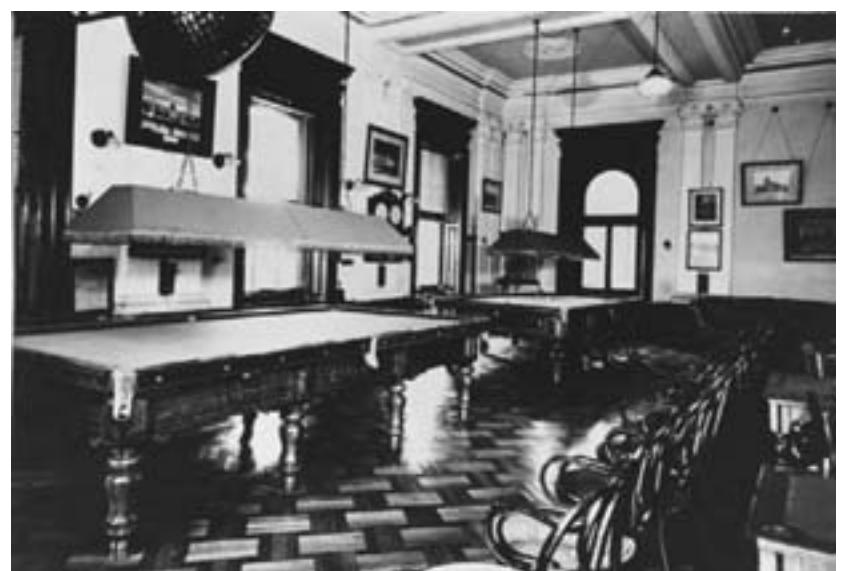
Figure 77: The Smoking Room in 1950 with its new parquetry floor

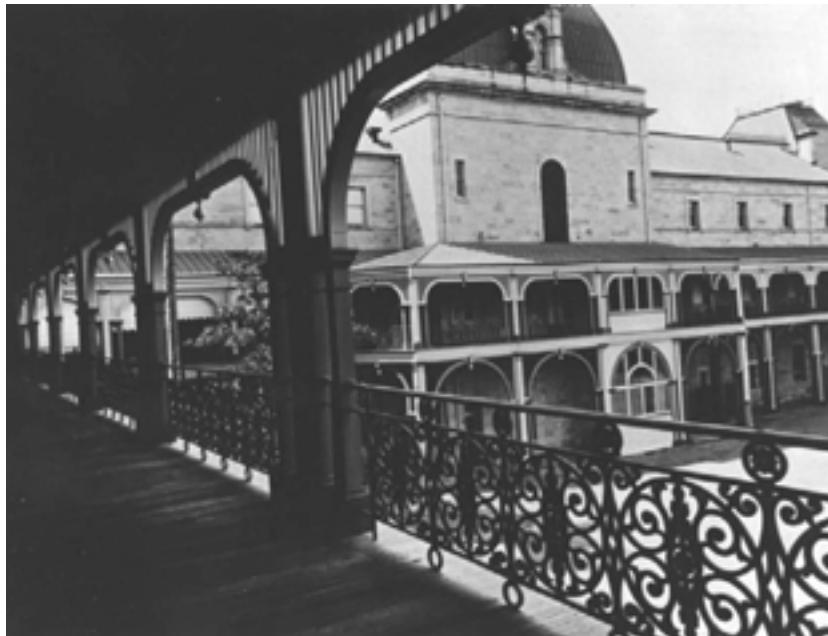
Figure 78: The back verandahs in 1950, showing the original cast iron balustrade and timber enclosure behind the grand staircase

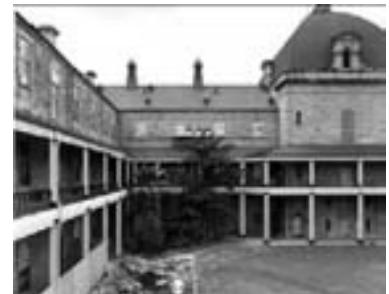
Figure 79: The back verandahs of reinforced concrete in 1979

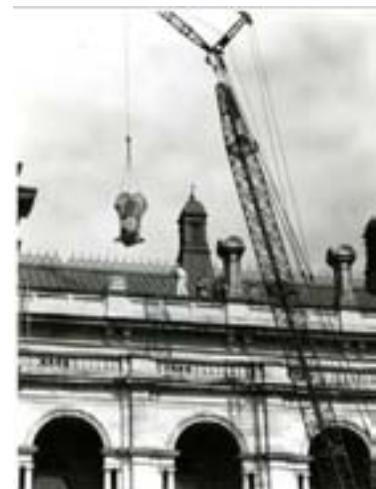
Figure 80: Removing pinnacles from the parapet above the Legislative Assembly Chamber, 1966. Some pinnacles can now be seen along the western edge of the Speaker's Green.

Already by 1917 the building's stonework was suffering the effects of weathering and pollution. An inspection of that year identified, among other problems, cracked cornices and pinnacles as well as fretted stone. Some of the work undertaken to repair such problems was less than satisfactory, as noted by members of the United Operative Stonemasons' Society of Queensland when they visited Parliament House in October 1952. They reported that '...instead of fretted stones being replaced, they are only being plastered over.'³² The masons' complaint went unheeded because as late as the 1960s the stonework was still being patched with coloured plaster. It was at this time that the stone pinnacles were removed from the parapets. By then, some of the pinnacles had fallen from the building, posing a threat to public safety.

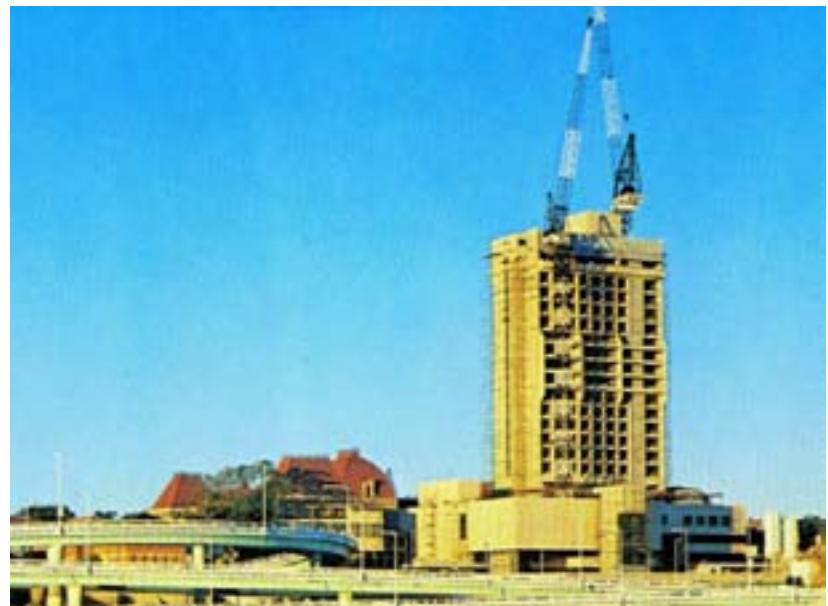
Figure 87: Parliamentary Annexe under construction

Upon its completion in March 1979, the Annexe consisted of two basements, a four-storey podium complex, surmounted by an eighteen-storey tower block. Although estimates vary, the final cost of the building was approximately \$20 million. As Russell Cope, a former NSW Parliamentary Librarian, later wrote, the Annexe was 'notable for setting the standard of its time among state parliamentary buildings. Its design was much studied by visiting members from other parliaments in Australia'.³⁴ It remains Australia's only residential block for parliamentarians and continues to provide for ever-growing parliamentary needs.

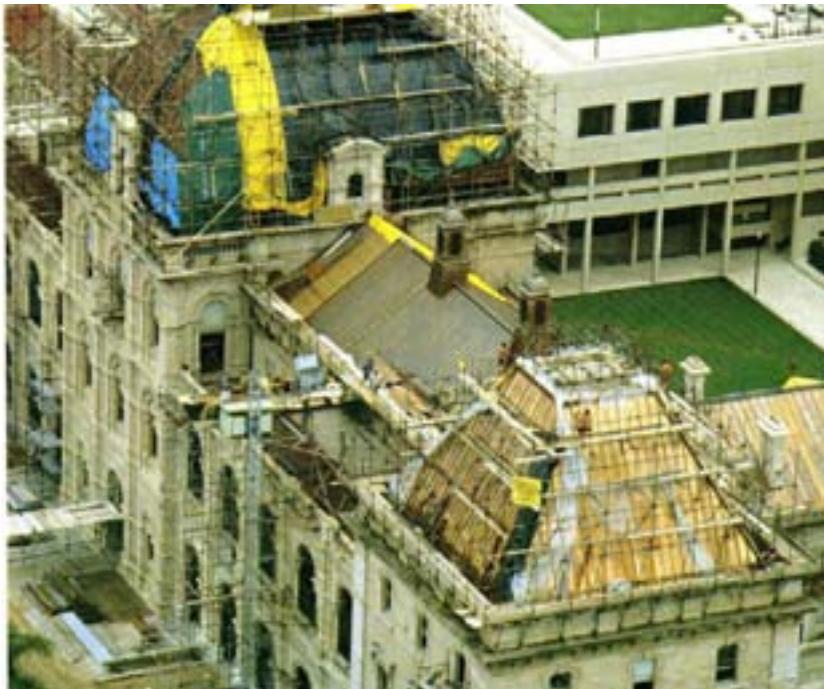
Figure 88: Installing the new roof sheeting

The first stage of the project, undertaken in early 1980, was to eradicate the West Indian termite from the building, requiring it to be enveloped in plastic sheeting and fumigated. Also that year, the original zinc and galvanised iron roofing, which by then had corroded, was replaced by sheet copper, chosen not only for its durability but also its appearance. At the same time defective roof timbers were replaced. In 1979, before work within the building commenced, the interiors were carefully documented in hundreds of photographs, which now form an invaluable guide to how the building was altered during the renovations. In addition, to determine what the building was like originally, historical research and site investigation was undertaken by the local heritage architects Bruce Buchanan & Associates.

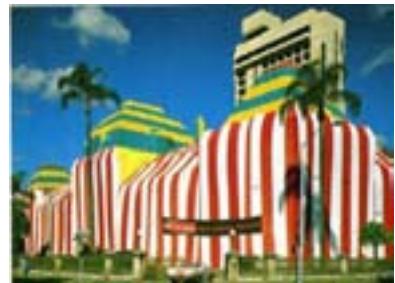
Figure 89: Parliament House being fumigated in 1980 to rid the building of the West Indian termite. About 16 km of reinforced plastic sheeting was used to stop poisonous gas escaping in the process.

7.10	Repair and maintenance.....	162
7.10.1	Maintain the exterior of the building weather tight and in good condition.	162
7.10.2	As a traditional masonry building Parliament House is vulnerable to termites, hence regular termite inspections should be carried out.	162

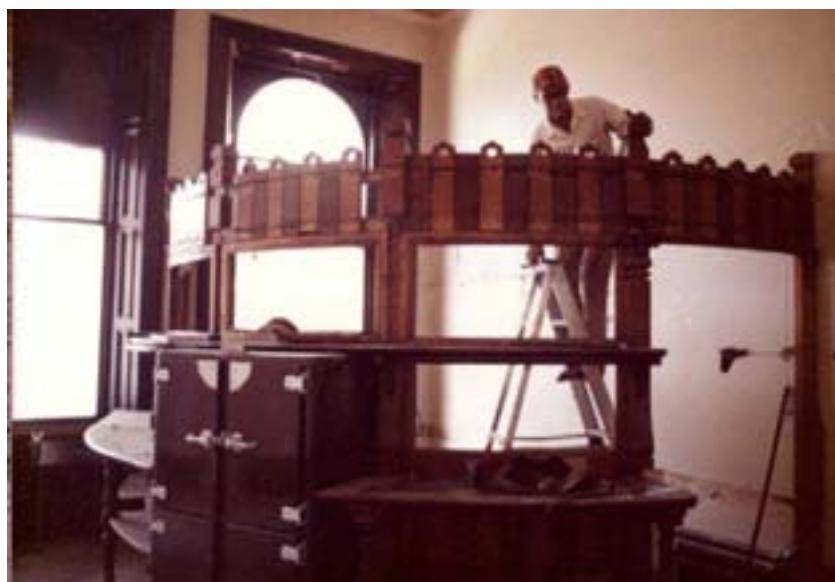
Figure 93: The curved bar being dismantled for relocation

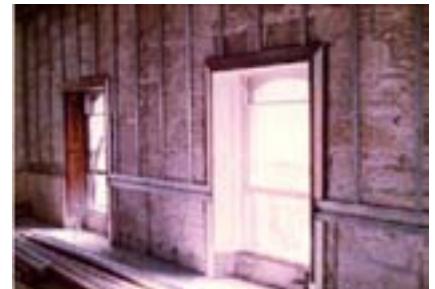
Figure 94: The old staff dining room, now the Billiard Room, where solid plaster was replaced with sheeting on steel battens to allow the introduction of services

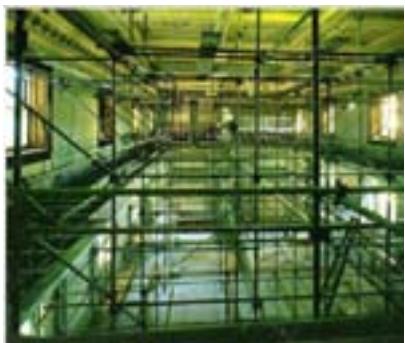
Figure 95: Restoration of the Legislative Chambers required scaffolding to be erected from floor to ceiling

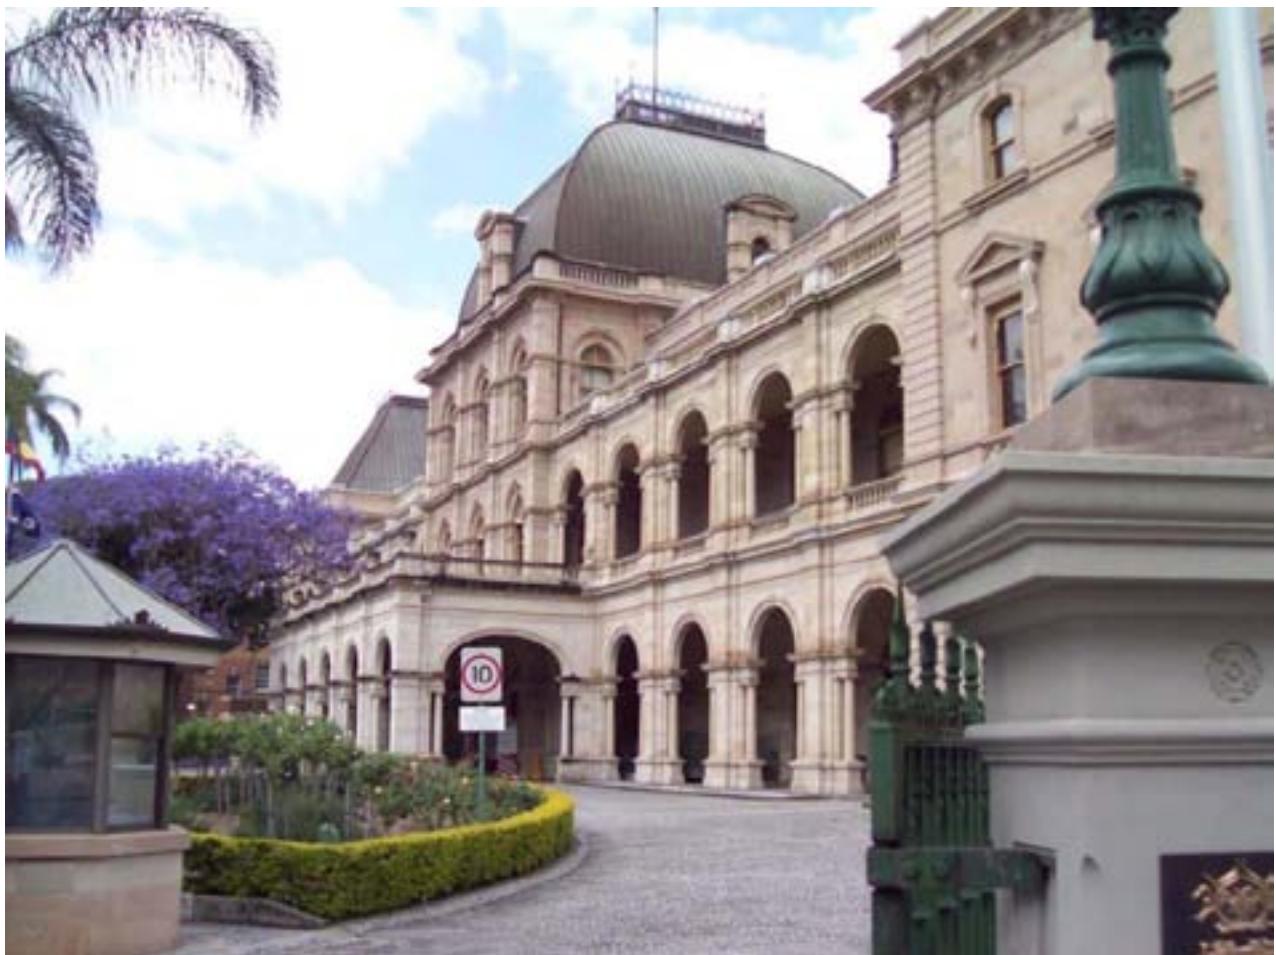
Figure 98: Parliament House from the north, showing Charles Tiffin's George Street wing of 1865–68 with arcades added in 1878–79. The porte-cochere, guard house and granite set paving were added in the 1980s.

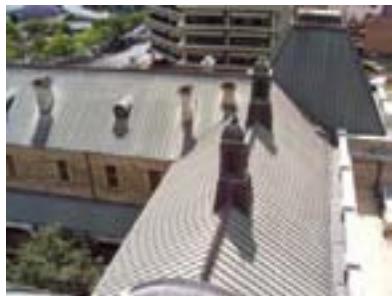
Figure 104: View towards the north tower. The new copper roof is sympathetic in scale to the original roof and cresting has been repaired. The 1895 fleches over the Assembly Chamber survive reclad.

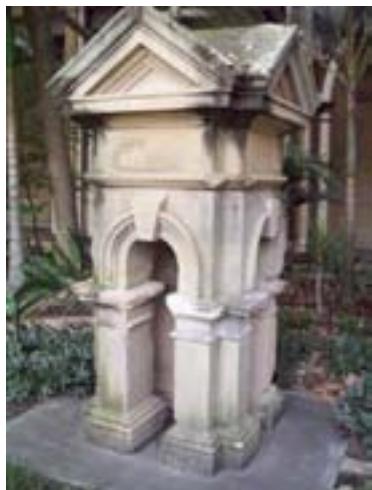
Figure 105: Some of the pinnacles removed in 1969 have been salvaged and stand in the Speaker's Green

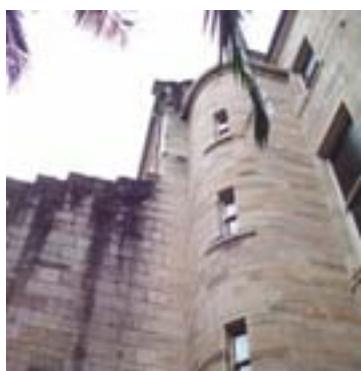
Figure 106: The circular reporters' stairs to the Legislative Council Chamber and the abutment wall to the rear verandah. The abutment would have formed the back wall of the south eastern wing.

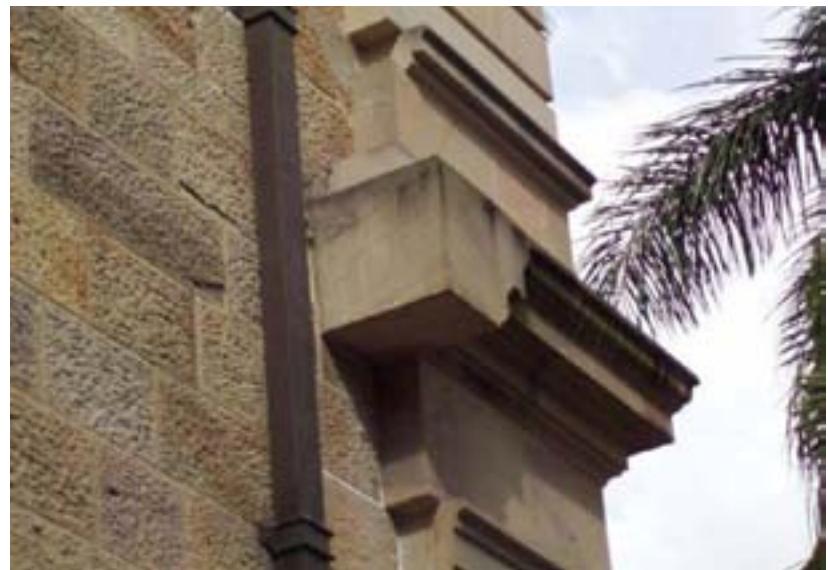
Figure 107: String course on the east tower prepared for adding the south eastern wing, which never eventuated

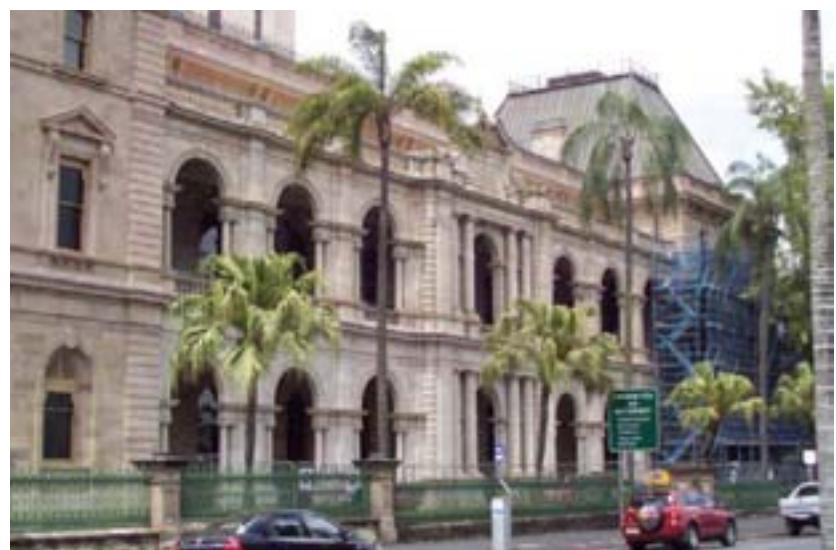
Figure 108: Alice Street wing with its arcade rebuilt in 1898

Department of Public Works Inspector, W.T. Jack, was almost killed while inspecting damaged stonework; in ascending the parapet some of the cornice gave way, throwing him to the ground 40 feet below. He reported that 'the entire work is loose and falling to pieces, endangering the lives of any one passing...' and called for urgent action.²⁵ Government Architect A.B. Brady directed that the entire arcade should be demolished immediately and that plans be prepared for rebuilding it as soon as possible.

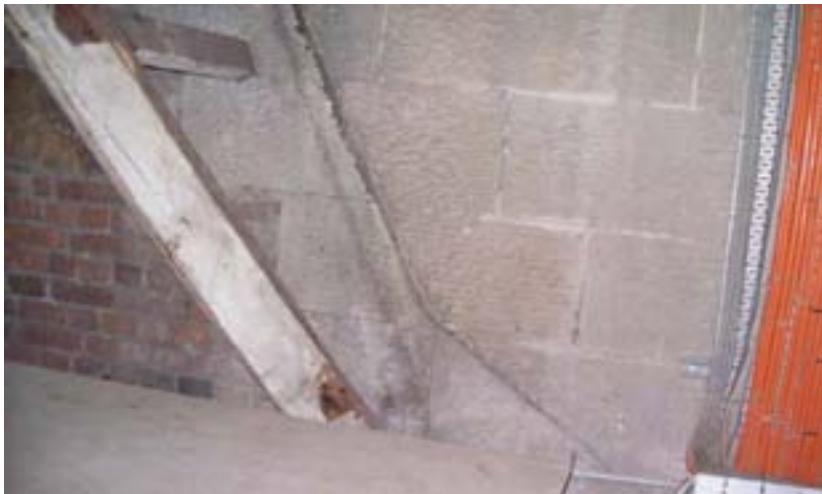
Figure 109: Portion of the attic wall showing the stone facing of the George Street wing with the mark of the flashing of the rear section of mansard roof which was demolished for the Alice Street wing

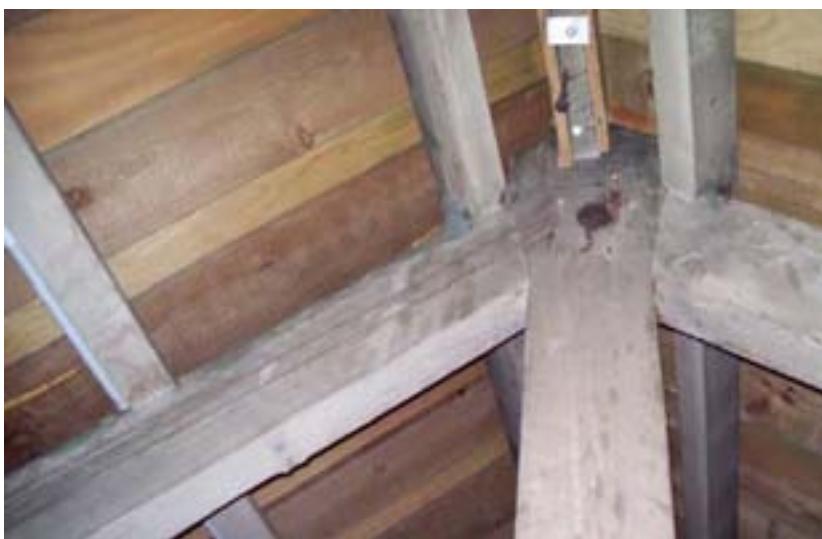
Figure 110: Ridge in the George Street wing. The gaps between the original boarding (the darker timber), which have now been filled, may relate to the laying of the original zinc roofing.

7.11.3	The exterior pinnacles and chimneys should be reconstructed.	164
7.11.4	Next time the roof covering needs to be replaced, the use of a modern zinc sheeting should be investigated	165
