Parliament House Conservation Plan

Prepared for:
Parliamentary Service
Parliament House
Brisbane

Prepared by:
Project Services
80 George Street
Brisbane

Date: March 2010

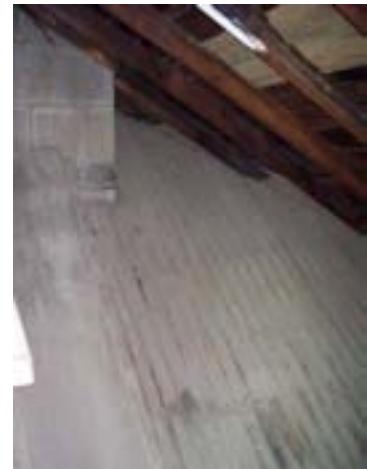
Figure 111: Early roofing survives in the attic at the back of the George Street wing where the Alice Street wing was added. It is not known why this is a different profile to the original samples.

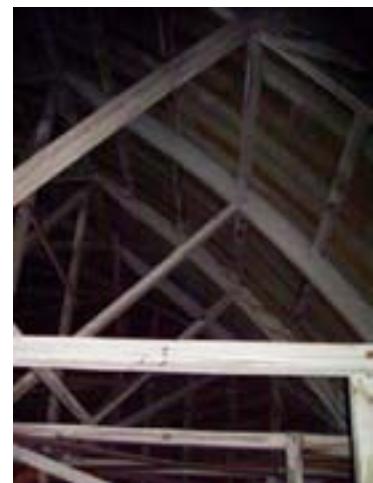
Figure 113: Curved pine rafters form the shape of the mansard roof over the main entrance. This was repaired in the 1980s renovations.

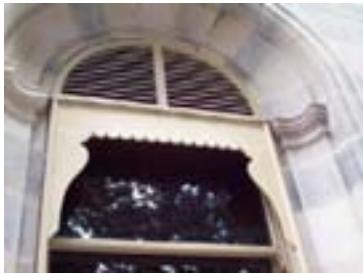
Figure 114: Remains of louvred shutters and the valance for a canvas blind on a window in the east tower. The valance appears to have been retrofitted and has a lead flashing at the top.

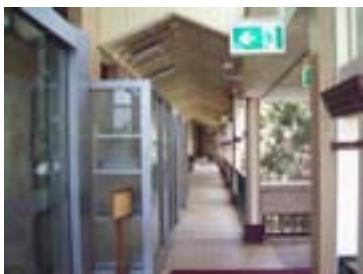
Figure 116: Glass doors added to a new entrance to the Alice Street wing (at left) leading from the Annexe. The modification of the verandah ceiling for ductwork is also visible.

Automatic glass doors have also been installed on the rear verandahs allowing the doors into the building to remain open during the day, protecting them from abrasion and providing an air seal. The balustrade on the Alice Street arcade at first floor level has been made safe by adding a taller glass balustrade inside the original stonework.

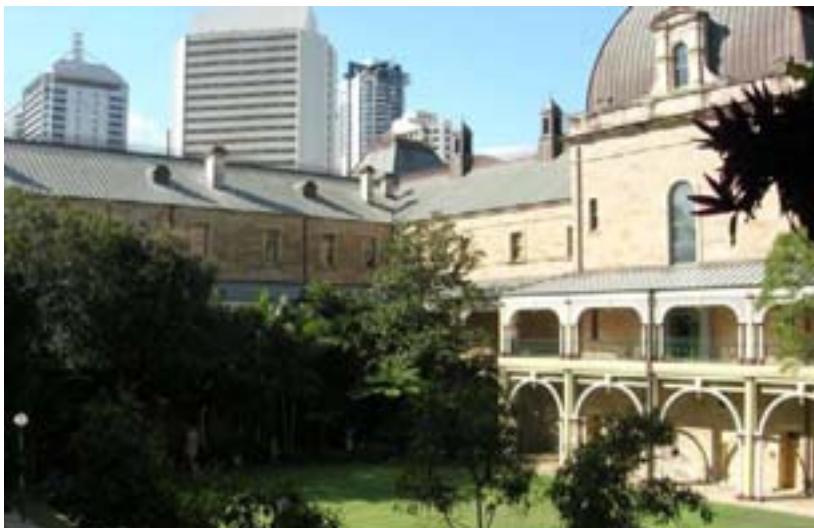
Figure 118: View from the Annexe with the Speaker's Green in the foreground. There are no parapets on the back walls consistent with the plainer character of the courtyard elevations.

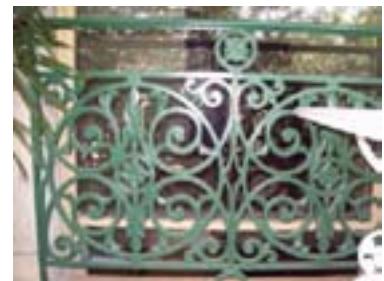
Figure 119: A section of original balustrade survives on the Alice Street verandah at first floor level, reused as a safety barrier for the window over the stairs

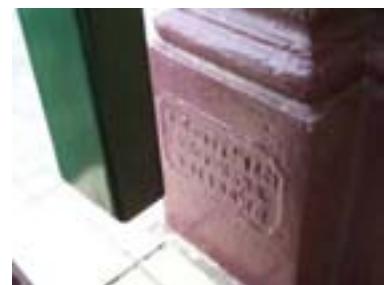
Figure 120: Manufacturer's mark 'J.W. Sutton & Co. Engineers Brisbane' on the bases of verandah posts at second floor level on the Alice Street wing

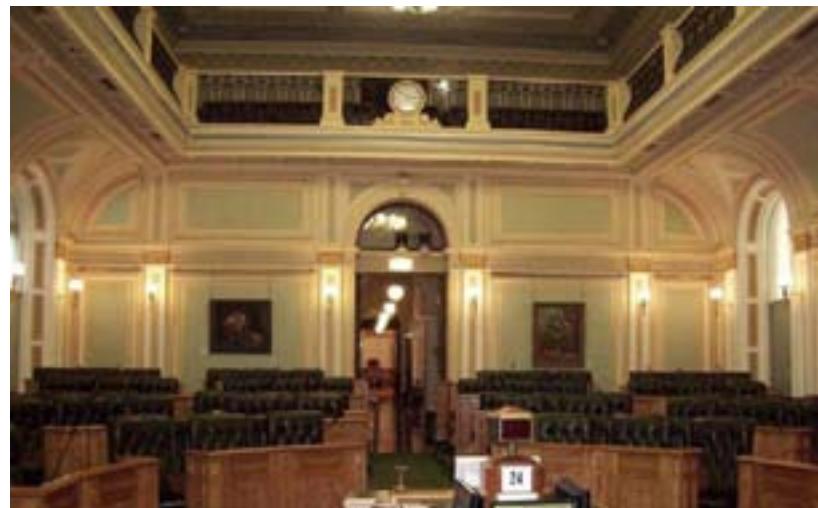
Figure 124: View from the Speaker's dais through the entrance doors. The Members' benches are new. The clock is thought to date from the 1930s.

The Assembly Chamber retains its original use. It is a double-height space with the dais framed by pairs of Corinthian columns which support the Reporters' Gallery (C19) above.

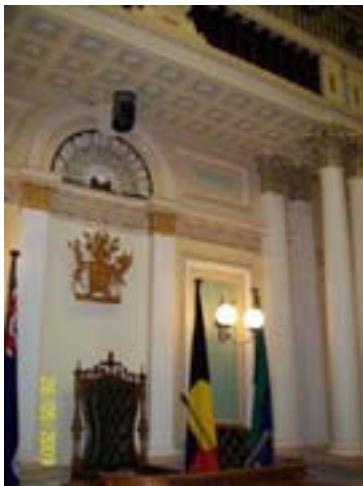
Figure 122: The gallery for the press over the Speaker's Chair was extended forwards in 1868 and sideways in 1904

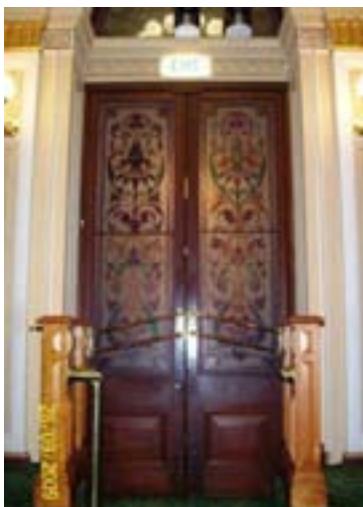
Figure 123: Doors from the Assembly Chamber to the main hall

The French doors in the external walls on either side of the dais, which were added by 1912, are grained with diagonal push bars. The doors into the Chamber from the main hall are varnished cedar with decorative glass in both the doors and the

fanlight above. The original glass was broken in the 1920s and the doors removed. They were reinstated in the 1930s but again removed for safety during World War II. At least some of the decorative glass appears to be reproduction, though the glass in the fanlights may be original.

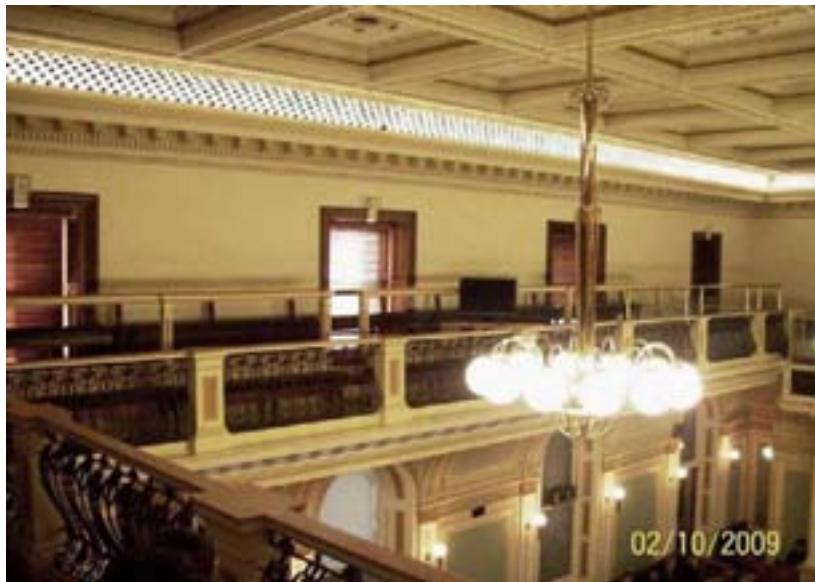
Figure 125: Legislative Assembly Chamber galleries with raised platforms and new railing behind the original balustrade. The light fittings are new.

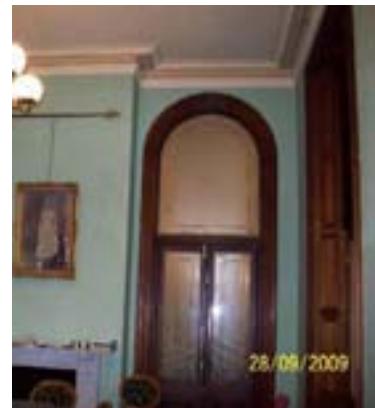
Figure 126: Doors to the Ministers' Room (B14) from the Assembly Chamber, added in 1889 viewed from B14

The Ministers' Room is very intact and retains most of its original plasterwork, chimneypiece and door and window joinery. However, the doorway to the balcony does not appear to be original and detracts from more important doors into the Assembly Chamber. The specification suggests that these doors, added in 1889, were copies of the original doors which led from the Under Secretary's room (now the lobby between the stairs and the anteroom) into the anteroom of the Chamber.

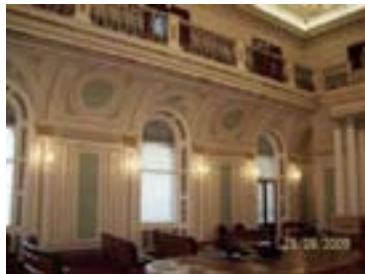
Figure 129: Council Chamber showing the circular panels under the galleries

The Council Chamber has always been more elaborately decorated than the Assembly Chamber. The obvious differences today are the royal coat of arms over the President's Chair, the round, as opposed to square, plaster panels on the undersides of the galleries, and the extent of the original furniture. This includes the President's Chair and desk, the large oval table, writing desks, bookcases and bench seats. The large cedar bookcase in the anteroom probably dates from ca.1900.

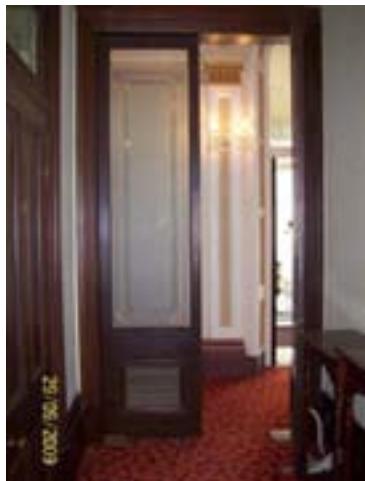
Figure 130: Anteroom doors, which have new etched glass and louvred panels

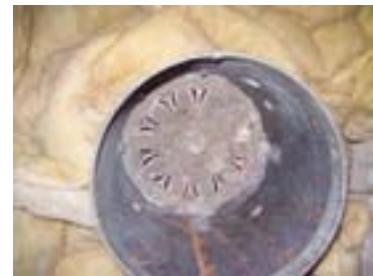
Figure 133: Possibly the remains of a 'sunlight' fixing in the roof space above the Council Chamber photographed from above

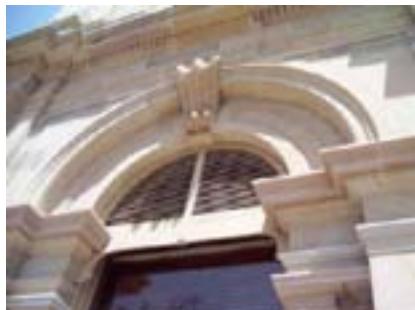
Figure 136: External louvres remain from blinds at first floor level, the valance may be a reproduction

The Libraries, which originally had blinds, are curtained in a style that is too lavish for their solemn character and hides the joinery. The Library on the first floor originally had exterior louvred shutters, of which the fixed heads survive.

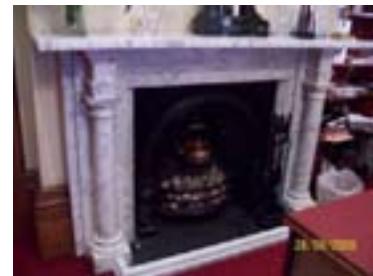
Figure 140: Chimneypiece in the original Speaker's Office, which is similar to that in the second floor Library. It retains early fireclay pieces in the grate.

Both register grates survive complete with fireclay decorations in the grates. The fire irons date from the 1960s.

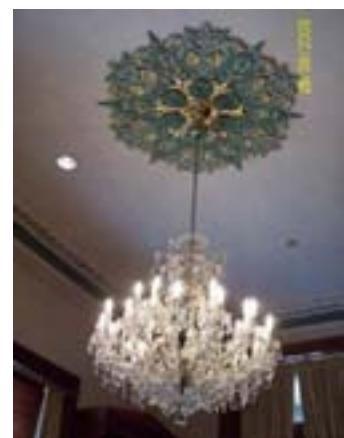
Figure 141: Ceiling rose in the original Speaker's Office of particularly ornate filigree plasterwork. The chandelier probably dates from the 1950s.

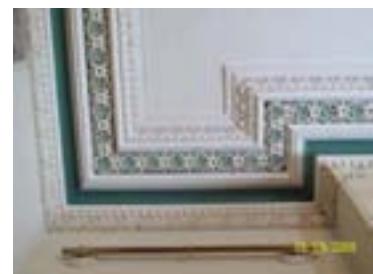
Figure 142: Cornice in the original Speaker's Office with the flowered border and a picture rod below on early patera

The picture rods may hang on original patera although the rods themselves were probably bronzed with brass ends, similar to those in an early photograph of the President's office at the other end of the building (see figure 41). The bookcases probably date from the 1950s but are well built and are sympathetic to the room.

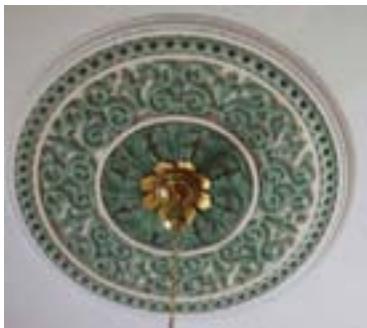
Figure 143: Ceiling rose in the Speaker's former bedroom matches that in the President's former bedroom

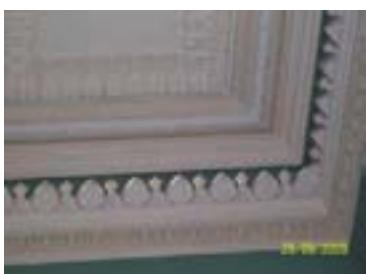
Figure 146: Cornice in the President's Office is more severe than the one in the Speaker's room

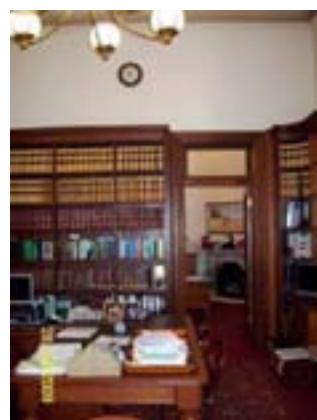
Figure 149: The Clerk's room (B13) looking through the 1980s doorway into (B11)

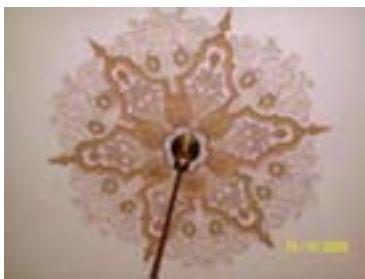
Figure 152: Ceiling rose in A25 matches the one in the Speaker's former office

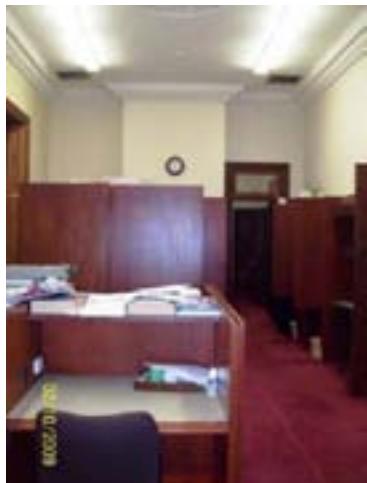
Figure 157: Press room C16 divided into cubicles

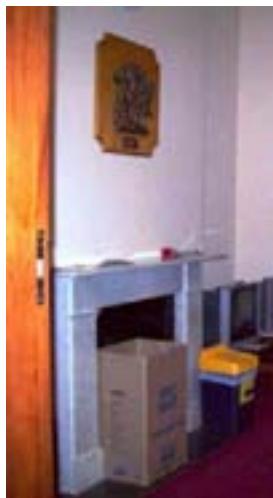
Figure 158: Plain chimneypiece in C14, above which is Queensland coat of arms presented by Premier Bjelke-Petersen to the press in 1979

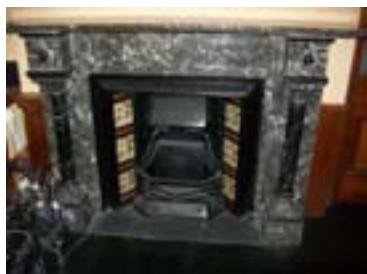
Figure 159: Black marble chimneypiece in the Dining Room with tiled register grate

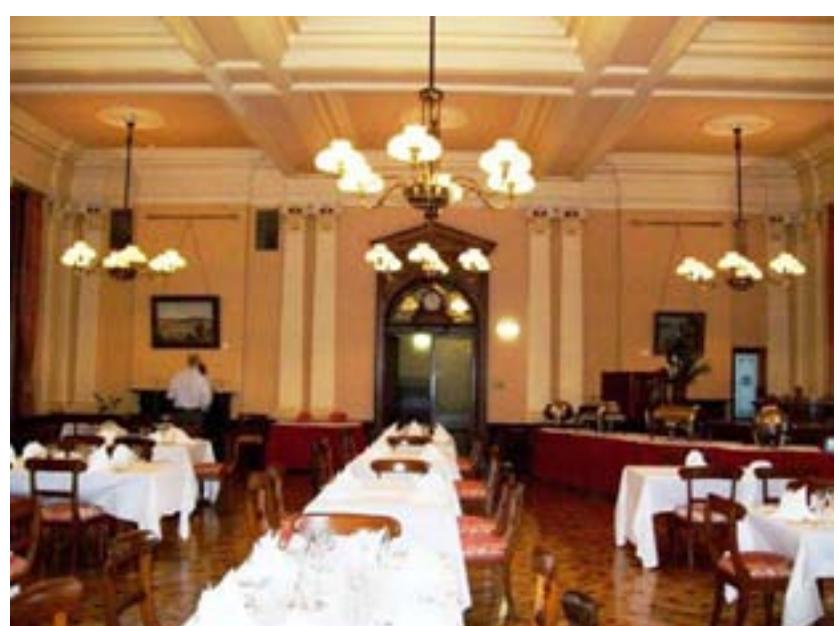
Figure 160: The Dining Room

The room has plastered walls with a panelled timber dado. The capitals of the pilasters are embellished with sunflowers, fashionable in the Arts and Crafts tradition of the late nineteenth century. The pilaster plinths are grained to match the adjacent panelling. The ceiling is coffered with ceiling roses in each coffer and modern electroliers. The floor is parquetry, as was specified in 1934 and renewed in the 1980s.

Most of the joinery is early. The original clock casing, designed especially for this room, survives over one doorway (see figure 57). The double doors into the dining room from the corridors have cedar aedicules. The floor springs have been replaced but the cast brass base plates to pull handles are original. The handles themselves may have been crystal rather than wood. The window sashes and sets of French doors leading onto the arcade and balcony on each side are original; however window heads on the south east wall have been modified for air conditioning vents.

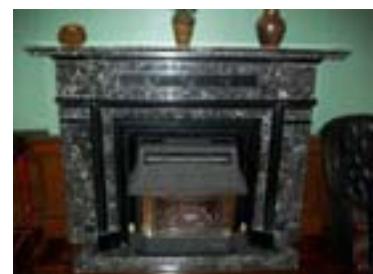
Figure 164: Chimneypiece in the Members Lounge Bar

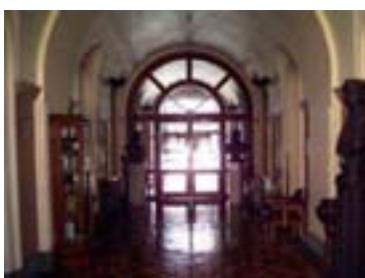
Figure 166: The carriageway is now enclosed with glazed screens and a tiled floor has been added

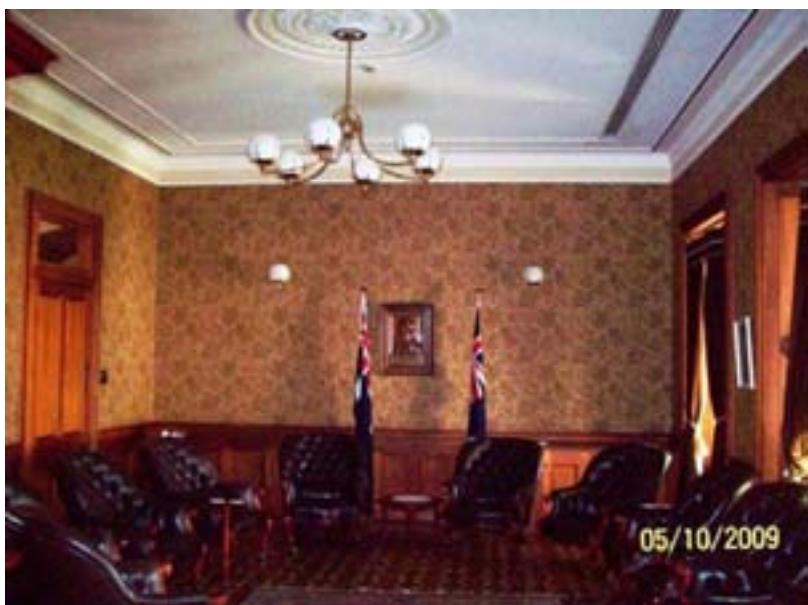
On the second floor, the original kitchen has been converted into a function room now called the Bernays Room. This retains its tessellated floor, repaired and slightly modified, and has been made more elaborate with panelling, wallpaper and decorative plasterwork.

Figure 169: The Bernays Room

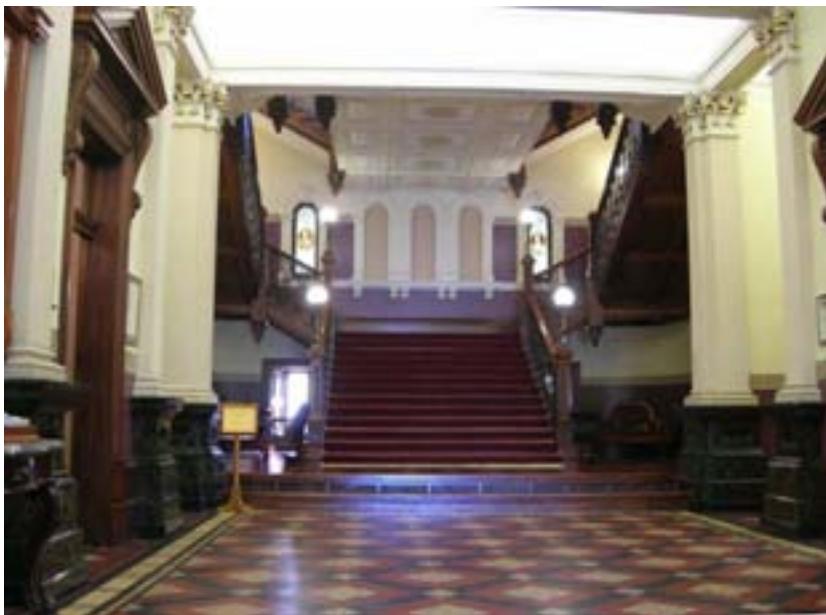
Figure 170: The main entrance hall from George Street and the grand staircase. The reception room on the right is now a shop.

The main entrance hall appears to be reasonably intact and retains its tessellated floor. The parquetry has been relaid. The aedicules and doors to the reception rooms on either side are intact with double margin door leafs surviving. The pilaster plinths were finished with high quality marbling in the 1980s renovations. The grand staircase is likely to have been extensively repaired but retains original balustrades and detail.

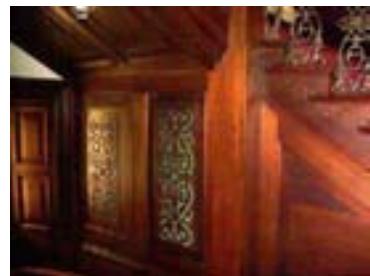
Figure 171: The cedar casing on the grand staircase at ground floor level incorporates fretwork panels

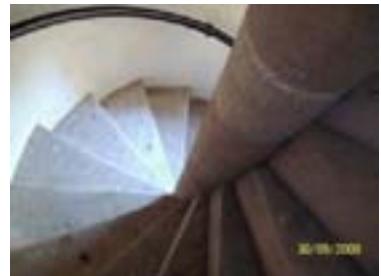
Figure 172: Spiral stone stairs to the Reporters' Gallery of the Legislative Council Chamber

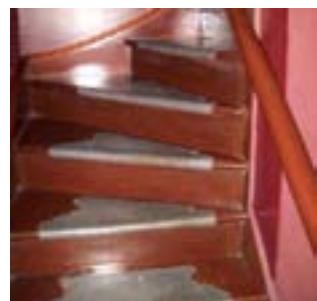
Figure 173: Stairs to the cellar retain lead nosings, these were specified for all public stairs, with cork carpet being reserved for the more important stairs

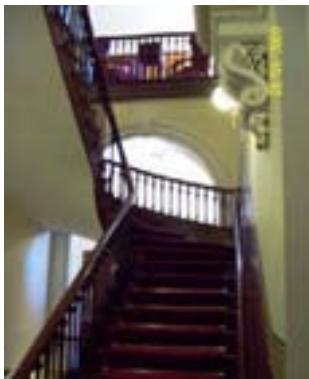
Figure 174: Staff stairs in the north tower, the balustrade against the archway is cast aluminium whilst the remainder is the original cast iron

Because of alterations to the lobbies, some new balustrading was inserted to match the original but this is of cast aluminium.

The staff staircase in the north tower was returned close to its 1860s form when the present lift was installed in the 1980s.

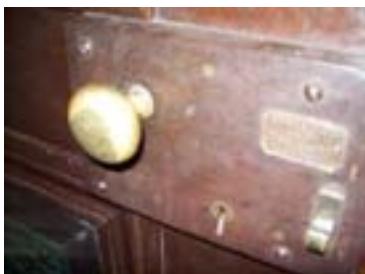
Figure 175: Early rim lock

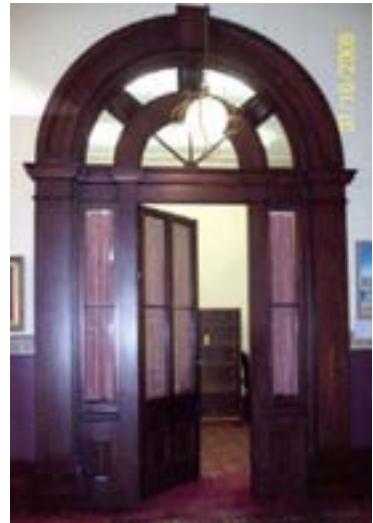
Figure 176: Doorway from the eastern entrance lobby into room A24, originally a waiting room. There is a similar doorway at the other end of the wing. The waiting rooms provided access to the reporter's stairs leading to the galleries.

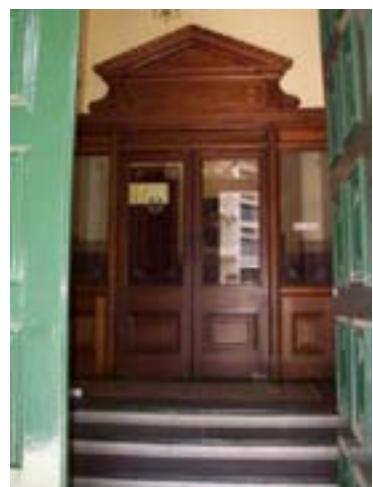
Figure 177: The main Alice Street entrance. The joinery detail echoes aedicules in the main entrance lobby from George Street

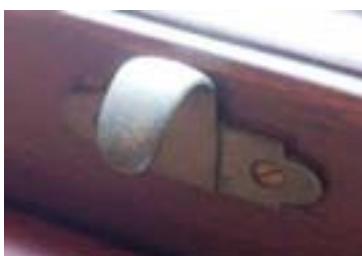
Figure 181: Original sash lift in the George Street wing

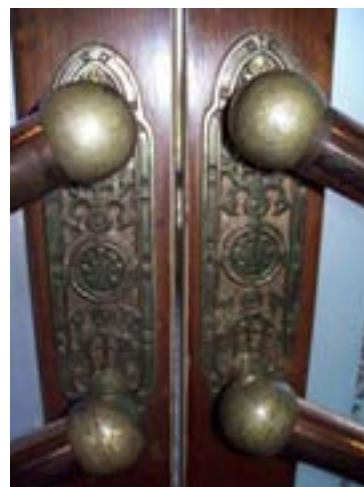
Figure 183: Handles to the Legislative Chamber and anteroom doors with matching relief pattern. The date of these is uncertain. They appear to be early but have been used on doors which were not installed until the 1880s.

It is difficult to date door handles in the Legislative Assembly Chambers because some, which could be original, are used on doors which were not installed until the 1880s and some appear in other locations within the Chambers in photographs from the 1950s, suggesting they have been moved. Diagonal push bars on the French doors may have been modified with the push bars mounted off centre on the base plates.

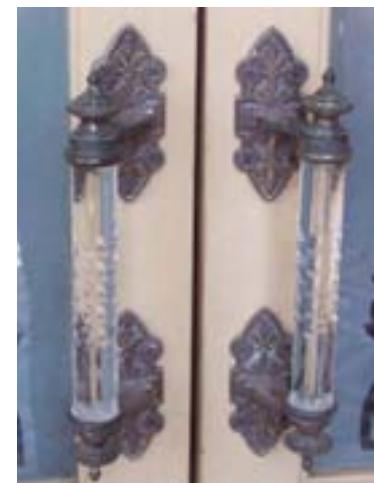
Figure 184: Handles to French doors in the Legislative Chambers dating to the 1880s.³⁶ The base plates of the crystal handles are the same as those on the 1880s dining room.³⁷

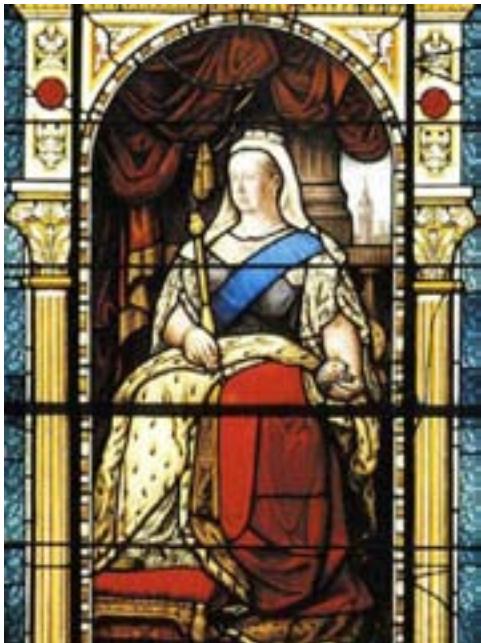
Figure 185: Detail of the Queen Victoria window, new lead camees have been used to repair breaks in the glass

7.10.5	The decorative glass should be further researched and a condition report prepared by a suitably qualified and experienced conservator. A priority is to determine whether the protective cover on the Queen Victoria window is detrimental to the glass.	163

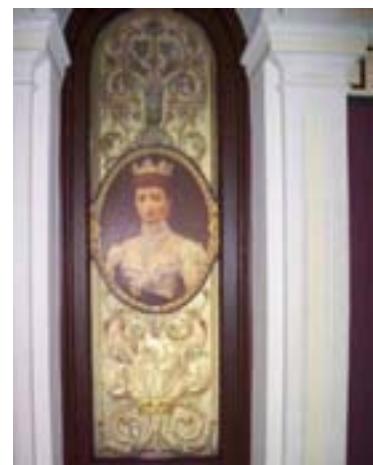
Figure 186: Princess of Wales window. The stained glass is in large panes, the only lead camees being around the portrait. Some of this may be original glass by Chance Bros.

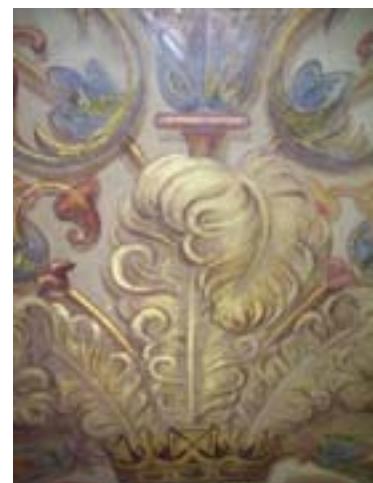
Figure 187: Detail of Princess of Wales window showing the painting

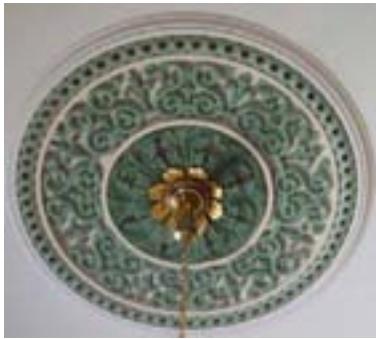
Figure 188: Ceiling rose in the Speaker's present office, incorporating acanthus leaves and a scroll design

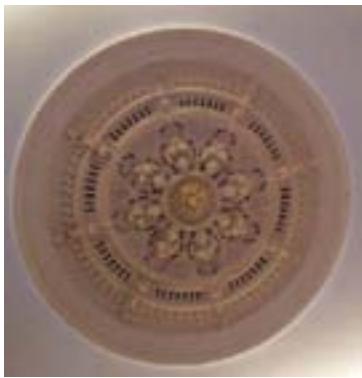
Figure 189: Ceiling rose in the Alice Street wing

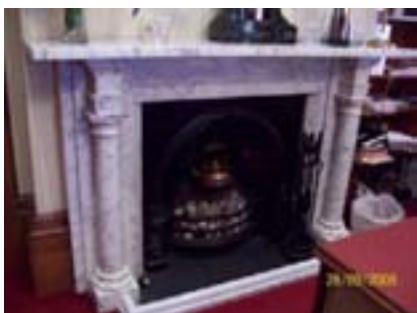
Figure 190: Chimneypiece in the Speaker's former office, 1860s

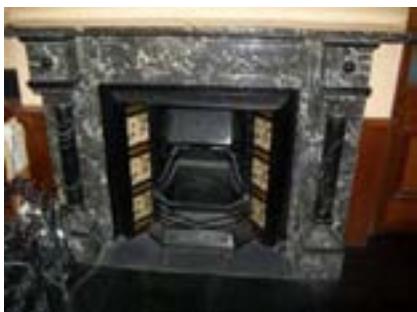
Figure 191: Chimneypiece in the Dining Room, ca.1891

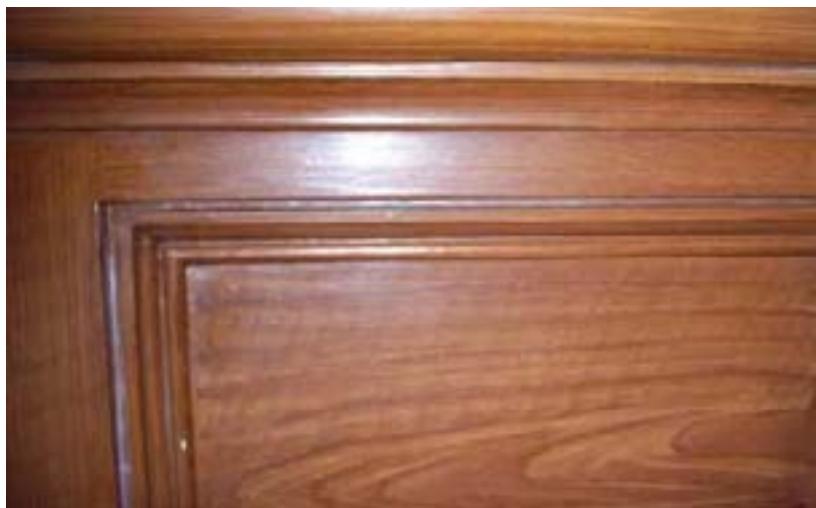
Figure 192: Grained plaster on the pilaster plinths in the Dining Room

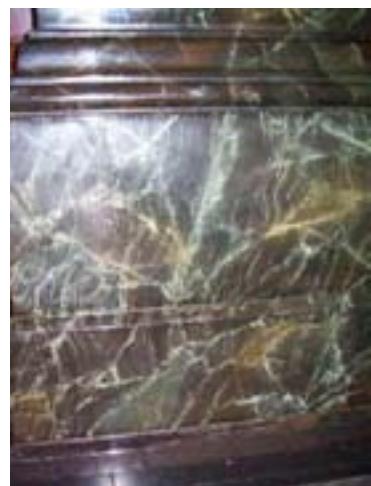
Figure 193: High quality marbling in the main entrance hall carried out by craftsman Keith Pollard in the 1980s renovations

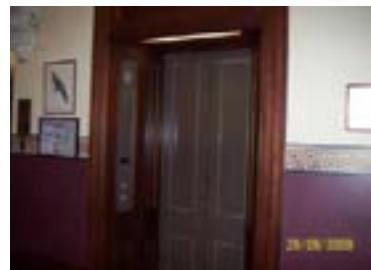
Figure 194: Lift door with reproduction cedar casing and stencilled dado on the walls

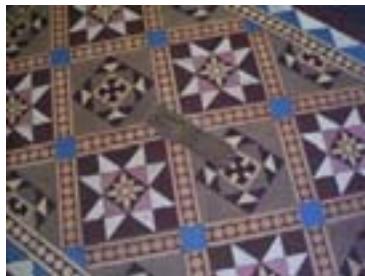
Figure 195: Tessellated tiling in the Alice Street entrance lobby

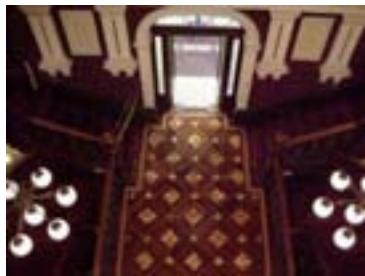
Figure 196: Parquetry on the first floor landing of the grand staircase is reproduction

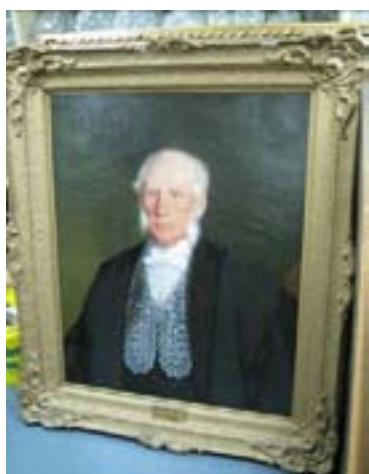
Figure 232: Joseph Backler's disfigured portrait of Gilbert Elliott,—compare this with figure 208

The fate of Joseph Backler's historic portrait of Gilbert Elliott, the first Speaker, provides a sobering example of inexpert care. Originally a full-length portrait when painted in 1866, it was cut down to half-length in relatively recent times and the original frame replaced. It is not known when this travesty occurred except that it was before the renovations of 1981–82. The cut-down painting is mentioned in Backler's entry in Joan Kerr's *The Dictionary of Australian Artists*, published in 1992.⁴⁵ Obviously, the person who authorised this action had no idea of the painting's significance. Sadly, Queensland's 'first national portrait' has been (literally) disfigured forever. Presently it is hanging in the Speaker's Hall in the Parliamentary Annexe and advice will be sought from a professional conservator on its future care.

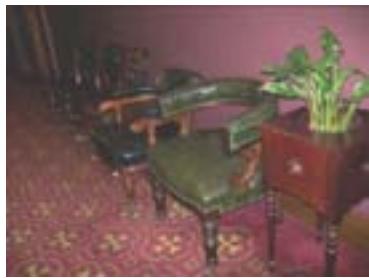
Figure 236: Excess furniture lining a corridor

The building has too much antique furniture, with excess being stacked in corridors, galleries, etc. Some bookcases purchased in the 1981–82 renovations remain empty or are used only for displaying silverware and glassware, which is out of place in offices anyway.

Excess furniture acquired relatively recently, and therefore having no association with the building, should be sold and the proceeds used to conserve significant items. However, replicas of the original Petrie yellowwood furniture should not be disposed of, nor purchased items that are outstanding examples of colonial furniture.

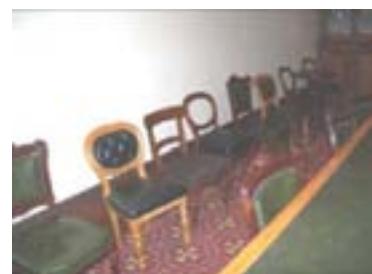
Figure 239: This assortment of chairs in committee room A35 illustrates the haphazard moving of furniture

The haphazard moving of furniture is not only damaging but also reduces its visual impact. The room allocations so carefully planned by Conrad & Gargett in the 1981–82 renovations, grouping like pieces together, has been abandoned, so that few rooms now have matching furniture and originals and reproductions are hopelessly mixed.

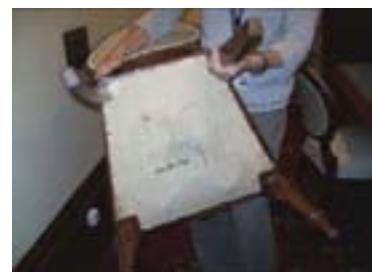
Figure 240: On this chair, the small metal plate bearing a reference number has been removed and replaced by a flimsy paper label

The Conrad & Gargett furniture register, now held only by the Parliamentary Library, should be copied so that it is more accessible to Property Services staff. Also, the Antique Furniture Photographic Registers, ca.1983, should be scanned because the photographs therein have been damaged by sticky tape.

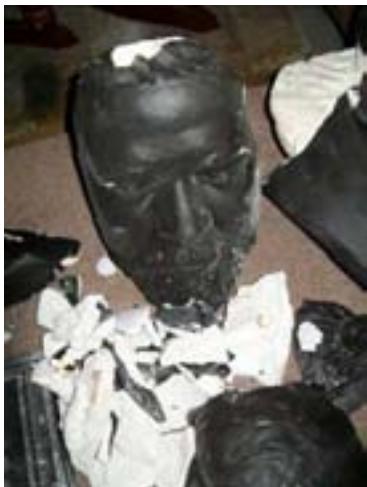
Figure 241: T.J. Byrnes, a fallen hero—compare this with figure 220

Throughout the building significant material is receiving inadequate care. The worst example is J.L. Watt's plaster portrait bust of Premier Byrnes, which fell off its pedestal when being moved, but fortunately the pieces have been saved. Other plaster busts of premiers by the same sculptor have been damaged by moving and abrasion and, as plaster is an unstable medium, the surfaces are cracking.

The smashed bust of Premier Byrnes should be sent to an appropriate conservator to repair and then cast in bronze.

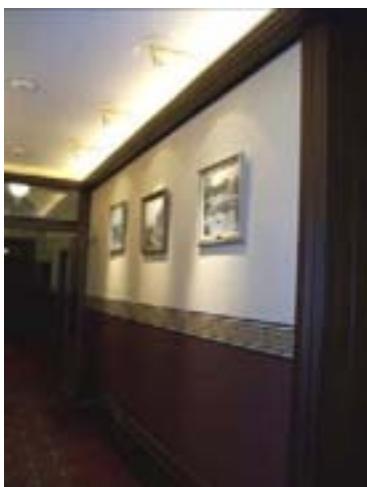
Figure 242: An example of pictures being displayed under intense light, resulting in fading

Works of art on paper, photographs and costume are fading under intense light. The recommended light level for these materials is only 50 lux and even so they should not be on permanent display. Other materials—such as objects made of metal, glass or wood—are not as susceptible to light damage and can remain on permanent display.

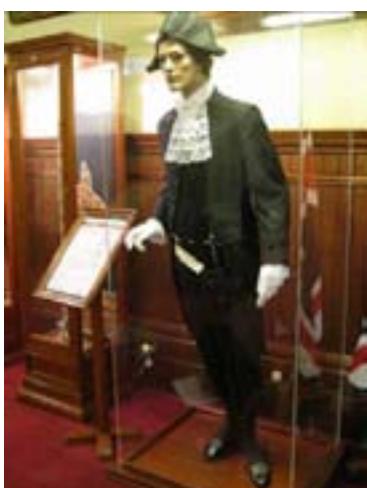
Figure 243: An example of costume fading under intense light

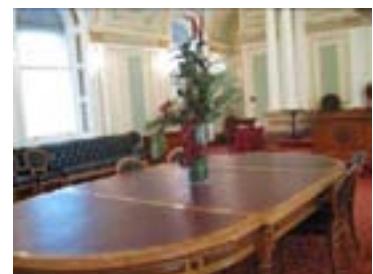
Figure 244: A vase of flowers on the large table of the Legislative Council Chamber, exposing the table to risk of water damage

Damage is also resulting from allowing rooms with significant furniture and fittings to be used or hired for public functions. Instances were observed of vases and other damaging objects being placed on significant furniture and of catering trolleys colliding with doors.

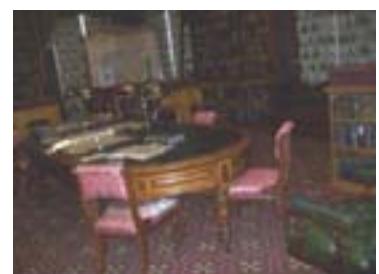
Figure 246: The O'Donovan Library now has a mixed assortment of furniture

Where possible, the allocation of furniture to rooms, as detailed in Conrad & Gargett Pty Ltd Architects, Parliament House Renovations Loose Furniture Register, ca.1983, should be reinstated, particularly of chairs which are easily reinstated.

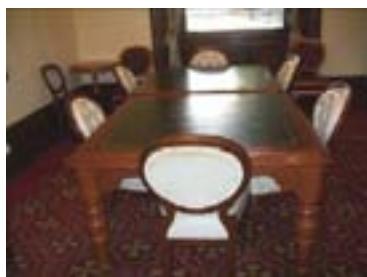
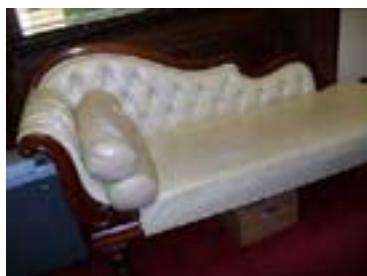
Figure 247: The furniture above has been reupholstered in discordant white vinyl

In some cases, antique furniture has been reupholstered with inappropriate materials, and chair frames have been damaged in the process.

Antique furniture should not be reupholstered, repaired or re-polished without professional advice.

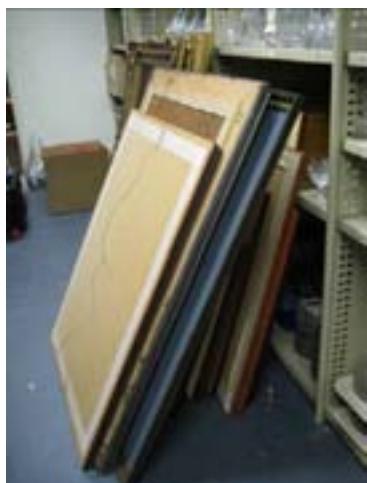
Figure 248: Paintings being stored inadequately

Significant material is being stored inadequately. The present storage in the Annexe and the external store lacks 24-hour air-conditioning and equipment needed to protect items from abrasion, dust and light damage.

To protect significant material, a store should be established with necessary equipment and stable environmental conditions.

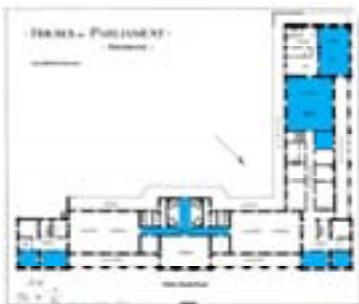
Figure 257: First floor plan showing parquetry installed in the 1980s renovations. This was similar to the original scheme.

- elaborate plasterwork in its correct location;
- reconstructed timber door and window joinery, architraves, panelling and skirtings;
- high-quality graining and marbling;
- parquetry floors which have been relaid in the original 1934 locations and patterns;
- the one remaining woven mesh grille to the stained glass; and
- decorative glass which is found to be post World War II.

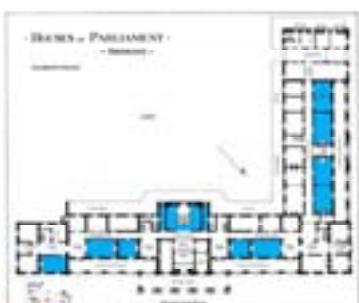
Figure 258: Ground floor plan showing parquetry installed in the 1980s. The rooms facing the George and Alice Street arcades were not proposed as parquetry in 1934.

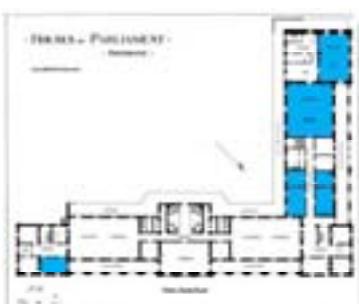
Figure 259: In the 1980s, fire place kerbs were scheduled to be retained in the rooms shown on the first floor plan (above) and the ground floor plan (below).

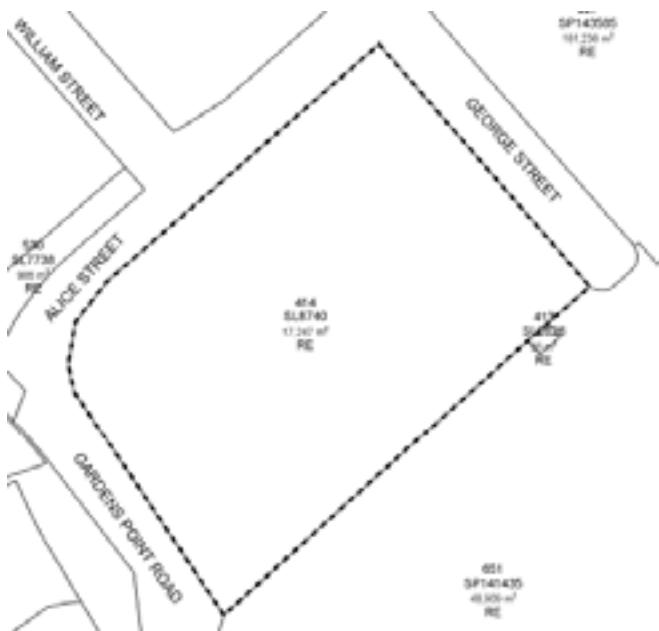
Figure 260: Heritage boundary from the entry in the Register 600069

The heritage boundary of Parliament House covers the whole of the allotment. As a result the whole of the area and the structures on it are subject to the development provisions of the Queensland Heritage Act even though not all the components of the site are mentioned in the entry in the Heritage Register.

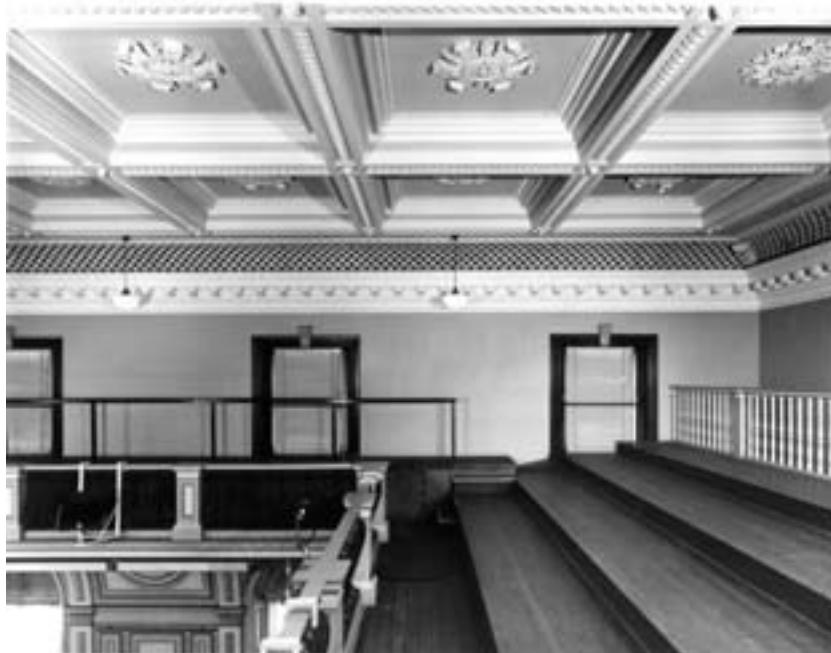
Figure 262: Legislative Council Chamber galleries showing the arrangement before the 1980s renovations, an example of the valuable record photographs taken in 1979

The archive includes the collection of record photographs taken by the Public Works in 1979 before the extensive renovations were undertaken. This collection is particularly valuable as it covers the building exterior and most of the interiors.

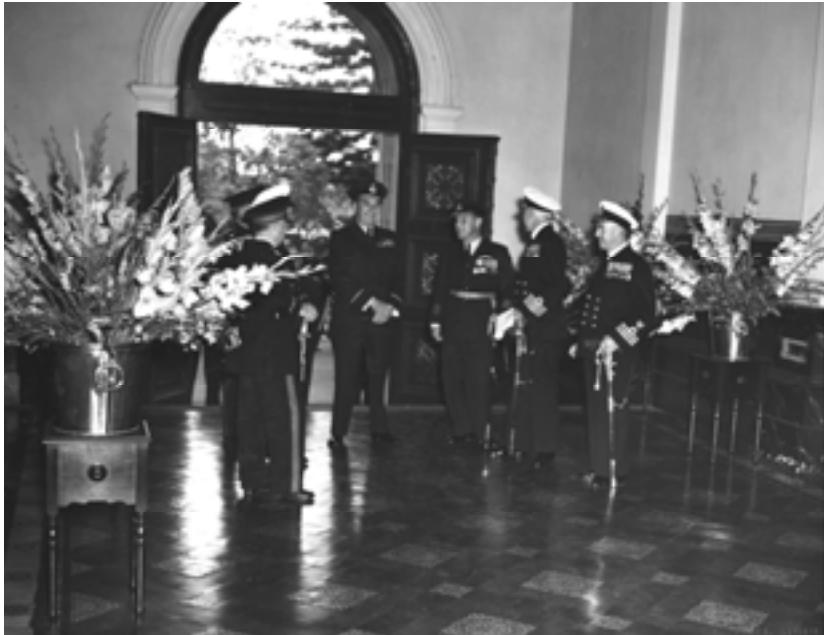
Figure 263: The main entrance hall prepared for a ceremonial arrival.
Marbled decoration and the dado stencil are visible on the far wall.

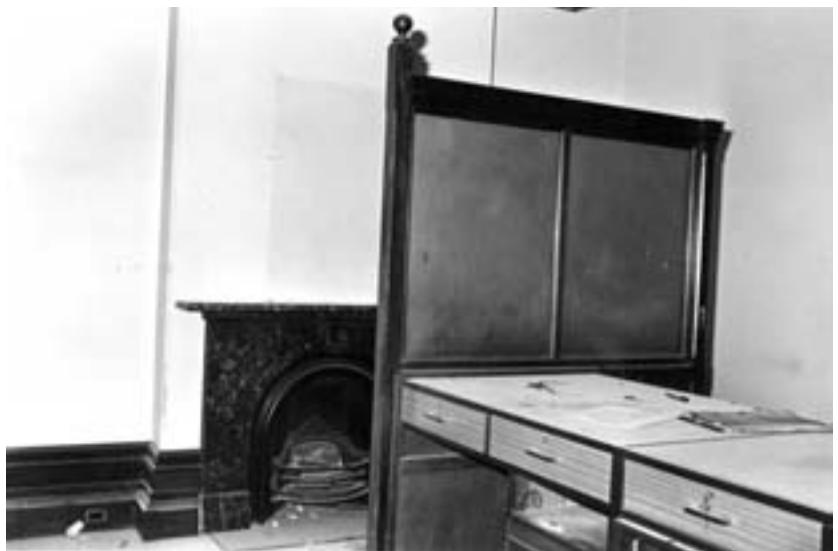
Figure 264: Small committee room in the George Street wing which was used as a post office, photographed in 1979. This chimneypiece has now been replaced with another of white marble from elsewhere in the building.

Significant components, such as chimneypieces and plaster decoration, belong in particular parts of the building and should not be moved to other locations as this distorts the historical evidence and makes interpretation of the interiors difficult.

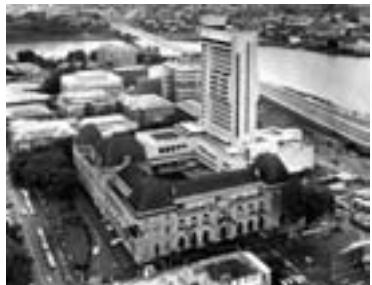
Figure 265: Configuration of the parliamentary buildings around the courtyard from a photograph taken in 1979
