Cairns Tilt Train derailment (Ingham-Hinchinbrook)

19 March 2011

Final report, rail safety investigation TMR 3947

Major rail incident investigation

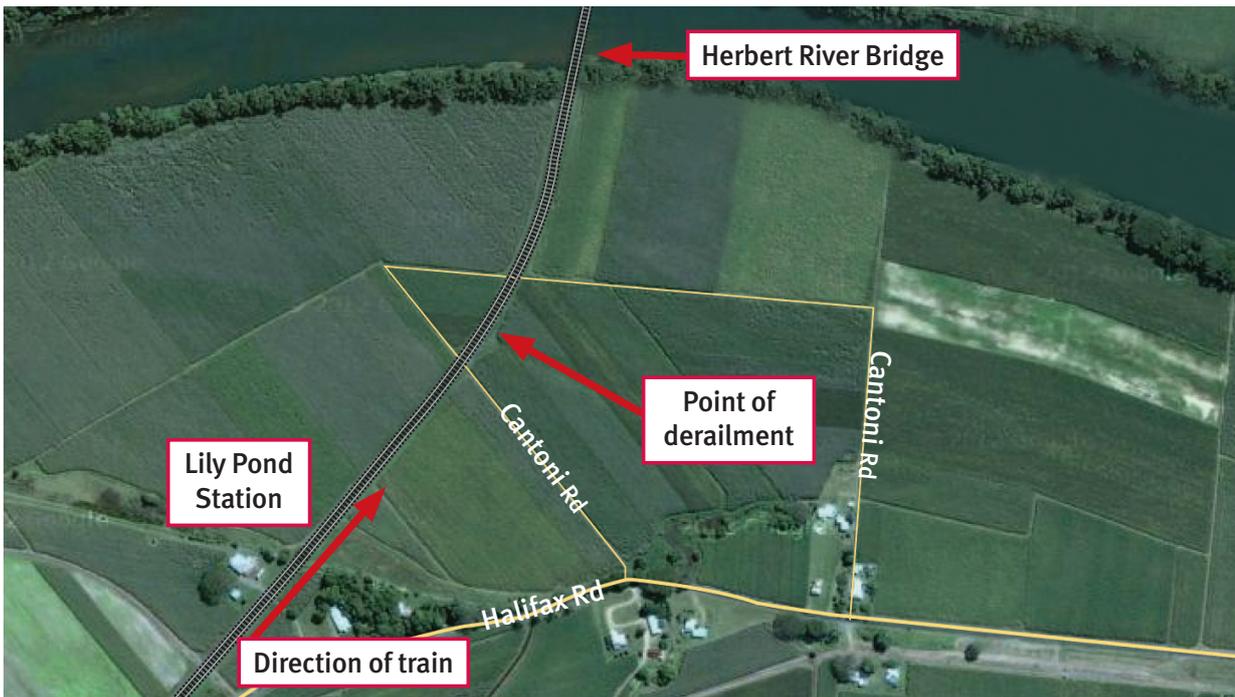
Figure 2: Rail layout and point of derailment

For northbound rail traffic (direction of service VCQ5), and approaching the point of derailment, trains encounter a left hand curve in the track following a straight section. The derailment occurred on the curved section of the track. The area is rural in nature, with the derailment point surrounded by sugar cane plantations. The sugar cane can restrict the forward vision of train drivers when approaching bends.
