Serious Injury Collision, Draper Street, Cairns **15 June 2015**

Final report, rail incident investigation QT5128

Major rail incident investigation

Final report, incident reference: QT5128

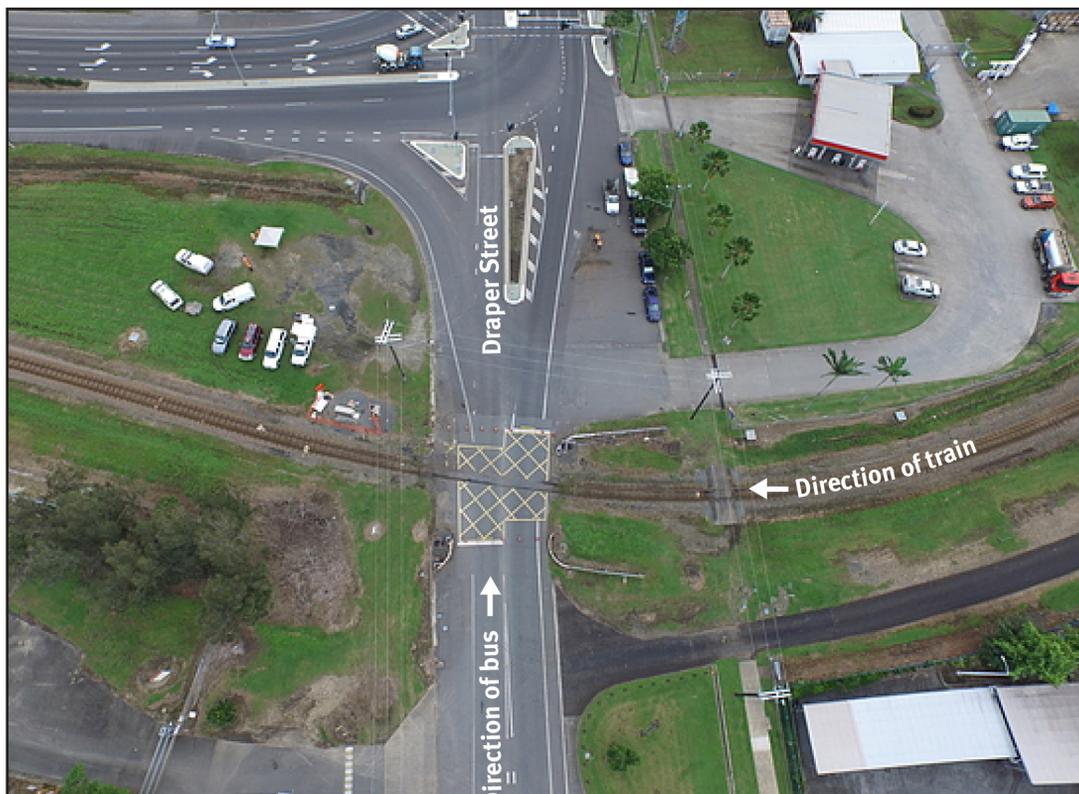
When stopped at the level crossing in the direction of the bus, the first vehicle has approximately 135m of vision to oncoming trains travelling from Cairns (direction of involved train).

Figure 2: Image showing layout of roadway and level crossing at the time of the incident

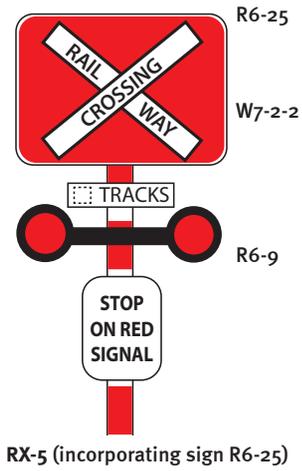
- RX-5 flashing lights pedestal and signage on both approach sides of the level crossing (figure 9). The level crossing was fitted with primary and secondary LED¹³ red flashing lights (figure 15)
- box marking sign (G9-67-2), located on the approaches to the level crossing, installed to reduce queuing across the level crossing (figure 10)
- box markings on the approach and departure of the level crossing (figure 11)
- advance warning sign (W7-4), used to give advance warning of a crossing controlled by flashing lights (figure 12)
- a stop line marked on the approach sides of the level crossing (figure 13).

Figure 9: Red flashing light assembly

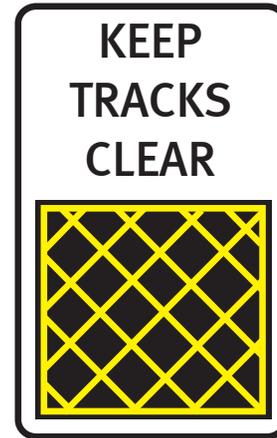
Figure 10: Keep Tracks Clear sign

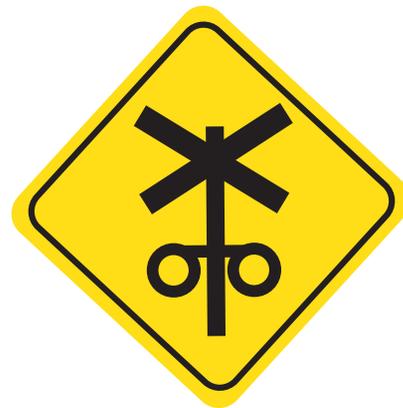
Figure 12: Advanced level crossing warning sign

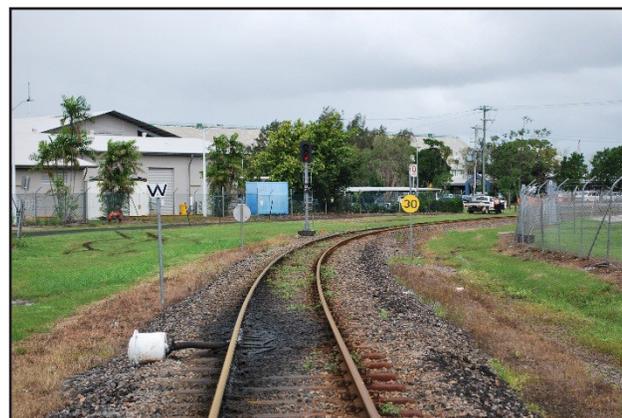
Figure 14: Train path approaching Draper Street Level Crossing

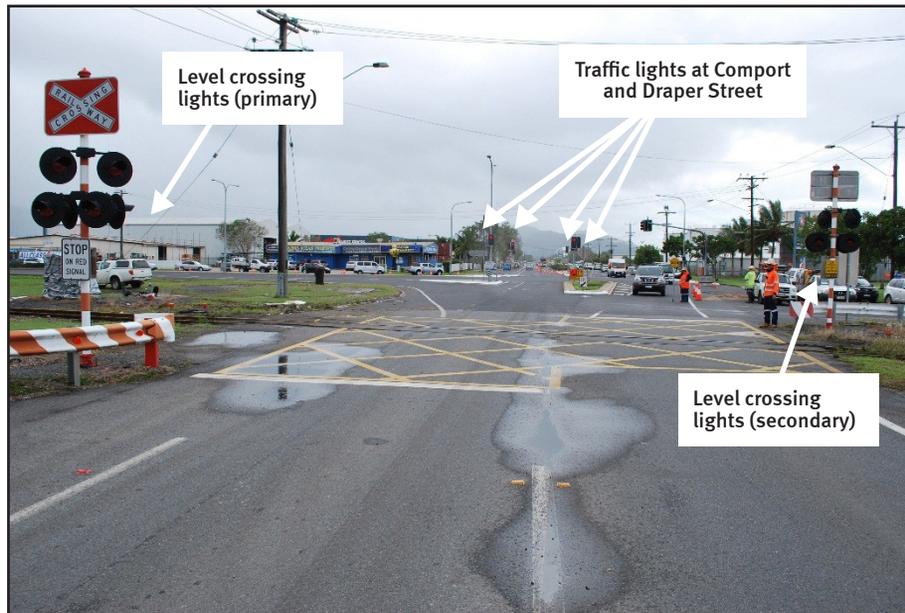
On the morning of the incident, a Queensland Rail signal electrician checked the Draper Street level crossing and verified that the crossing protection was operating correctly.

Figure 15: Draper Street level crossing, general north-westerly direction (direction of bus travel), also showing the vicinity of traffic control lights at the intersection of Comport and Draper Street.

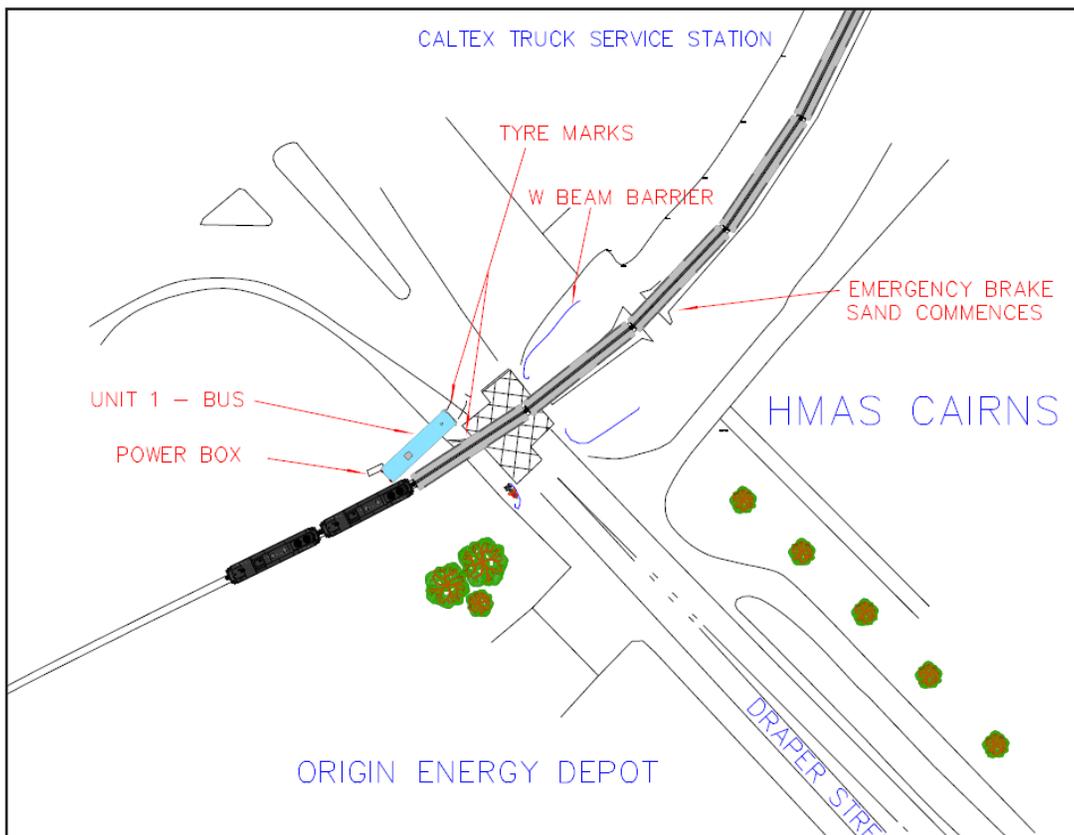
The event recorder, together with the Queensland Police Service measurements, the signalling report, level crossing assessment and related documents allowed Queensland Rail to determine the sequence of events as detailed in figures 17 and 18.

Figure 18: Queensland Rail diagram using the data download, scene examination and measurements taken by the Queensland Police Service and Queensland Rail.
