Serious Injury Collision, St Vincents Road, Banyo 14 September 2012

Final report, rail incident investigation TMR 4617

Major rail incident investigation

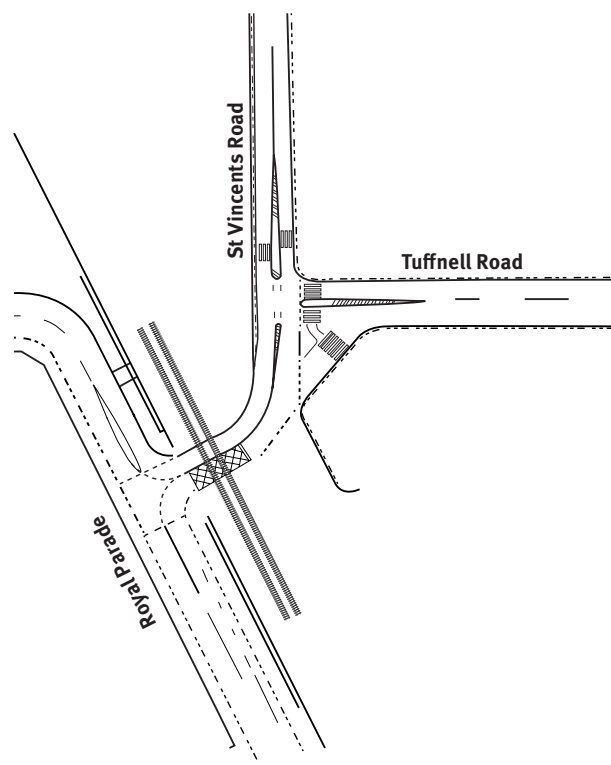
Figure 2: St Vincents Road level crossing layout

The level crossing is a straight section of roadway. Directly after the level crossing, St Vincents Road turns approximately 90 degrees to the left, which requires long vehicles to utilise a portion of the eastbound lane on the level crossing to negotiate the tight corner. The road layout is depicted in Figure 2.

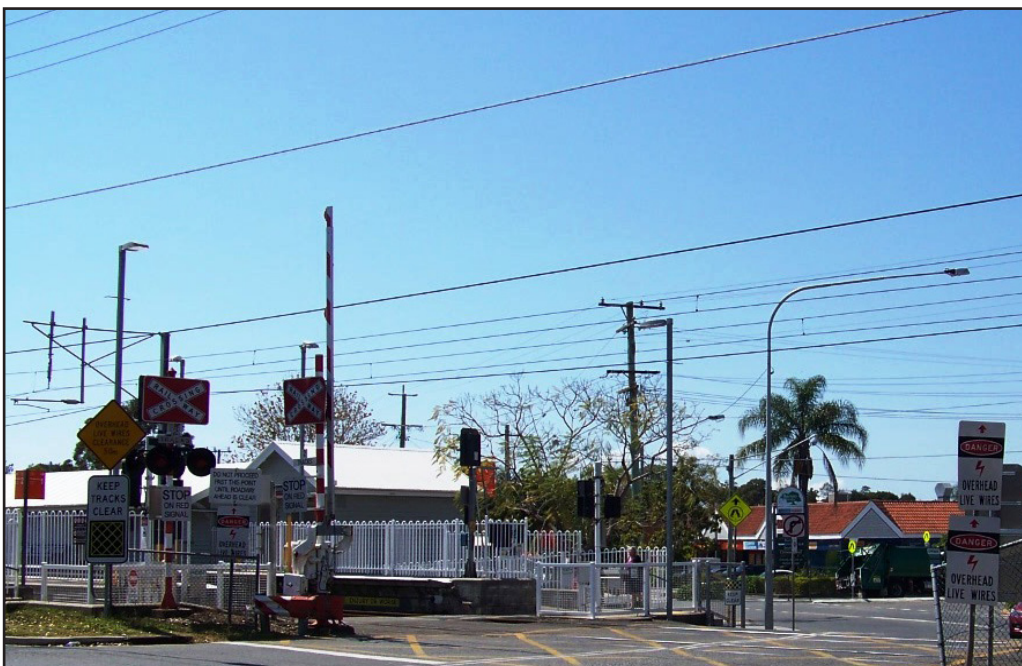
Figure 11: St Vincents Road level crossing

The St Vincents Road level crossing was last assessed on 5 March 2002. The assessment made several recommendations including:

- installation of advance warning signs for road traffic
- cross hatching to be painted on the roadway
- the pavement markings on pedestrian pathway to be repainted
- installation of LED lights.

All of the recommended upgrades were completed in mid 2003 (refer to Figure 11). On 12 September 2012, the RTO assessed the St Vincents Road pedestrian level crossing as part of scheduled inspections. During this assessment, the RTO did not observe any issues relating to the road level crossing protection.

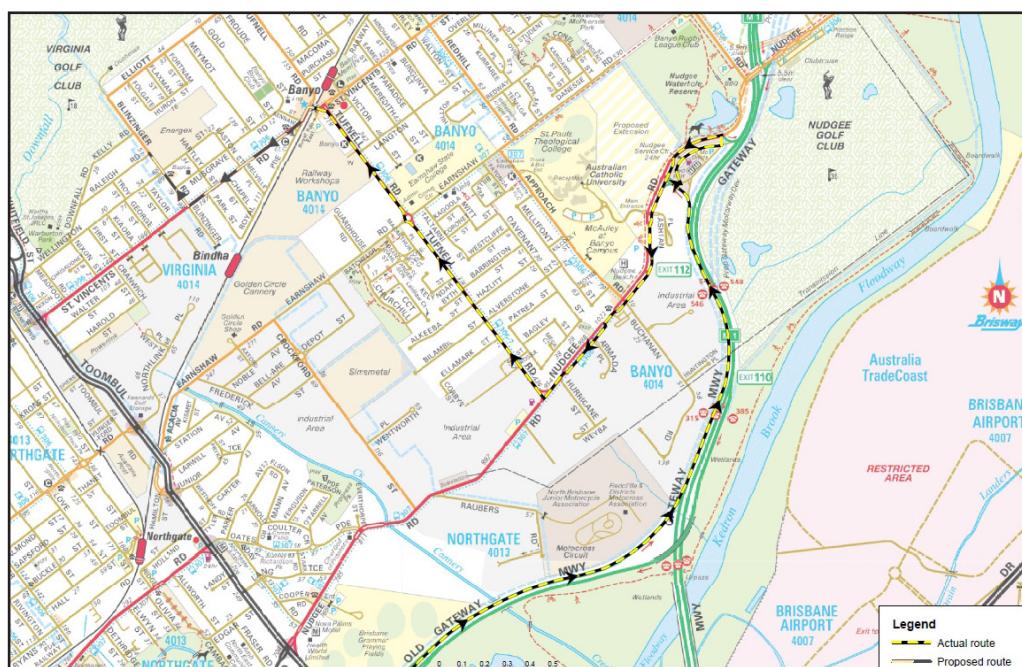
Figure 13: Route taken by the heavy vehicle

The proposed route included a combination of State controlled roads and local government roads. Under respective legislation, state controlled roads were the responsibility of Transport and Main Roads and local government roads were the responsibility of the road manager. The route is depicted in Figure 13.

The onus to seek approval from the local road manager for operations on local government roads is a condition of travel under the current process. At the time of the incident, the heavy vehicle operator, and therefore the heavy vehicle driver did not have authority to travel on the local government roads.

The investigation team identified that there is no process in place whereby Transport and Main Roads notifies the relevant road manager that a permit application had been received or that an approval had been granted that interacts with the local roads. As a result, a coordinated response did not occur to address the risks of public safety and damage to infrastructure.

- Establish a process for the coordination of permit approvals and notifications between Transport and Main Roads and other road authorities until the introduction of the Heavy Vehicle (Mass, Dimension & Loading) National Regulations.
