**Commission of Inquiry**  
PARADISE DAM

# REPORT

APRIL 2020

In accordance with the *Commissions of Inquiry Order (No. 1) 2019*, we have made a full and careful inquiry into the root cause of structural and stability issues identified with the Paradise Dam near Bundaberg.

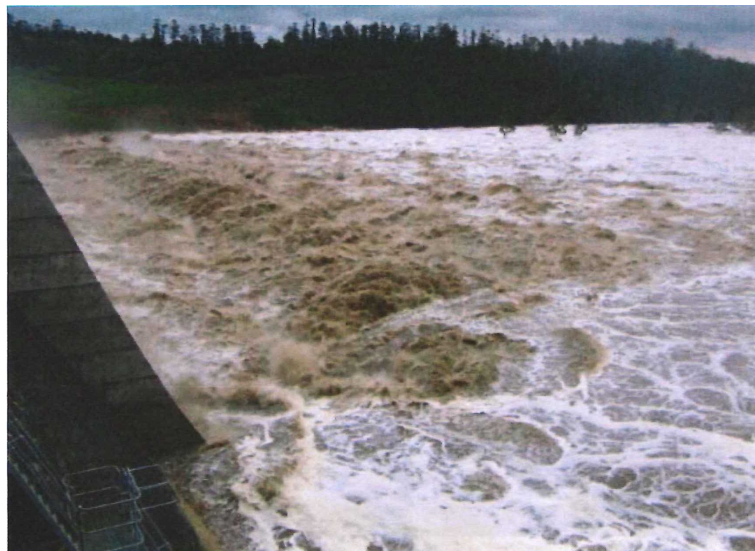
*Figure 2.1 – The primary spillway in flood during the 2011 event viewed from the right abutment looking across the river. (Exhibit 230, **DNR.006.3156**, .3212)*

- 2.3 The primary spillway continued to spill until September 2012, except for three days in November 2011 and two days in January 2012.<sup>4</sup> The prolonged flow precluded detailed inspection of the apron.

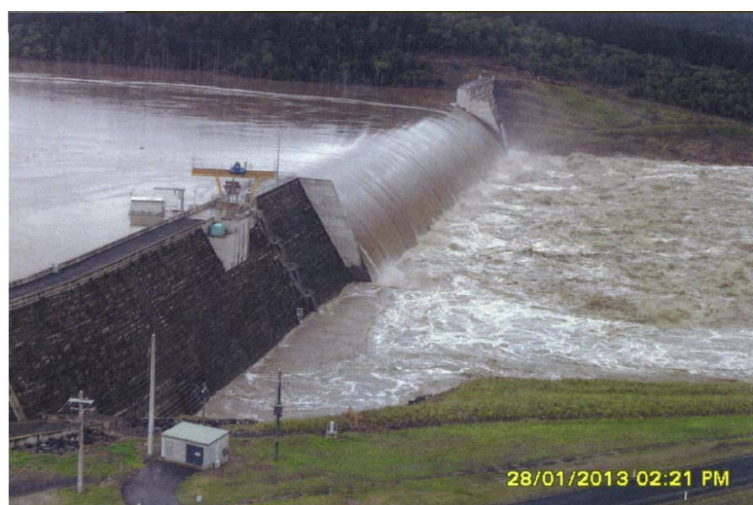
*Figure 2.8 – The Dam's primary spillway overflowing near the peak of the 2013 event.  
(Exhibit 237, SWA.512.001.0578, .0710)*

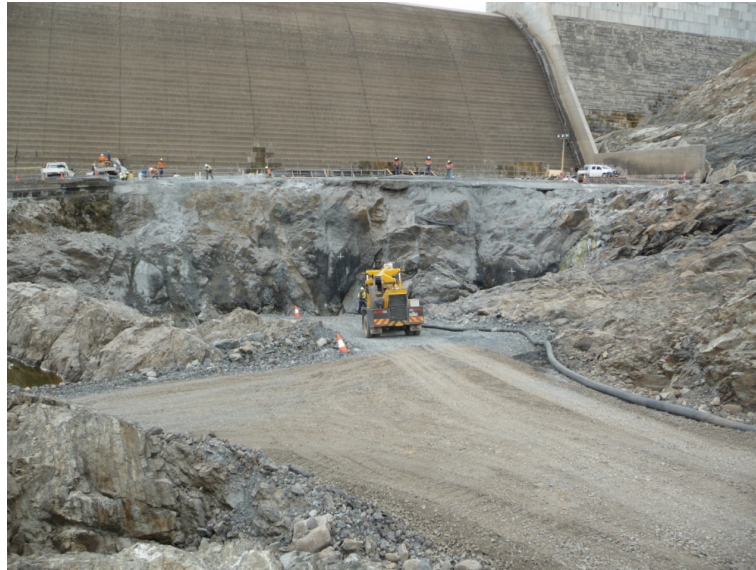
28. A root cause of the scour and erosion immediately downstream of the primary spillway apron was the apron's insufficient, 20 m width.
29. Advice from geotechnical engineers did not provide detail on the erodibility of the rock immediately downstream of the apron. And hydraulic studies gave the design team undue confidence that the erosive forces of the water would be largely contained within a 20 m apron.
30. It cannot be known with certainty what the result of comprehensive peer review would have been. But this accepted means to discover and correct problems was absent for the apron. Its absence created a significant risk of inadequate design of the apron. In this sense, the lack of full peer review of hydraulic structures was a root cause of the apron's inadequate width (and, therefore, also the scouring).

*Figure 2.10 – Scour on the left side, immediately downstream of the primary spillway apron.  
The hole was approximately 13 m deep. (DNR.001.0036, .0095)*

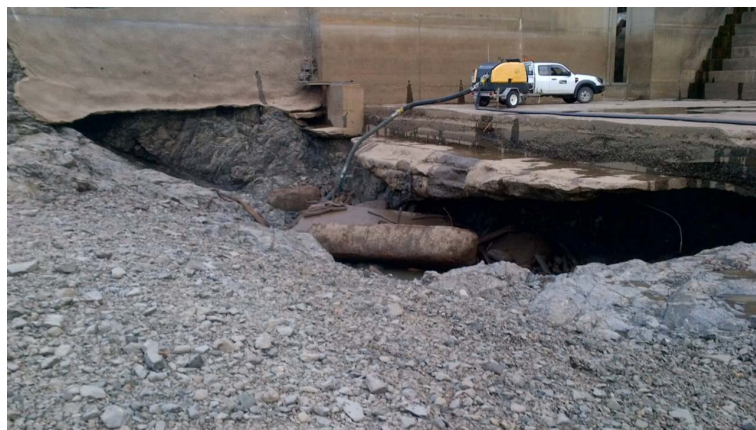
*Figure 2.11 – Scour on the right side, immediately downstream of the primary spillway apron.  
(DNR.001.0036, .0093)*

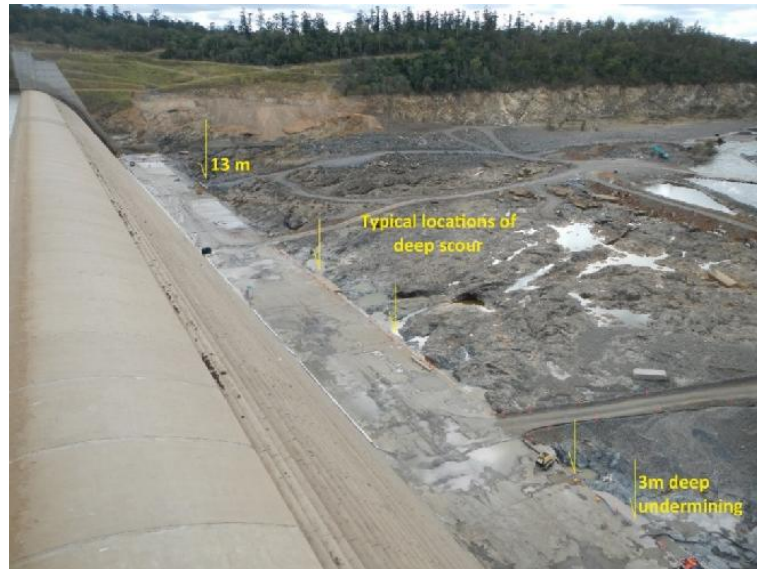
Figure 2.12 – Image looking over the primary spillway apron from the right abutment. The approximate locations of the scour are identified. (Exhibit 7, IGE.017.0001, .0058)

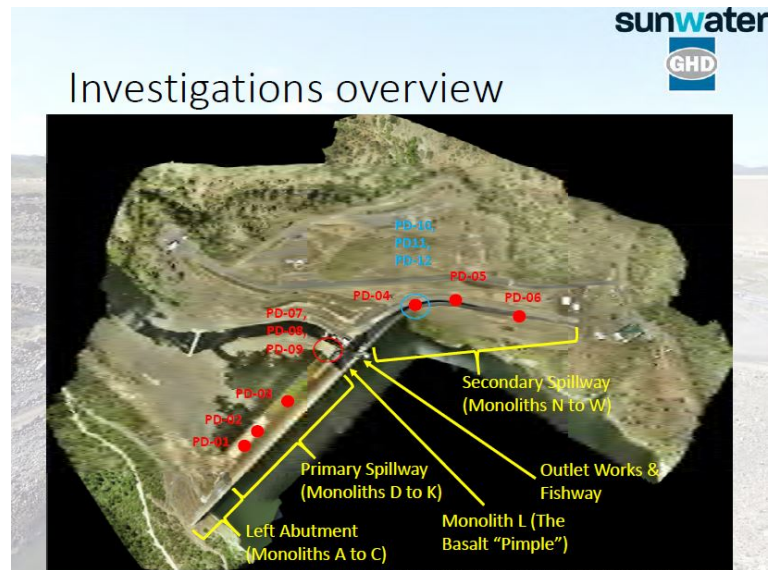
Figure 2.17 – An image from GHD's 27-28 August 2019 TRP presentation showing the location of the various monoliths. (ALC.002.001.1085, .1089)

*Overturning/sliding of the primary spillway monoliths through the RCC is the highest contributor to the risk as a result of the revised RCC lift joint shear strength adopted for this phase of the project. Undermining of the Primary Spillway Monoliths D to K due to overflow scour is the next highest contributor. These two failure modes account for over 85% of the total risk.*

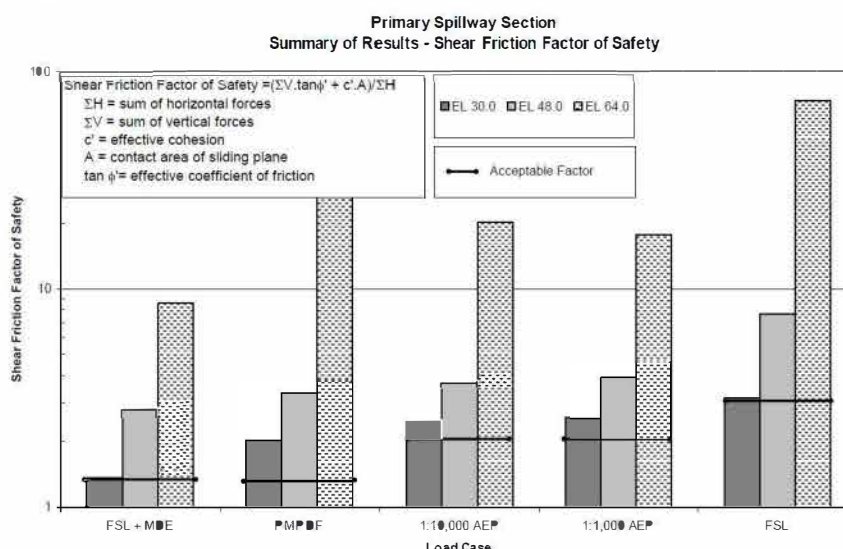
**Figure 5-13: Primary Spillway – Summary of Results – Shear Friction Factor of Safety**

4.135 Based on Dr Schrader's estimates, the summary of the stability analysis was presented in Figure 5-13 of the Detail Design Report, which follows.<sup>243</sup> More detailed results were set out in Appendix K.<sup>244</sup> They showed, for instance, that for the normal load case at Full Supply Level (FSL) with 50% uplift, the shear friction factor of safety was lowest at the base of the Dam and increased with the existing level.<sup>245</sup>

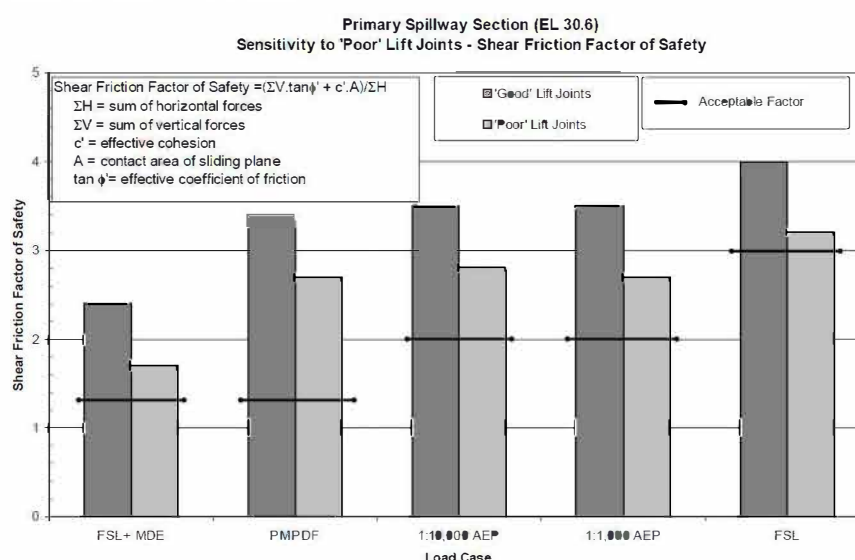
**Figure 5-16: Primary Spillway – Sensitivity to ‘Poor’ Lift Joints – Shear Friction Factor of Safety – EL 30.6m**

4.136 A sensitivity analysis was performed on the stability of the Dam based on untreated poor lifts joints with a friction angle of 35° and cohesion of 250 kPa.<sup>246</sup> Figure 5-16 of the Detail Design Report (below) shows the results for a lift joint in the Dam at EL 30.6 m.<sup>247</sup> A shear friction factor of safety of 3.2 was obtained under the normal load case with the reservoir at FSL and 50% uplift.<sup>248</sup> That compared with a minimum shear friction factor of safety of 3.0 for the normal load case.<sup>249</sup>

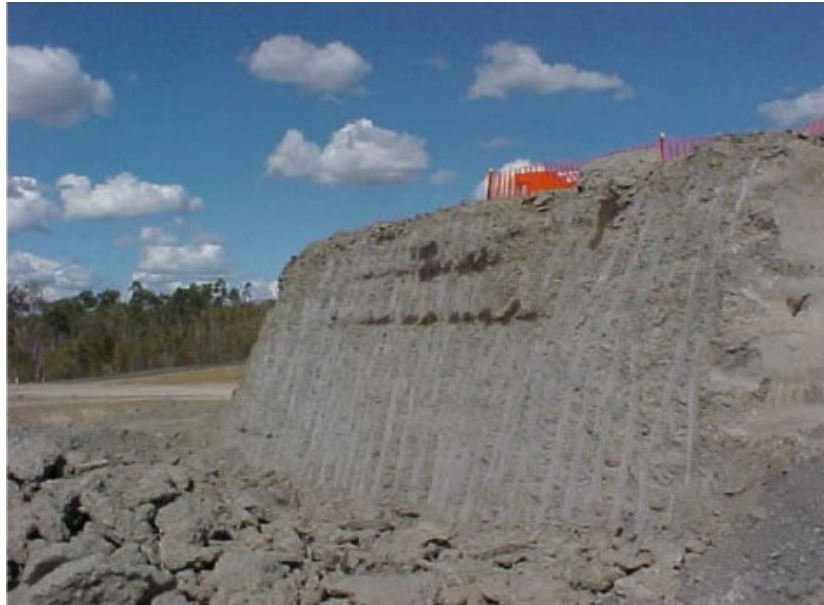
Figure 4.10 – Vertical face cut through at chainage 902 (Exhibit 109, **SCE.019.0001**, .0009)

*From a distance it has a very good and uniform appearance. Up close, localized defects can be seen, but these are less than typically seen in lean RCC, especially for a trial section, and of no major significance.*

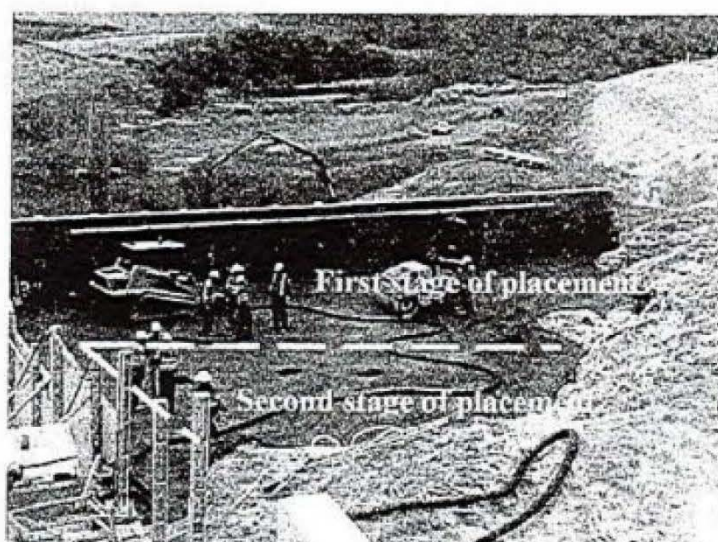
**Photo 1. RCC placement stages on the 2<sup>nd</sup> RCC layer placed on 15 July 04 next to Chainage 635 (EL 51.4)**

*Figure 5.4 – Second stage of RCC placed on 15 July 2004 in which low densities were detected.  
(Exhibit 31, SUN.009.002.0147, .0163)*

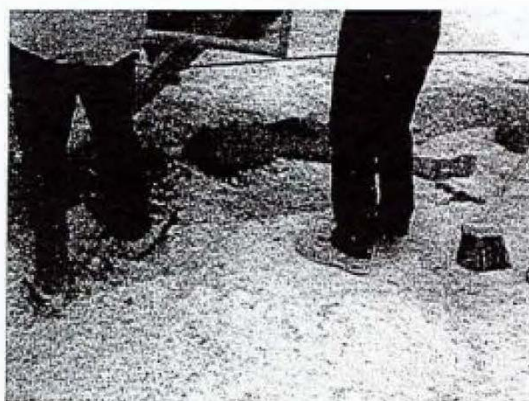
Picture 1 - 23 Oct 04- Bedding placement on RCC edge contaminated with debris

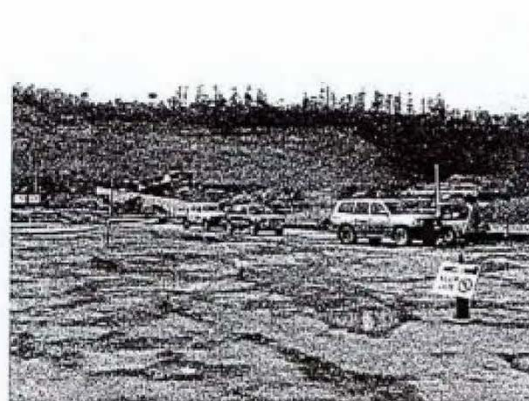
Picture 5 - 23 Oct 04 Cars on RCC surface causing contaminating and increasing cleaning activities. It is not allowed to circulate cars on RCC surface

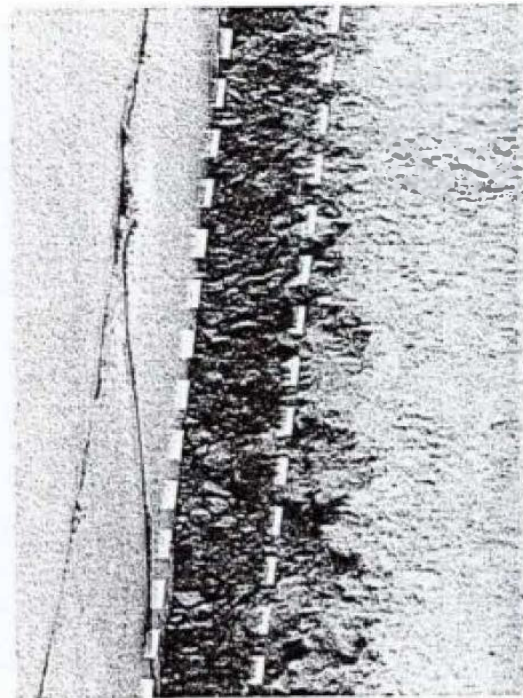
Picture 8. 25 Oct 04 - Detailed view of **debris** & **mud** next to U/S face panels.

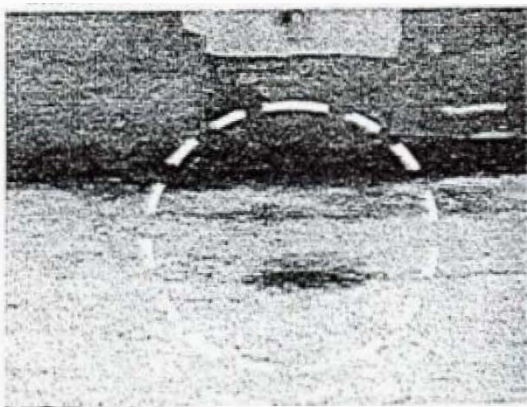
Picture 17. 26 Oct 04 - **Not acceptable U/S surface to place RCC. This is the most critical part of the dam regarding cleaning activities**

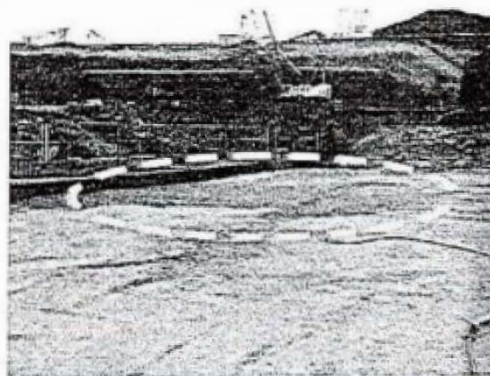
Picture 31. 27 Oct 04 10:30 AM. **Accumulation of debris after RCC surface cleaning by air jetting method. Lack of curing increases them.**

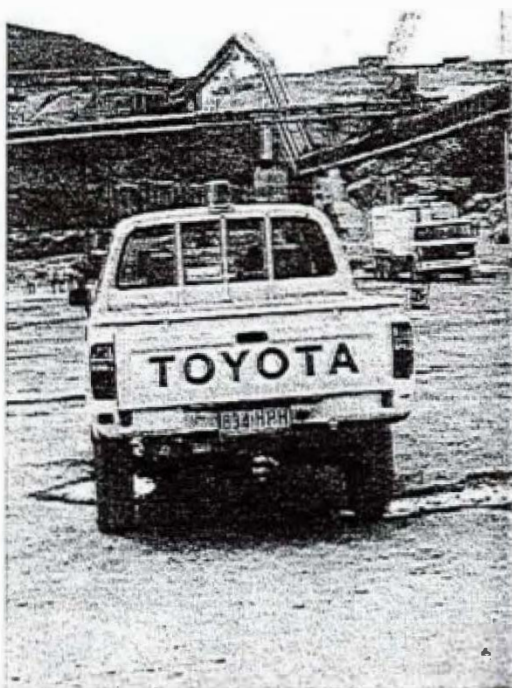
Picture 33. 27 Oct 04 10 AM. **Car inside the dam, contaminating the RCC surface. This is not acceptable.**

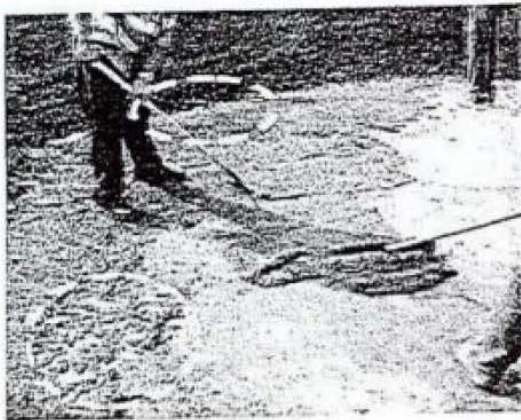
- MSA aggregate is 10 mm. Then, the minimum thickness of bedding mix should be 10 mm.
- The thickness of the bedding mix should be uniform and regular over all the RCC surface that requires it (See pictures).
- Attention is needed also in the bedding mix fillet along the U/S face: some areas have been left without bedding and some with insufficient bedding. This requires immediate correction.

Picture 1. 25 Oct 04 – Bedding mix spread on RCC surface by hand tools. RCC thickness is not being controlled. Some spots without bedding are possible to see.

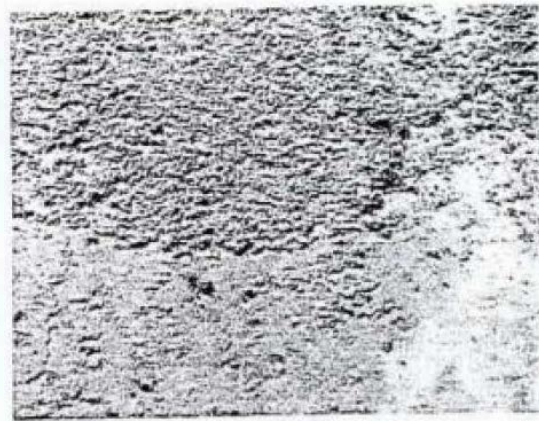
Picture 2. 25 Oct 04 – Detailed view of bedding mix spread on RCC surface. Not enough thickness of bedding is obvious.

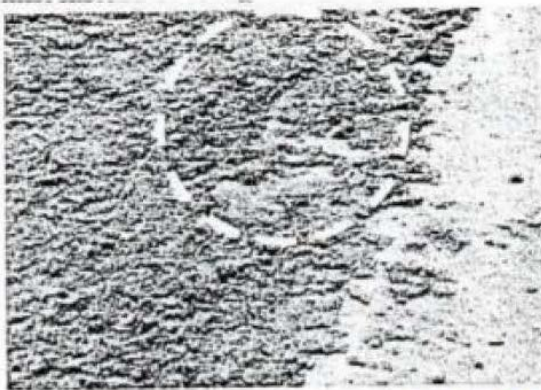
Picture 16. 26 Oct 04 – Irregular thickness of bedding mix. Some areas without bedding.

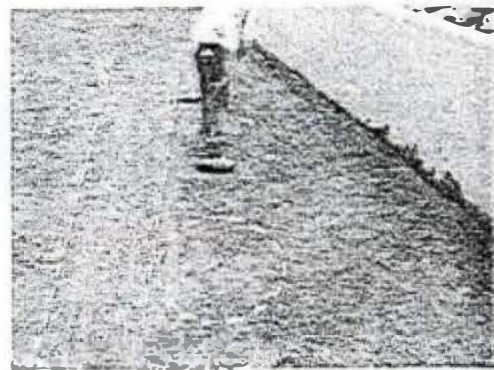
Picture 34. 26 Oct 04 – Area covered by bedding mix with irregular thickness. It is imperative that the Foremen control the bedding thickness (10 mm minimum).

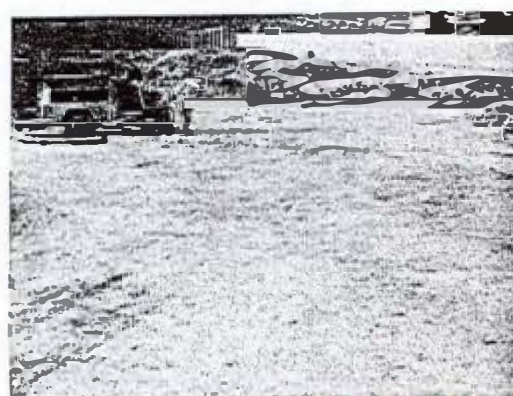
Picture 38. – 27 Oct 04 – Bad curing at left side of the dam (Ch 300 to 260) approx)

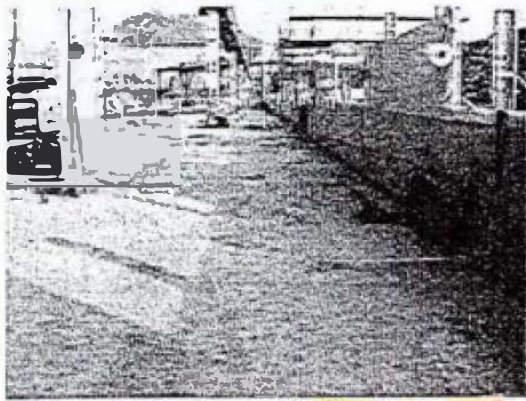
Picture 39. 27 Oct 04 - Bad curing area on critical area next to U/S face

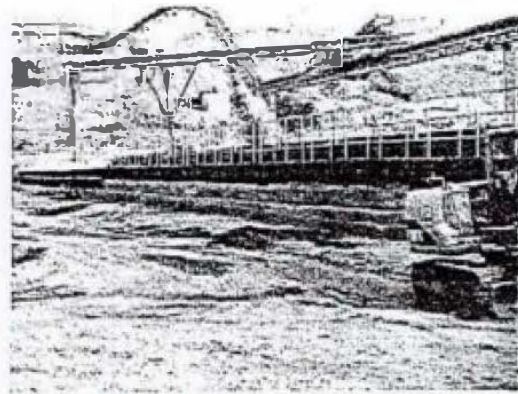
Picture 40. 27 Oct 04 - Bad curing at D/S step spillway section

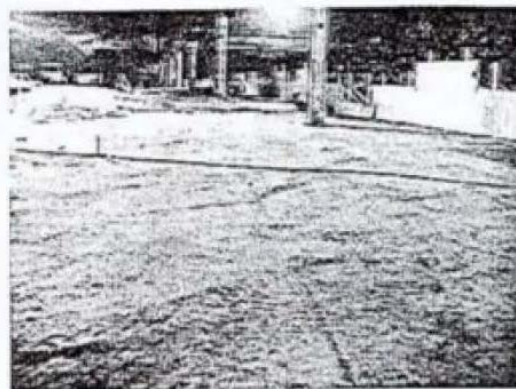
Picture 37. 27 Oct 04 NS. Good aggregate feed, good surface quality. Compare the surface of RCC placed 27-Oct to the one above placed 26-Oct

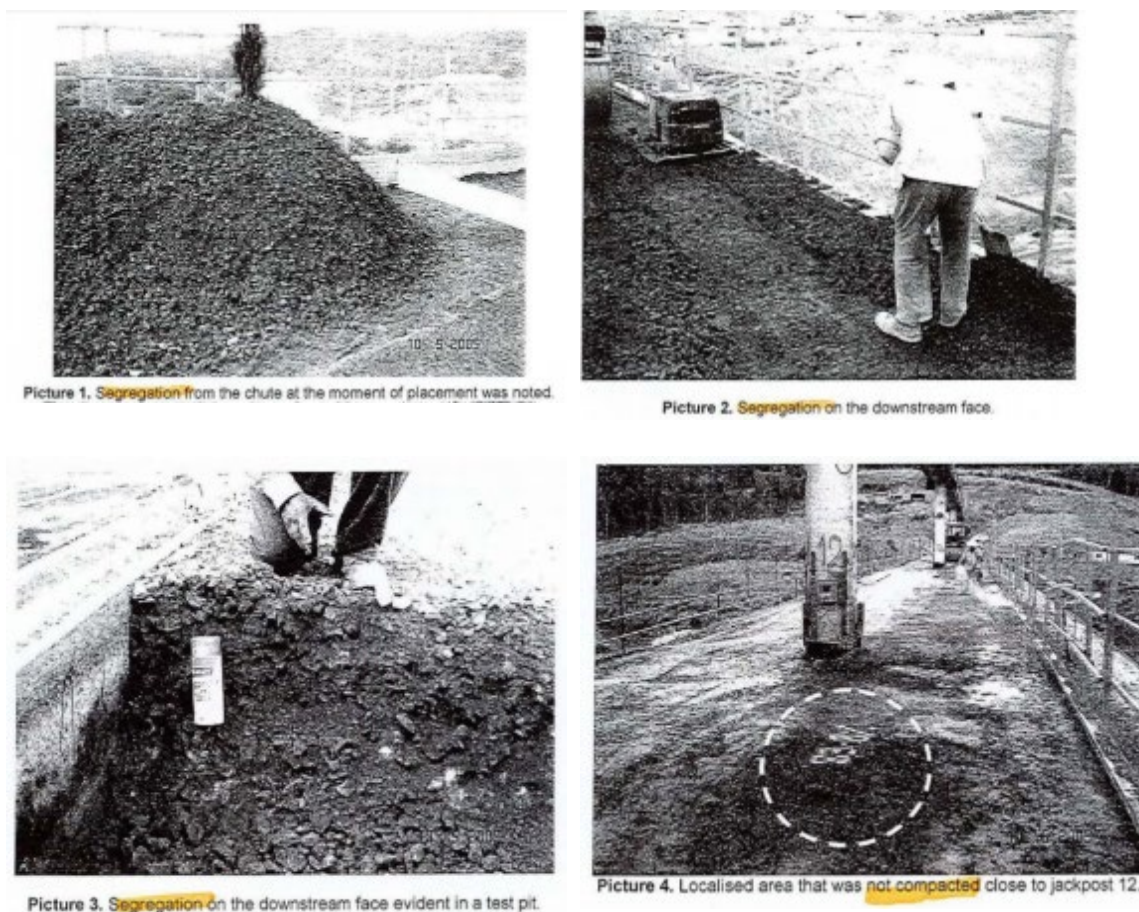
Figure 5.10 – Photographs included in QA memorandum dated 11 May 2005

- 5.101 The causes of the low densities were summarised in the following way:<sup>142</sup>
- *Compaction Delay (from 1 to 1.5 hours)*
  - *Use of new compaction equipment that did not comply with specifications (CC 422C HF)*

- *Segregation due to generation of high piles on hard RCC surface (see picture 1), lack of moisture, (area on the downstream where the chute delivers the RCC – see pictures 2 & 3)*

- *Lack of compaction in a localized area (near jackpost 12 – see picture 4)*
  - *Low Densities - Related to previous issues*
  - *Lack of moisture control on RCC surface at times*

5.108 In the picture report attached to the memorandum, the following photographs depicted segregation and a localised area not compacted:<sup>148</sup>

4. *Rollers complying with specification should be used*
5. *Moisture of RCC should be increased to account for loss of moisture until compaction and to control segregation*
6. *CC 422C HF in combination with vibrating plate is acceptable in areas where the big roller can not compact (only around jackposts).*

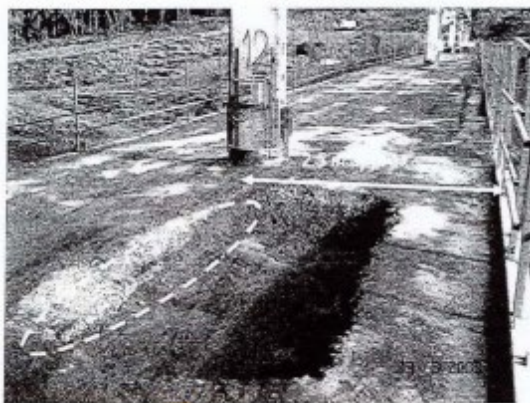
- *Segregation is noticeable at the bottom of the layer in some downstream test pits close to jackpost number 12 (Ch 286) and between jackposts 13 and 14 (Ch 226 to Ch 255)*
- *Segregation affects an area that ranges from 2.5 m (see picture 1) to 1.2 m (see picture 2) into the layer from the downstream side of the final layer. The upstream side of the layer looks good.*
- *Rain water from last night's showers is seeping through the layer, as reported by the sweeper operator, indicating the presence of segregation.*

Picture 1. Segregation 2.5 m from downstream is evident in this test pit.

5.110 Based on the visual inspections, the RCC Engineers had decided that all of the areas affected by segregation needed to be removed by an excavator. Segregation also appeared to have occurred on the downstream side of the RCC layer below. Photographs in the memorandum depict the issues with segregation:<sup>152</sup>

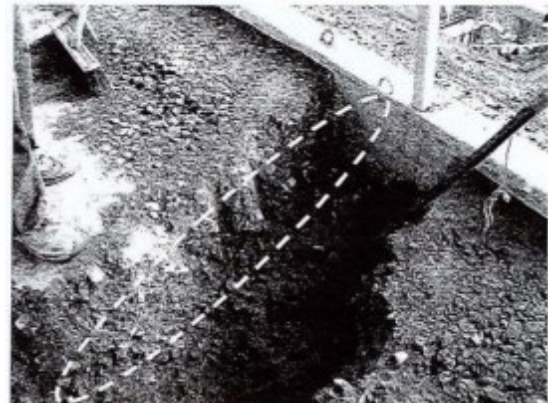
Picture 3. Segregation on the downstream face evident in a test pit.

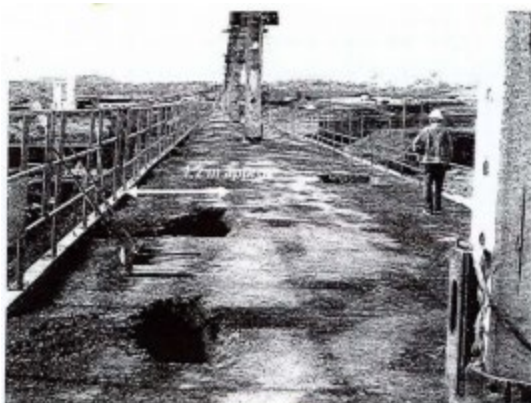
Picture 2. Extent of segregation on the downstream face.

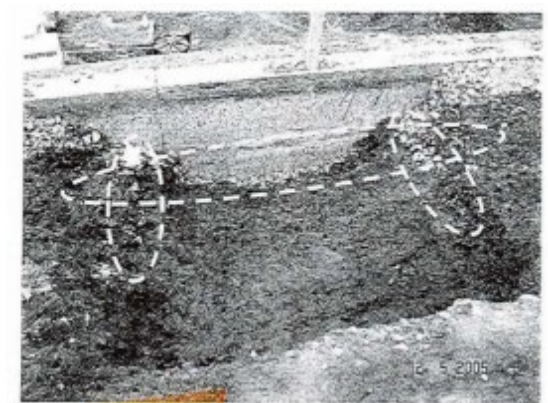
Picture 5. Segregation evident on the downstream also on the layer below.

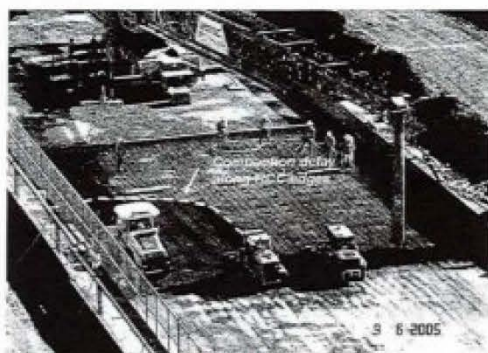
Picture 1 (9 June 05DS). RCC is compacted too close to the edges, the edges are then left without compaction for a significant time without leveling.

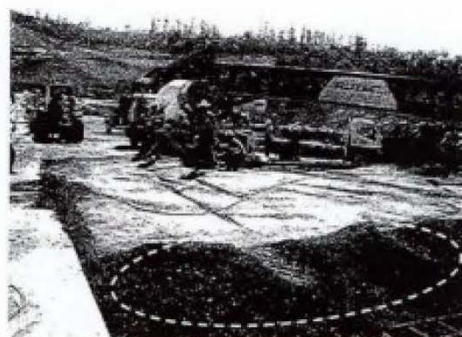
Picture 2 (28 May 05DS). RCC is compacted too close to the edges, the edges are then left without compaction for a significant time without leveling.

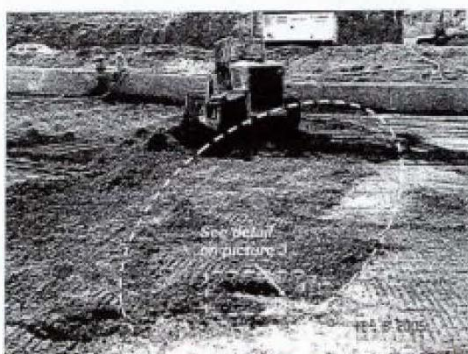
Picture 3 (12 June 05DS). Thin layer of RCC placed on top of previously compacted RCC surface.

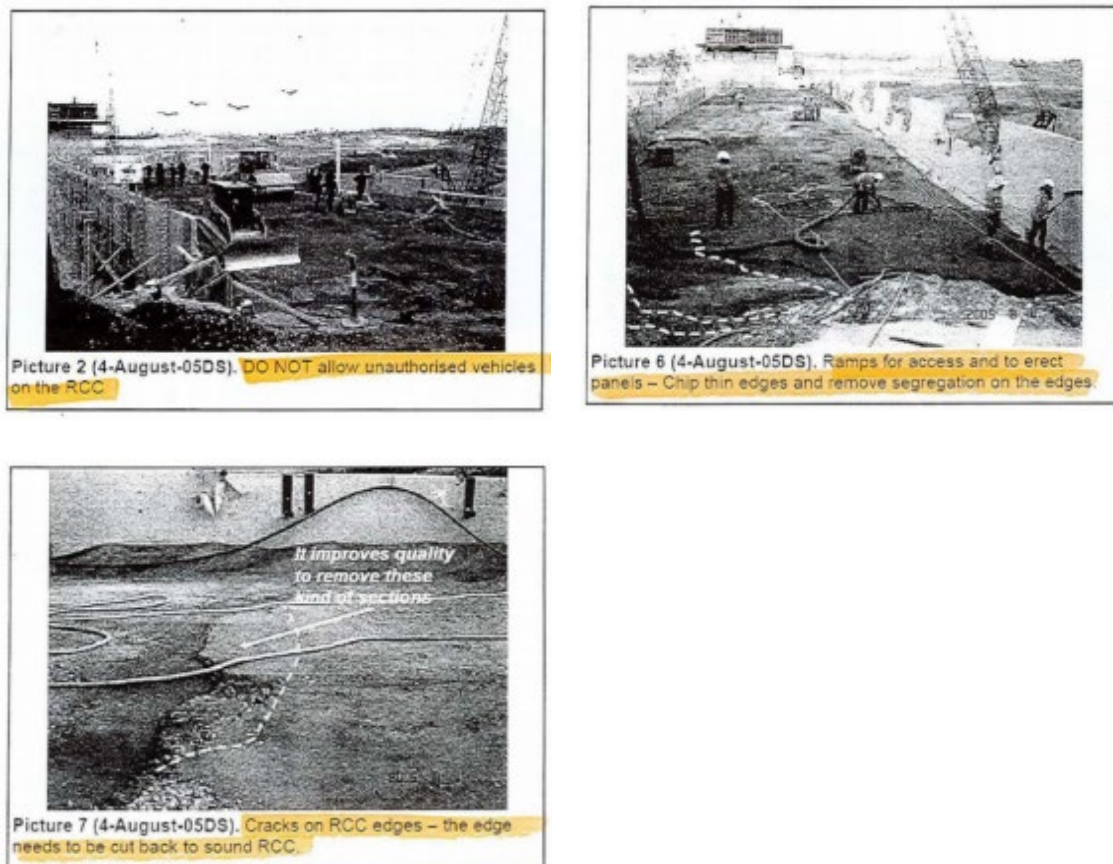
Figure 5.13 – Photographs from QA memorandum dated 4 August 2005.  
(Exhibit 32, **SUN.009.002.0203**, .0234 to .0235)

1. *Traffic onto the RCC requires control - as we all are aware, more traffic equals a bigger cleaning effort (See picture 2, unathorised vehicle on top of RCC.*
- ...
3. *A few ramps were placed in order to allow for access and to erect panels (Ch 125 approx). As it is known, the edges need to be chipped back when they are too thin, and segregation needs to be removed (See picture 6).*
4. *When an edge is rolled down or overlapped to another edge, it needs to be cut back to sound RCC. Picture 7 shows an area with cracks on the RCC. When this happens, it is advisable to remove this section.*

5.117 Pictures 2, 6 and 7 mentioned above are included below:

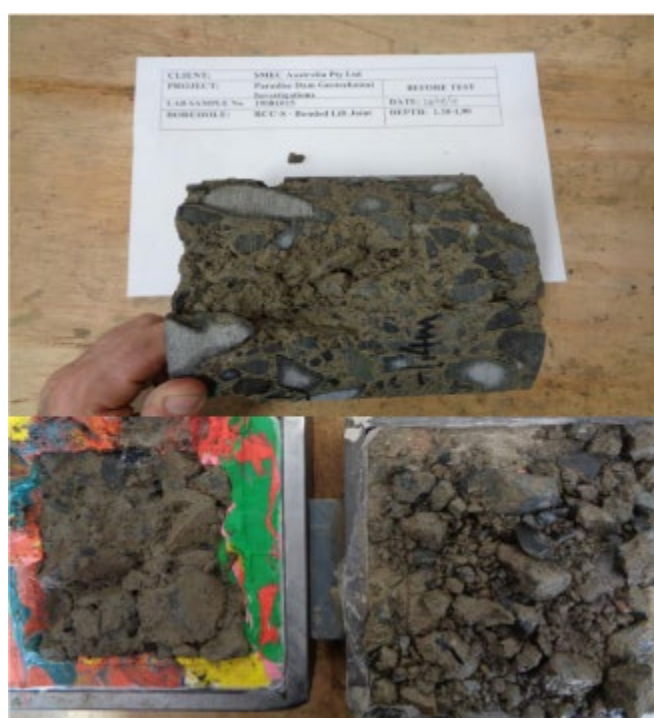
- 5.349 Mr Dolen considered that degradation of the samples subjected to testing was reflective of quality rather than the method of testing. Where only half of a surface showed substantial degradation, Mr Dolen interpreted that as primarily attributable to the quality of the RCC at that surface.<sup>594</sup> On that point, Mr Tatro agreed that a segregated sample of RCC would degrade ‘pretty quickly’. However, Mr Tatro said that he had never seen samples come out of a mould in such a poor condition as these samples. That struck him as a red flag that the testing procedure may not be appropriate.<sup>595</sup> A photograph of a sample before and after shear strength testing is included below:

- 5.350 Mr Dolen’s view was that the degradation of samples reflected that which would occur under displacement in the Dam.<sup>596</sup> Mr Foster said that the displacement to which samples were subjected in testing was representative of what would happen ‘*if you need large shearing to fail the dam, because you will be degrading the surfaces as it goes along with time, and that strength is what you’re going to end up with*’.<sup>597</sup>

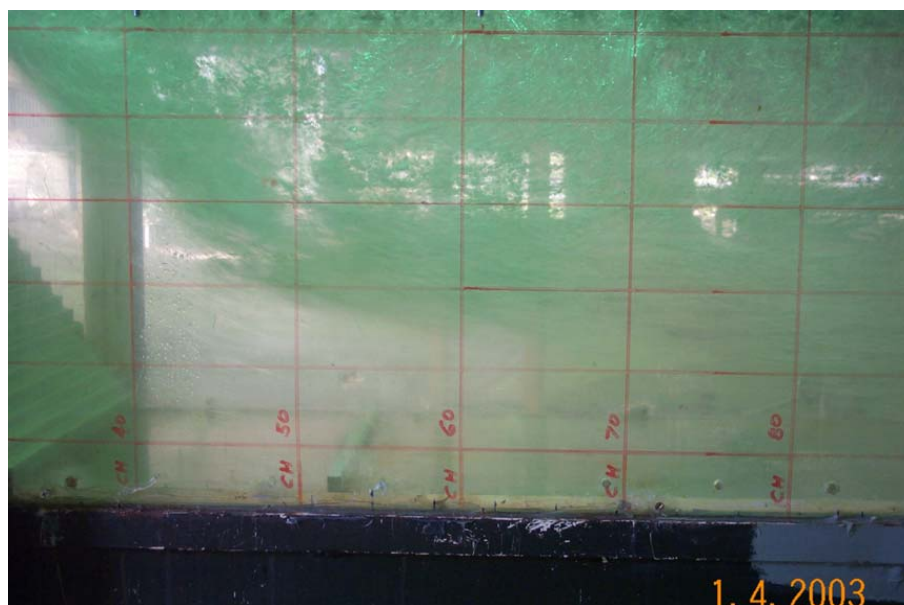
*A 'drowned jump' formed for higher discharges. At the drowned jump condition, instead of achieving good jump-type dissipation by the intermingling of the upstream and downstream flows, the incoming jet plunges to the bottom and carries along the basin floor at high velocity as shown in Figure 8. [Figure 8 is reproduced below as Figure 6.10.]*

Figure 6.10 – Image from SunWater's 2D model study showing the 'drowned jump' - the incoming water jet plunges to the bottom and carries along the basin floor at high velocity. The section of stepped spillway and end sill are visible. (SUN.018.027.0454, .0463)

6.236 A submerged, or drowned, jump is not the same as an hydraulic jump 'drowned out': such that '*the high tailwater level would drown out the [energy]*'.<sup>422</sup> A submerged jump '*can still carry erosive force*'.<sup>423</sup> It is an unfavourable hydraulic condition.<sup>424</sup>

6.237 A submerged jump may mean that the tailwater is not providing sufficient energy dissipation. That the jump is submerged does not mean it has lost its energy. It might still cause riverbed erosion. This phenomenon was identified by SunWater in its April 2003 2D model study. The relevant finding based on that model testing was:<sup>425</sup>

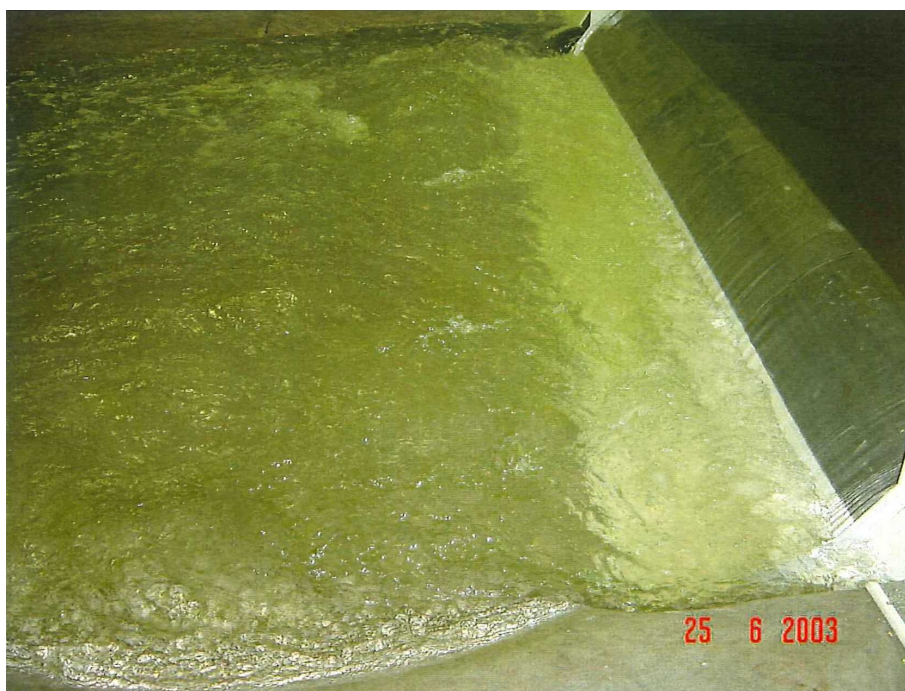
Figure 6.12 – 1:100 scale 3D model in operation. Primary spillway in approximate 1:500 AEP flood.  
(Exhibit 231, **DNR.007.0477**, .0826)

6.200 Comments were made in respect of each flow. Recirculation flows (in varying degrees depending on the section of the spillway and the discharge level) were noted as well as turbulent boils (again, in varying degrees; for example, the 1:1,000 AEP flood recorded an ‘unstable boil on the right hand side of the spillway apron’<sup>348</sup>). Due to the bend in the river near where the Dam was to be located, some ‘slight intermittent and unstable waves were observed’ on the left side of the spillway.<sup>349</sup> However, they were said to be of ‘no major concern to the overall performance of the spillway’.<sup>350</sup>

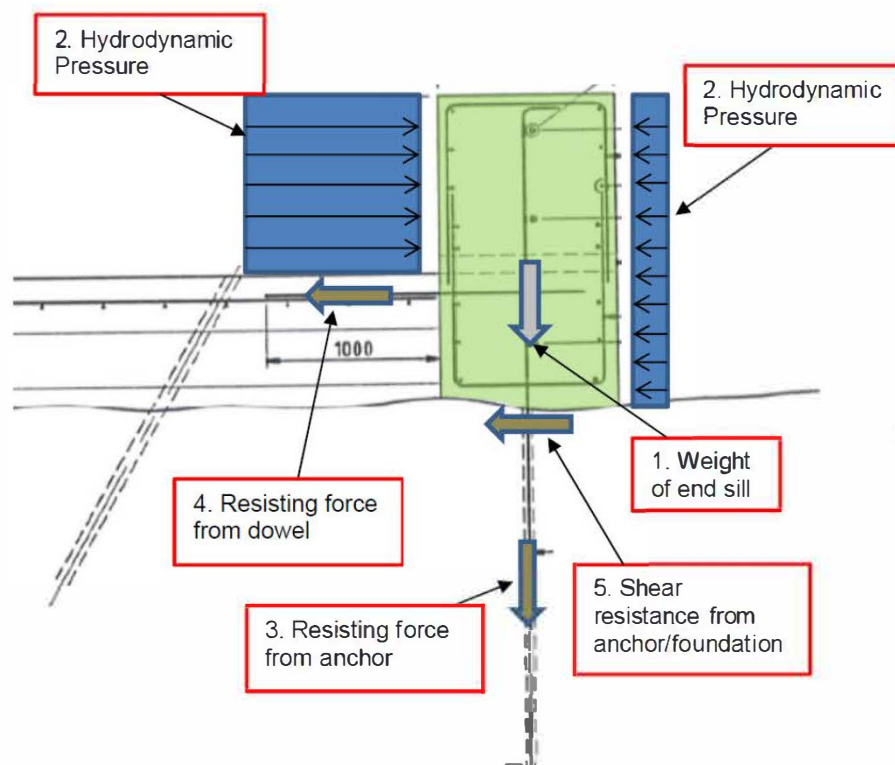
Figure 6.17 – Loading diagram for the end sill from the 2014 URS Review. The green shaded area is the end sill; the water is shown in blue. (Exhibit 237, **SWA.512.001.0578**, .0774)

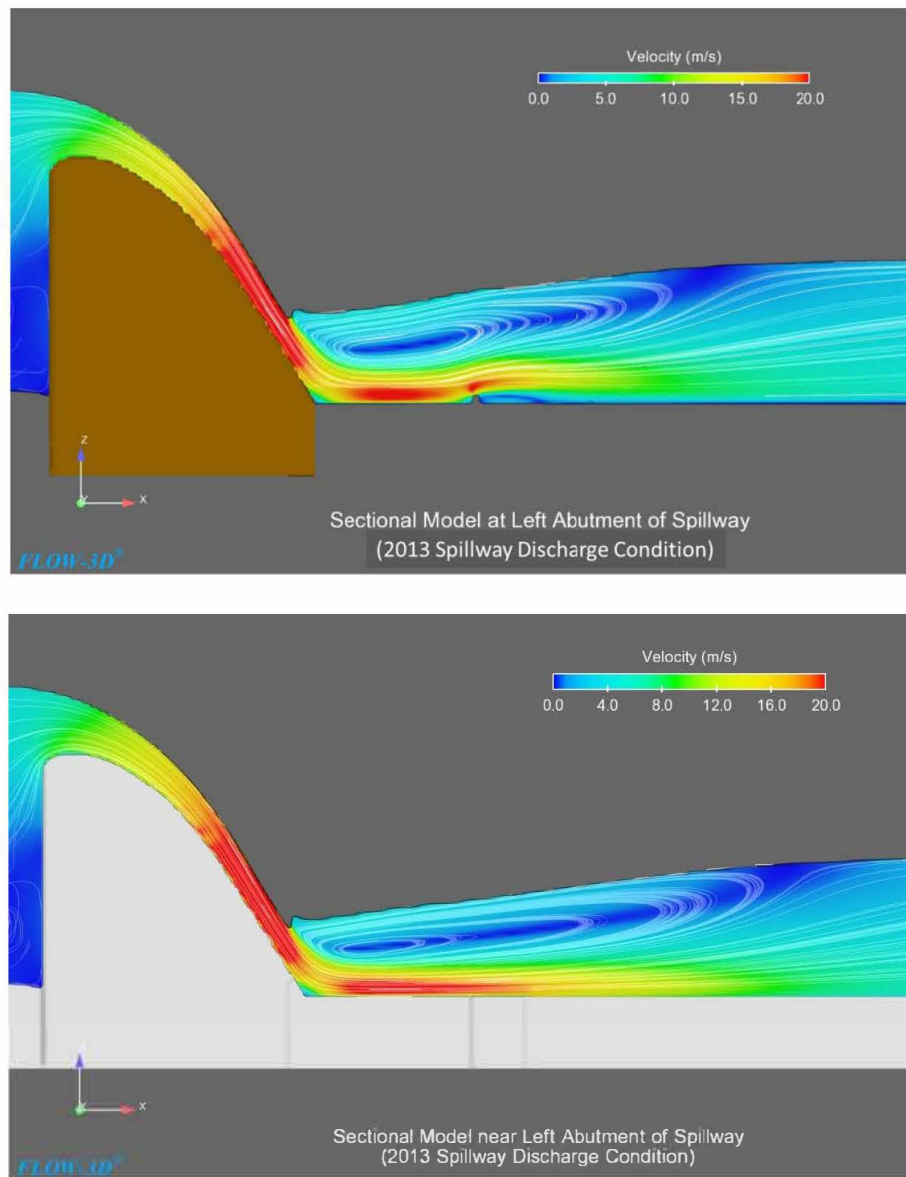
6.330 This condition was said to be ‘*primarily a result of the jet in the dissipation basin diving towards the bed, instead of rising up into flow towards the surface*’.<sup>568</sup> The relevant CFD model images are shown in Figure 6.18 below.

Figure 6.18 – URS CFD modelling for the 2013 event. The top image shows an ‘as-designed’ scenario (i.e. with an end sill) and the bottom image shows the situation without an end sill.  
(Exhibit 237, **SWA.512.001.0578**, .0634)
